Preliminary summary of storm-surge flooding on August 28, 2011 in coastal areas of Long Island and New York City

Update: Sept. 9, 2011

By: Chris Schubert U.S. Geological Survey, New York Water Science Center

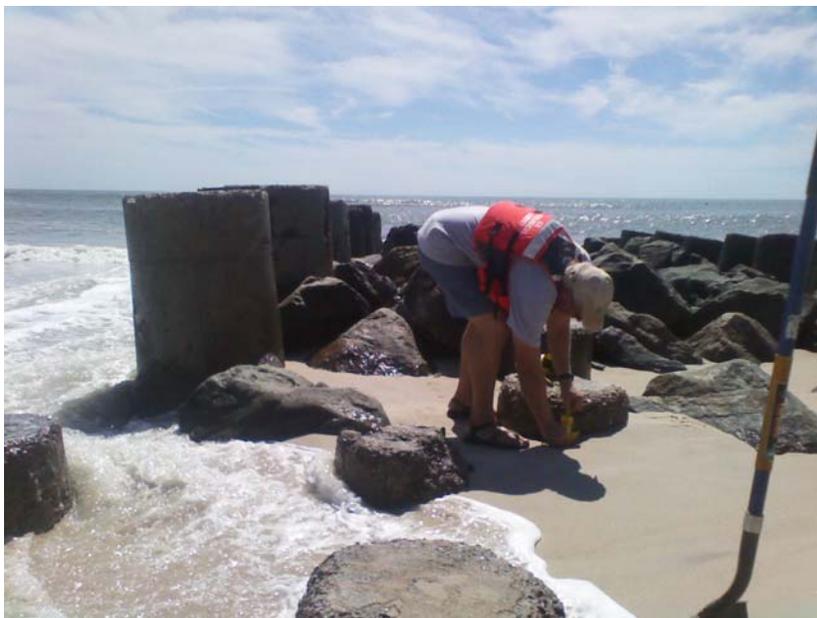
Figure 1.—U.S. Geological Survey hydrographer installing temporary storm-surge sensor on a jetty at Fire Island National Seashore, Suffolk County, New York. (Photograph taken by C.E. Schubert, U.S. Geological Survey.)

Prior to the storm's arrival, crews from the USGS installed 36 temporary storm-surge and barometric-pressure sensors and 2 rapid-deployment gages across the region. These temporary instruments supplemented an existing USGS network of 11 coastal monitoring stations on Long Island. The instruments were installed to monitor the potential impacts from Hurricane Irene as it moved up the coast. This New York deployment was part of a broader, regional effort by the USGS that installed over 250 temporary sensors from North Carolina to Maine. Crews from the USGS New York Water Science Center are currently recovering these sensors and beginning to process the collected data.

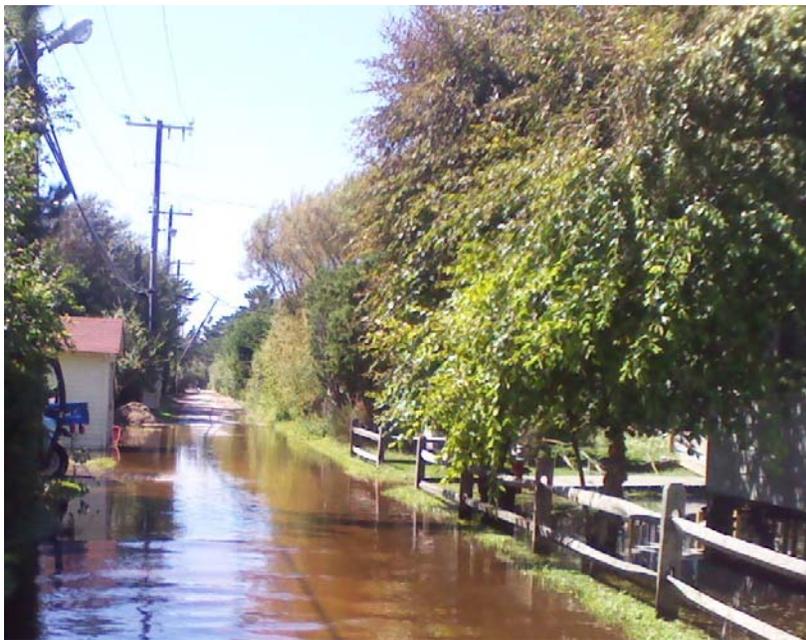
Figure 2.—Community flooded and telephone poles damaged at Fire Island National Seashore, Suffolk County, New York. (Photograph taken by C.E. Schubert, U.S. Geological Survey.)
