FLOOD OF SEPTEMBER 18-19, 2004 IN THE UPPER DELAWARE RIVER BASIN, NEW YORK

Open-File Report 2005-1166

By Lloyd T. Brooks

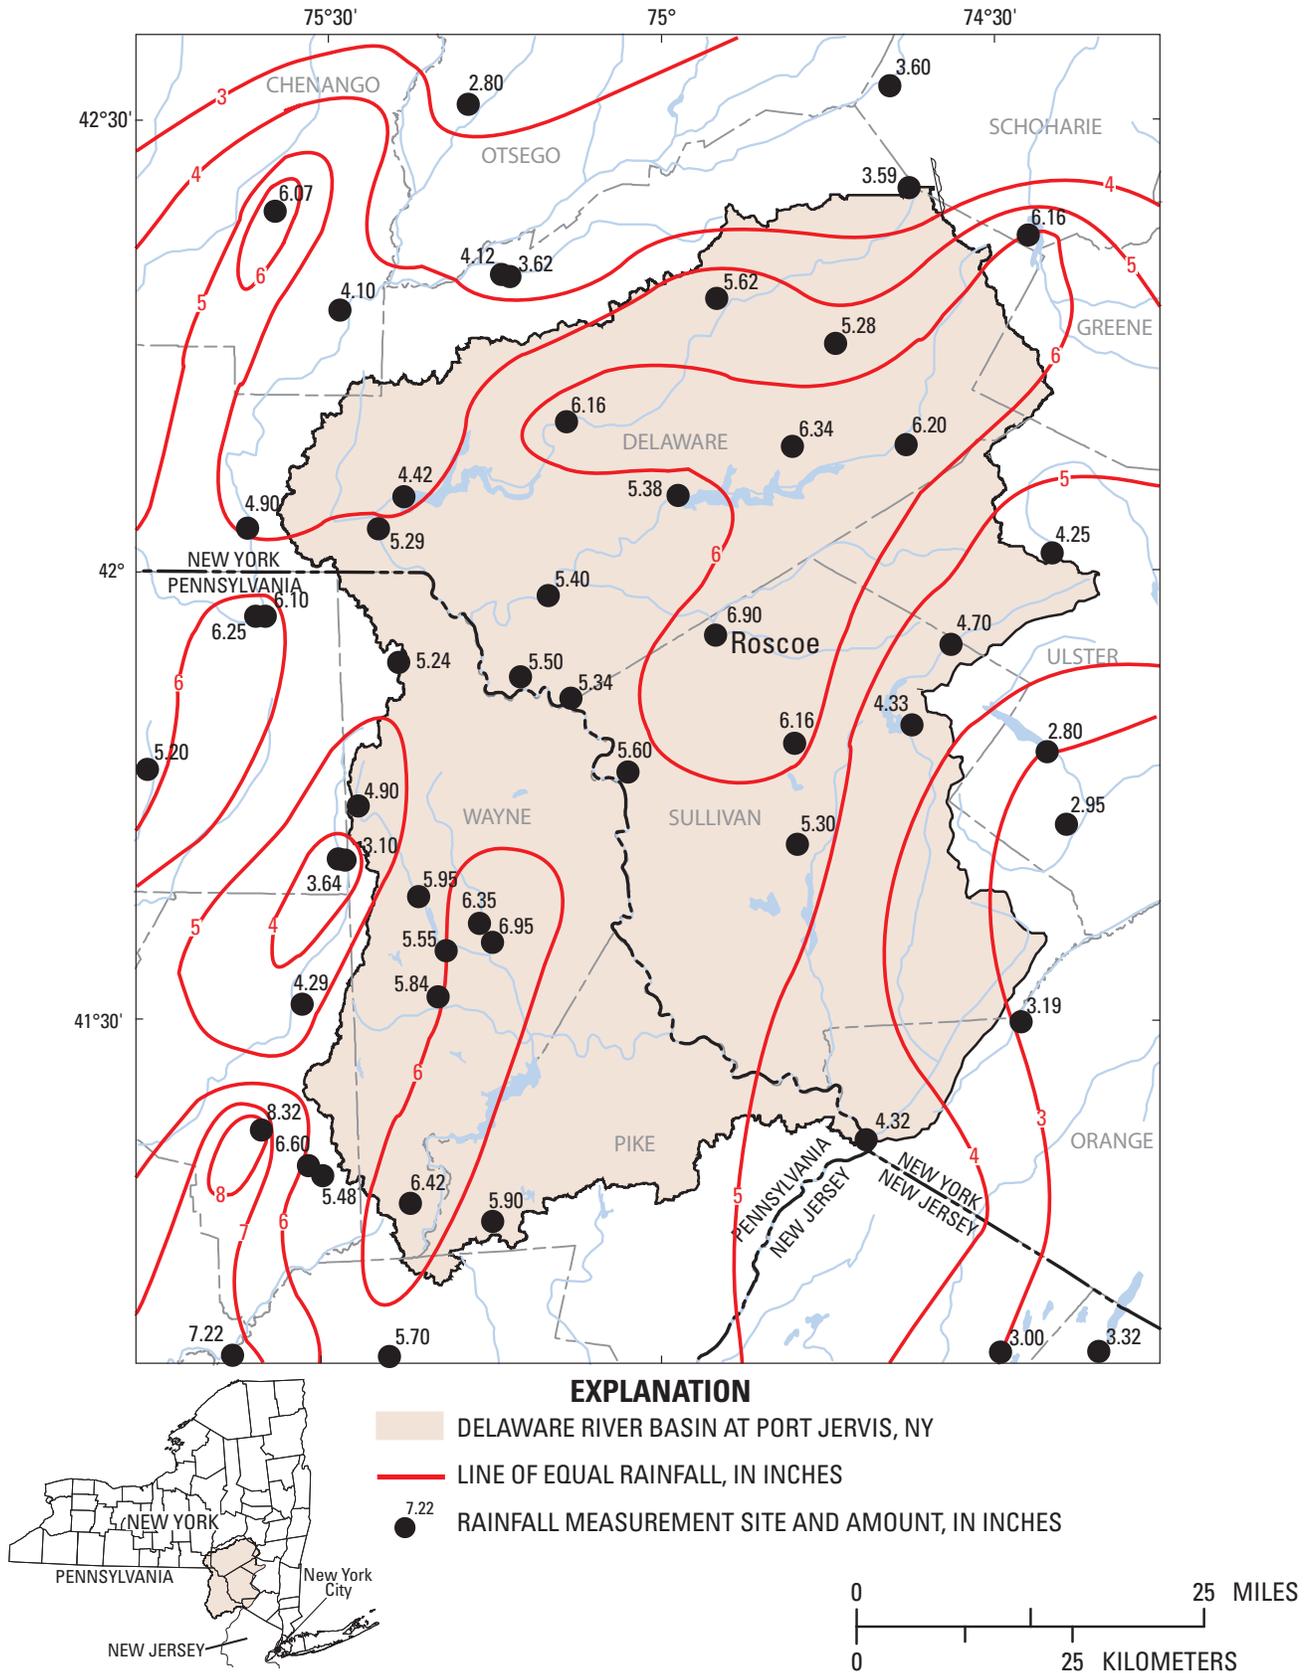
Figure 1. Pertinent geographic features of southeastern New York and rainfall from the storm of September 17-18, 2004 (Data provided by National Oceanic and Atmospheric Administration).

Heavy rain associated with the remnants of tropical depression Ivan produced widespread flooding in the upper Delaware River basin during September 18-19, 2004 (fig. 1). From 4 to more than 6 inches of rain fell over the 24-hour period, and the runoff flooded many parts the basin. More than 100 homes were damaged and more than 1,000 people were evacuated. Delaware, Orange, and Sullivan Counties in New York were declared Federal disaster areas.

The interaction of the remnants of tropical depression Ivan with a frontal boundary in southeastern New York during September 17-18, 2004, (fig. 1), caused widespread rainfalls of 4 to more than 6 inches that inundated the upper Delaware River basin.

Selected rainfall depths with respect to frequency and duration at Roscoe, N.Y., which is centrally located in the upper Delaware River basin (fig. 1), are listed in table 2.

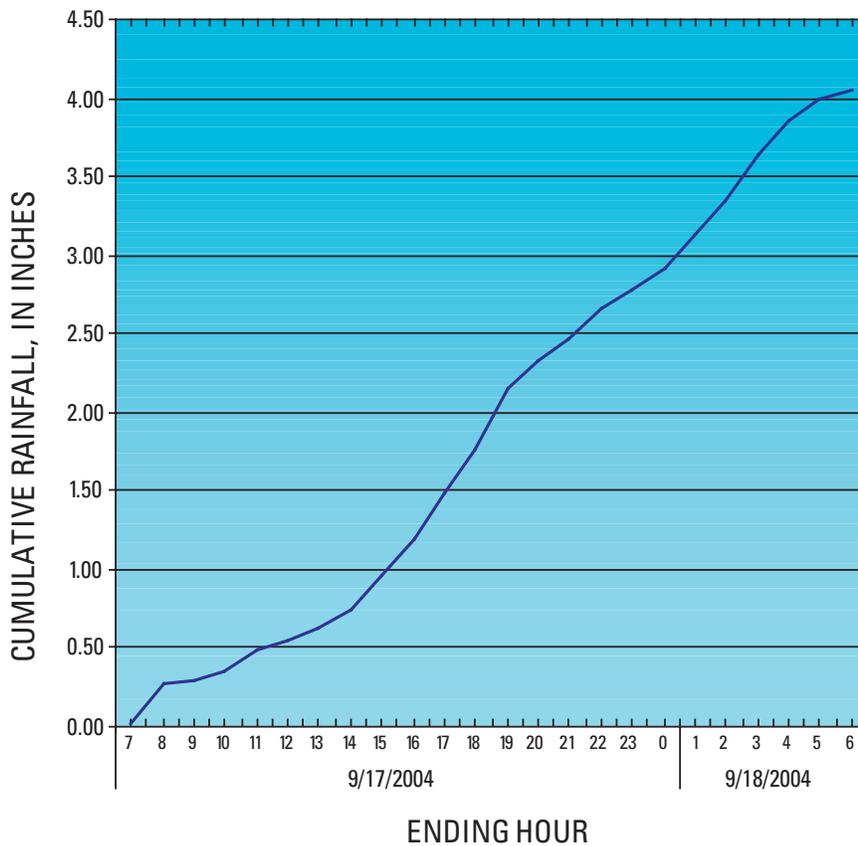
Figure 2. Cumulative rainfall during September 17-18, 2004 recorded at National Weather Service Office, Binghamton, N.Y.

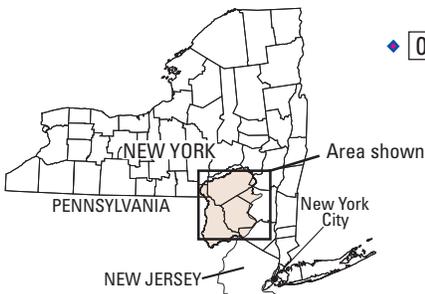
Figure 3. Locations of selected U.S. Geological Survey streamflow-gaging stations in the upper Delaware River Basin, New York. See Table 3 for station names and flood-related data.

Locations of the 33 USGS streamflow-gaging stations in the upper Delaware River basin are presented in figure 3, and historical flood peaks and the peak discharges for the flood of September 18-19, 2004, at those stations are presented in table 3.

A part of this study entailed measurement of peak water-surface elevations at 49 sites along five streams - Little Beaver Kill, Willowemoc Creek, Beaver Kill, East Branch Delaware River and the Delaware River in New York (fig. 7). Seven of these sites were USGS streamflow-gaging stations (fig. 3).

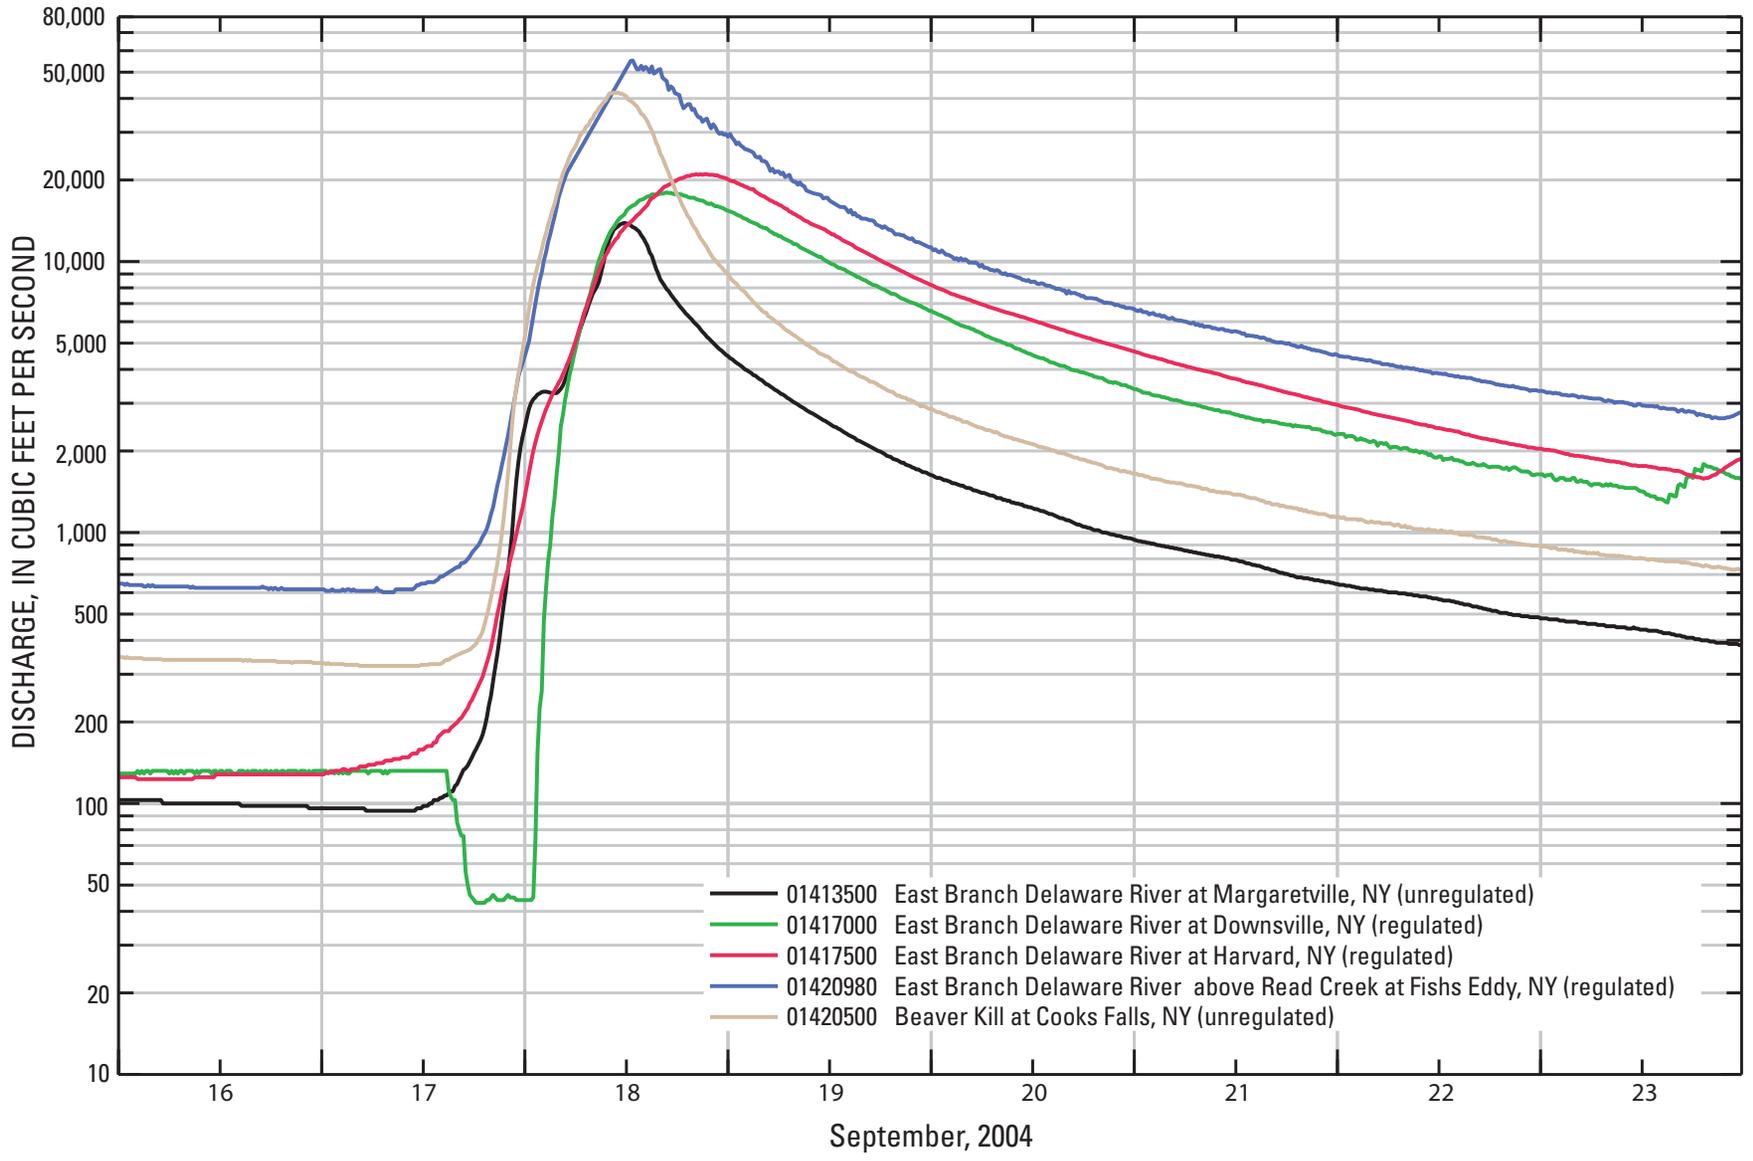
Figure 4. Discharge hydrographs for selected streamflow-gaging stations in the East Branch Delaware River basin, September 16-23, 2004. (Locations are shown in fig. 3.)

Discharge hydrographs for five USGS streamflow-gaging stations (two unregulated reaches of two streams and three regulated reaches) in the East Branch Delaware River basin during the storm are presented in figure 4.

Flows at stations on the unregulated streams peaked in the late morning on September 18, whereas peaks at stations on regulated streams were a few hours later (fig. 4).

Peak discharges at stations on the regulated reaches of the East Branch Delaware River at Downsville (01417000), Harvard (01417500) and above Read Creek at Fishs Eddy (01420980) (fig. 4) equaled or exceeded a 100-year recurrence interval. These stations are downstream from Pepacton Reservoir. Computation of recurrence intervals used the period since the current degree of regulation (1955 to present). The storm brought new peaks-of-record for the period of regulation at these stations. Except for the station on Oquaga Creek, peak discharges at stations in the West Branch Delaware River basin had recurrence intervals of less than 40 years.

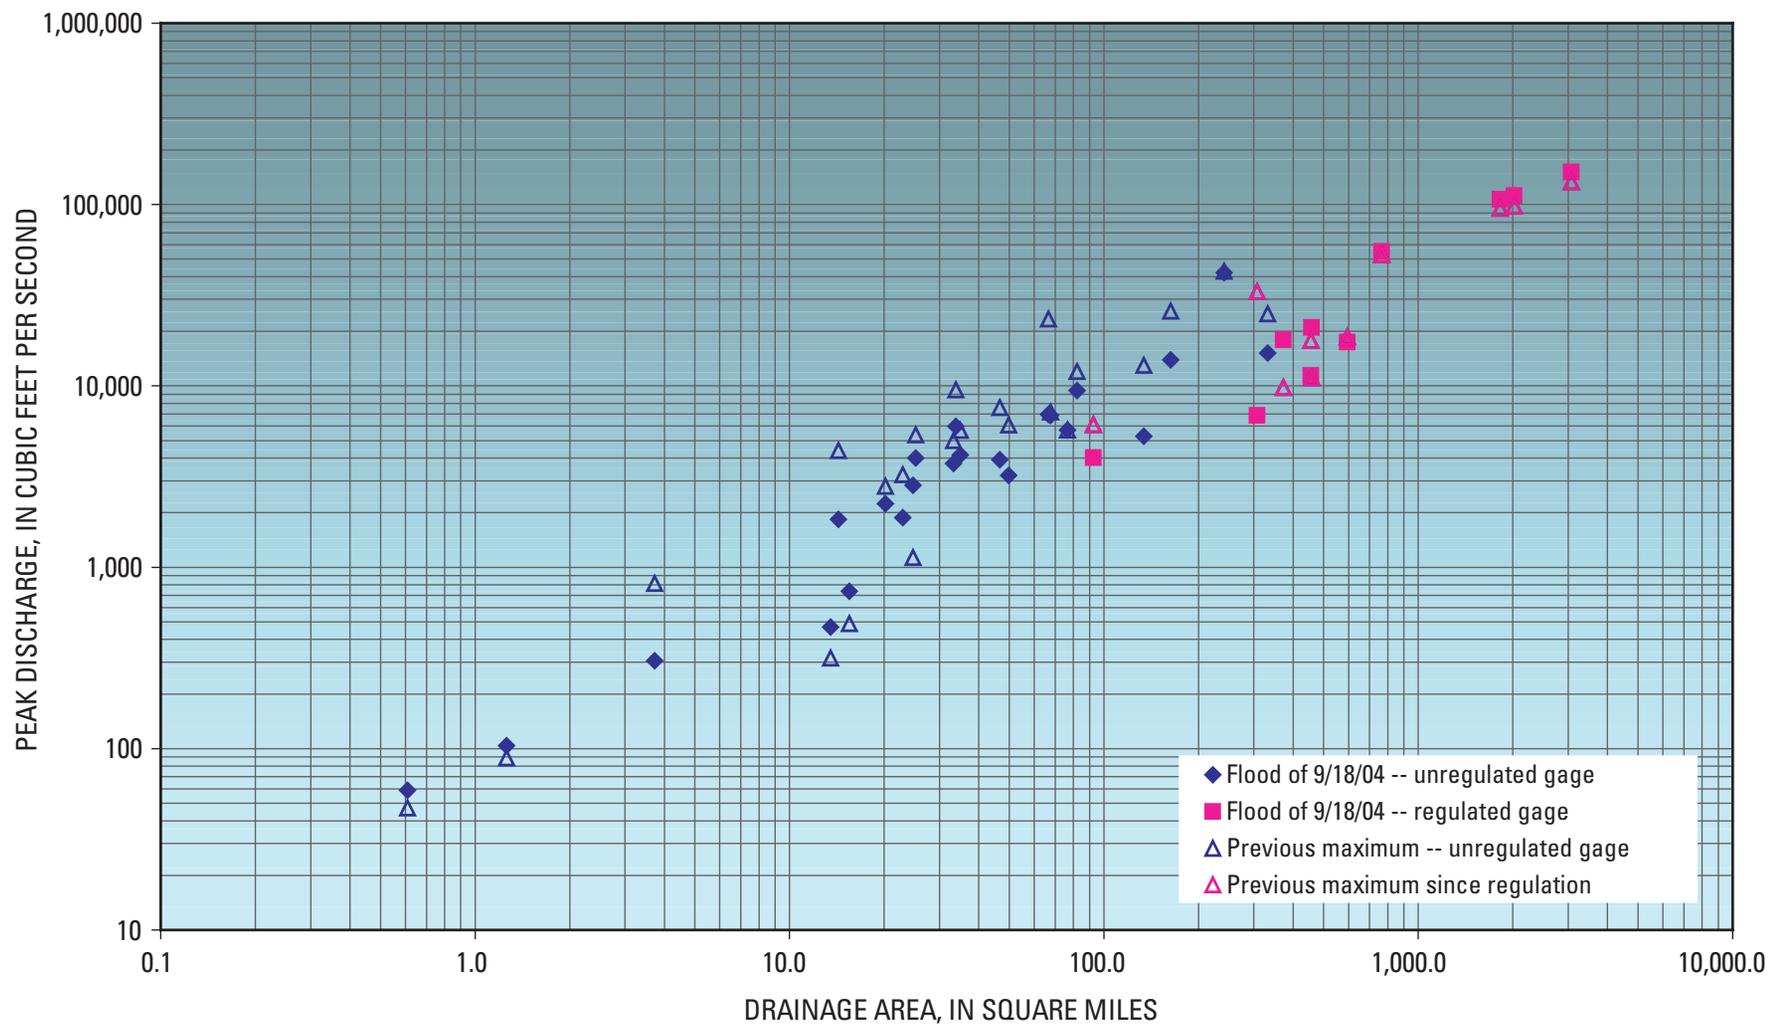
Figure 5. Peak discharge at selected streamflow-gaging stations in the upper Delaware River basin, N.Y. as a function of drainage area during the flood of September 18-19, 2004 and previous maximum known discharges.

Three stations on the Delaware River below the confluence of the East and West Branch Delaware Rivers recorded new maximum discharges (since 1955) with recurrence intervals of 80 to 90 years. Peak discharges at selected sites in the upper Delaware River basin are plotted as a function of drainage area in figure 5 with previous peak-of-record discharges.

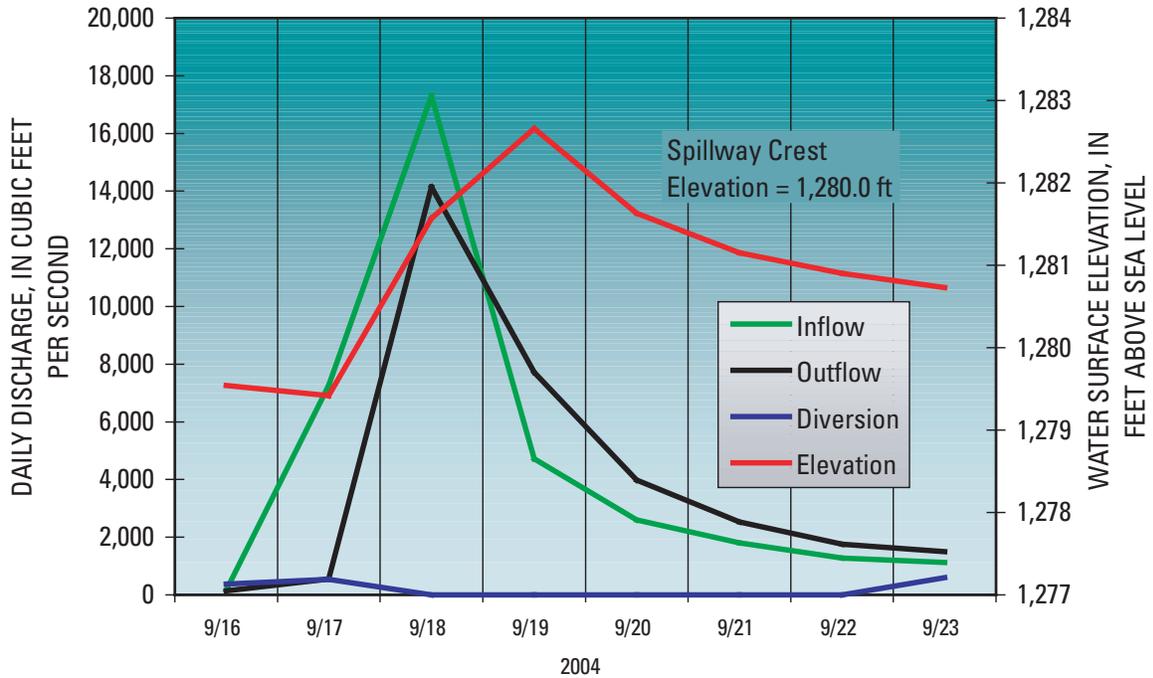
A. Pepacton Reservoir at Downsville, N.Y.

(sea level). The maximum computed daily mean inflow to the Pepacton Reservoir was 17,300 ft³/s on September 18 (fig. 6A).

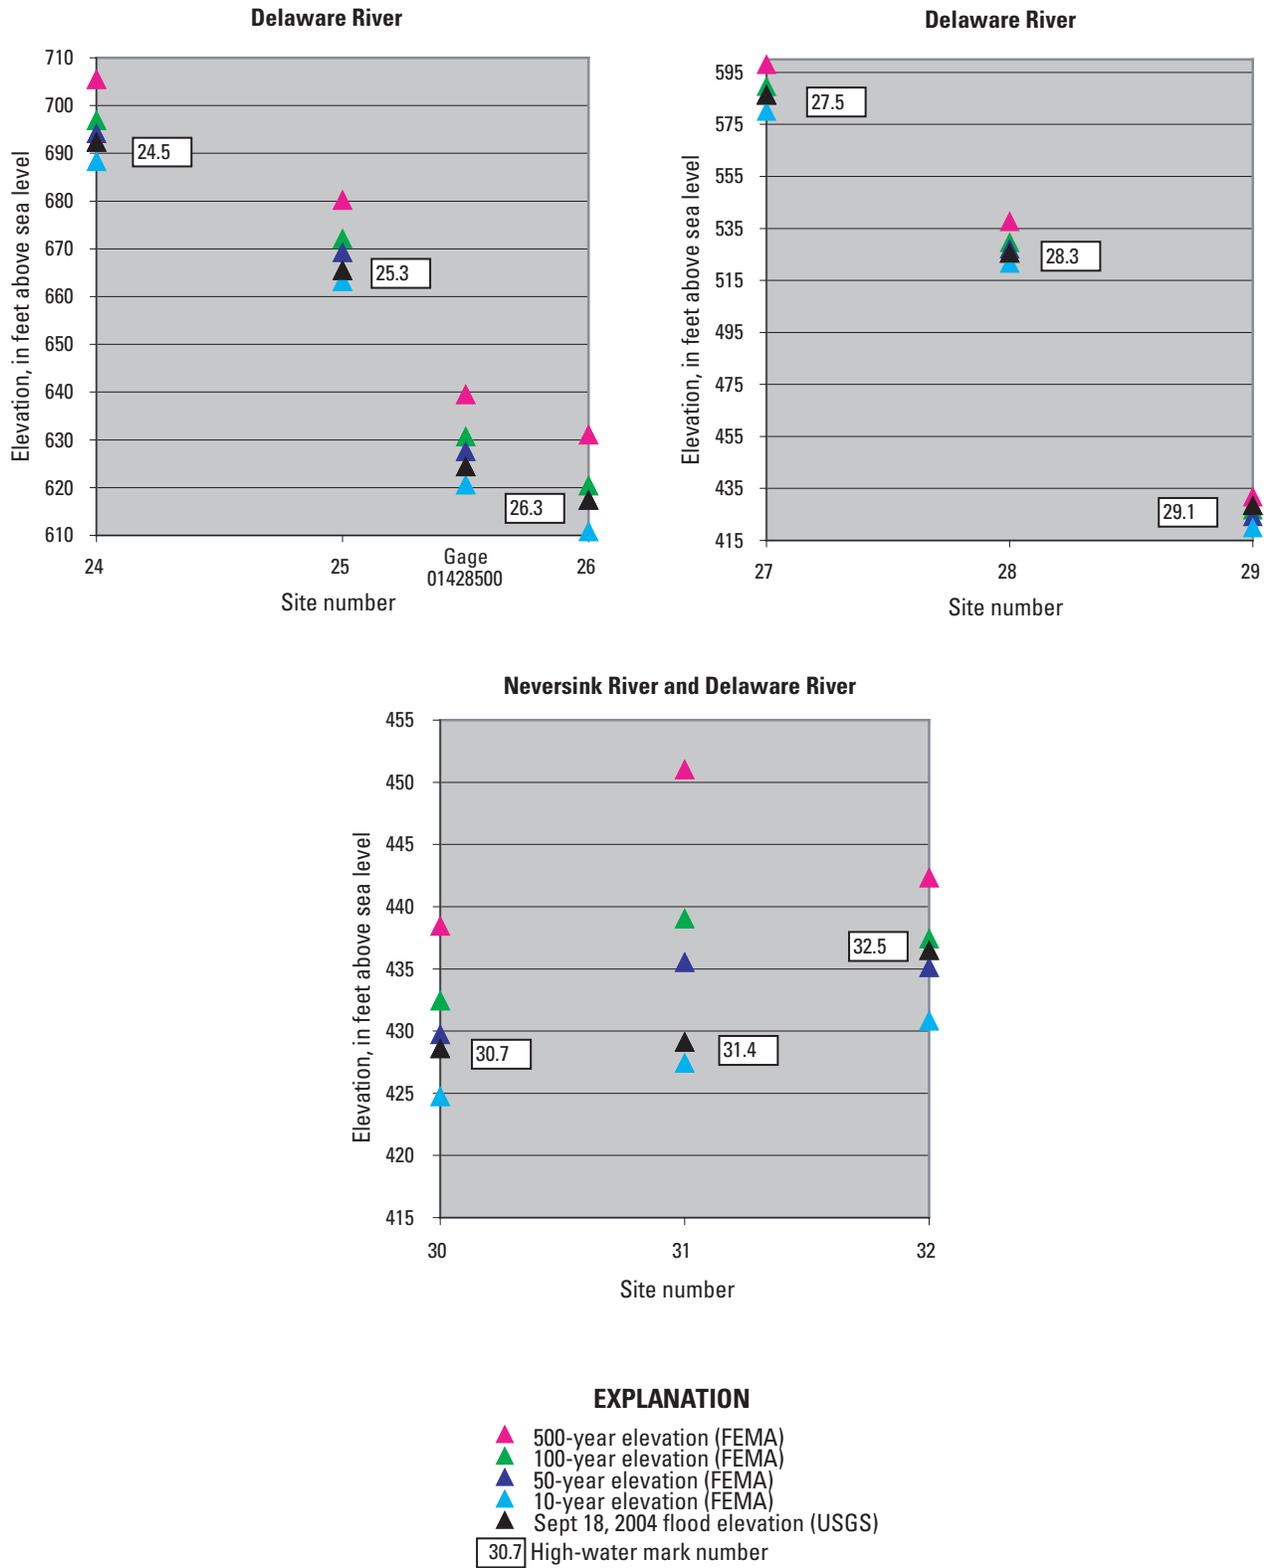
Figure 8. Peak water-surface elevations at selected sites in the upper Delaware River basin during September 18-19, 2004

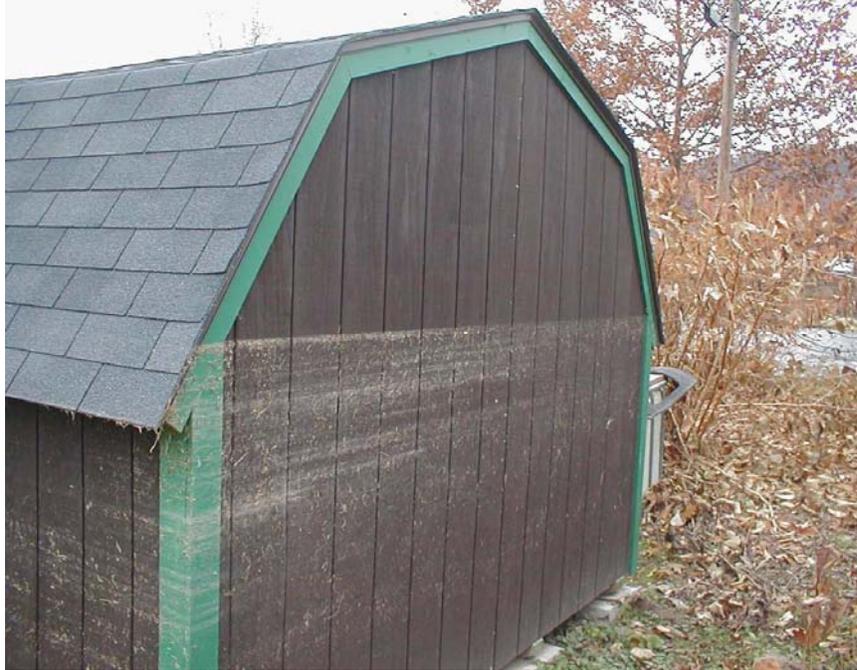
High-water mark 1.1 is an excellent seed line 4.7 feet above the ground, on the side of a wooden barn, on the left bank, 30 feet downstream from the State Route 30 bridge, at elevation 1,105.44 feet above sea level (Lat 42° 04' 27.1", long 74° 58' 55.4").

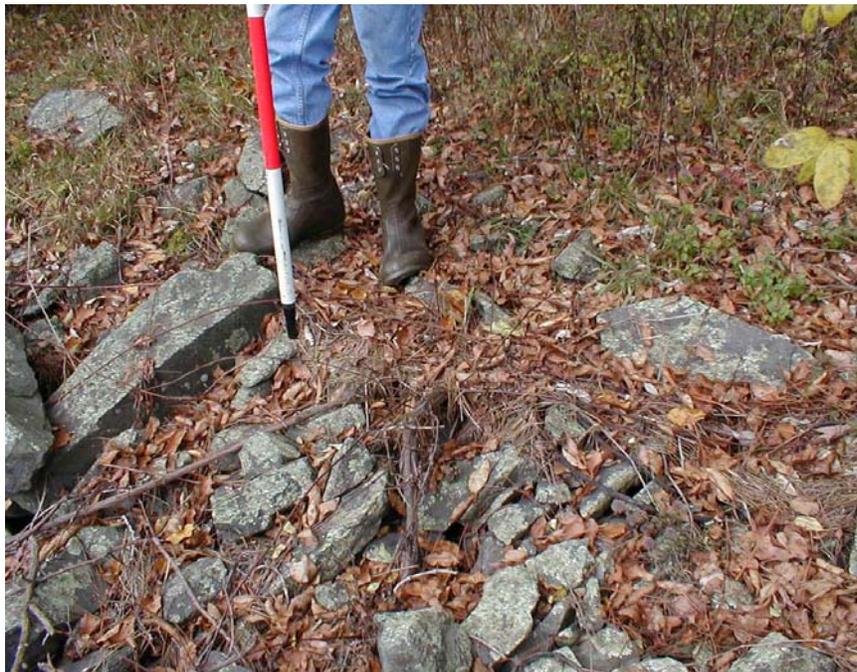
High-water mark 1.4 is a poor debris line on the ground, on the right bank, 120 feet upstream from the State Route 30 bridge, at elevation 1,105.38 feet above sea level (Lat 42° 04' 30.5", long 74° 58' 53.2").

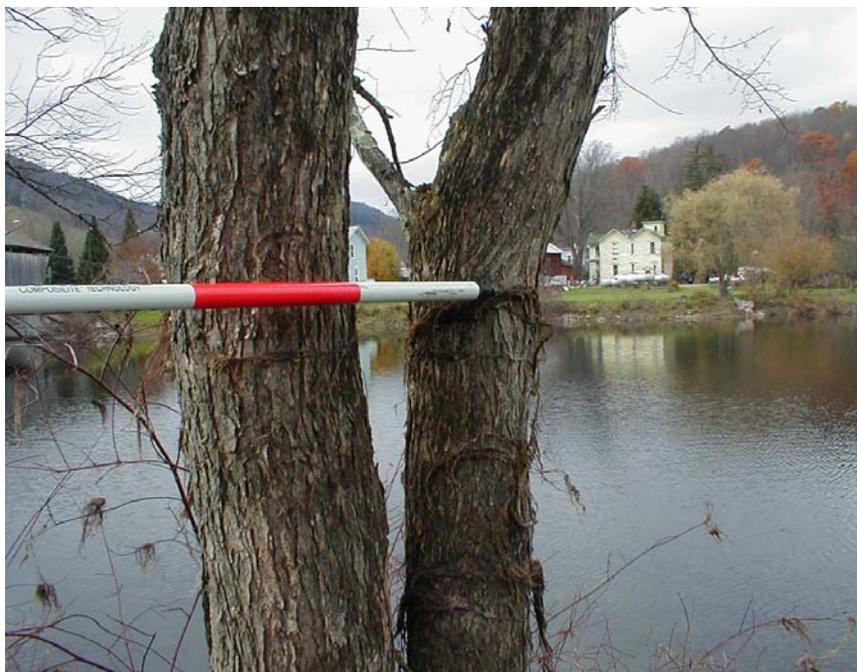
High-water mark 2.1 is a poor debris line about 5 feet above the ground, on a tree on the left bank, 100 feet upstream from the Bridge Street bridge, at elevation 1,103.12 feet above sea level (Lat 42° 04' 34.1", long 74° 59' 23.8").

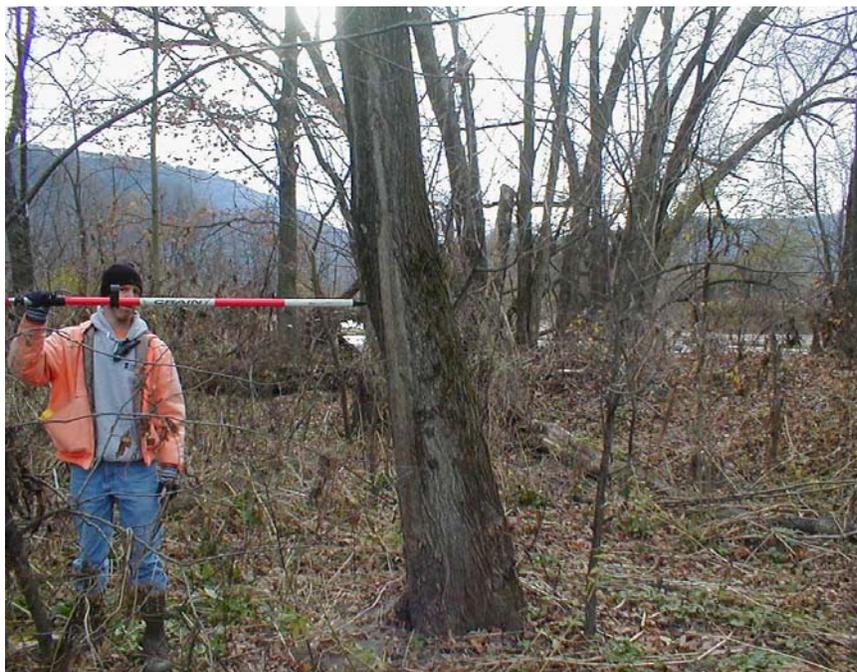
High-water mark 2.3 is a poor debris line about 5 feet above the ground, on a tree on the left bank, 70 feet downstream from the Bridge Street bridge, at elevation 1,102.93 feet above sea level (Lat 42° 04' 34.2", long 74° 59' 27.1").

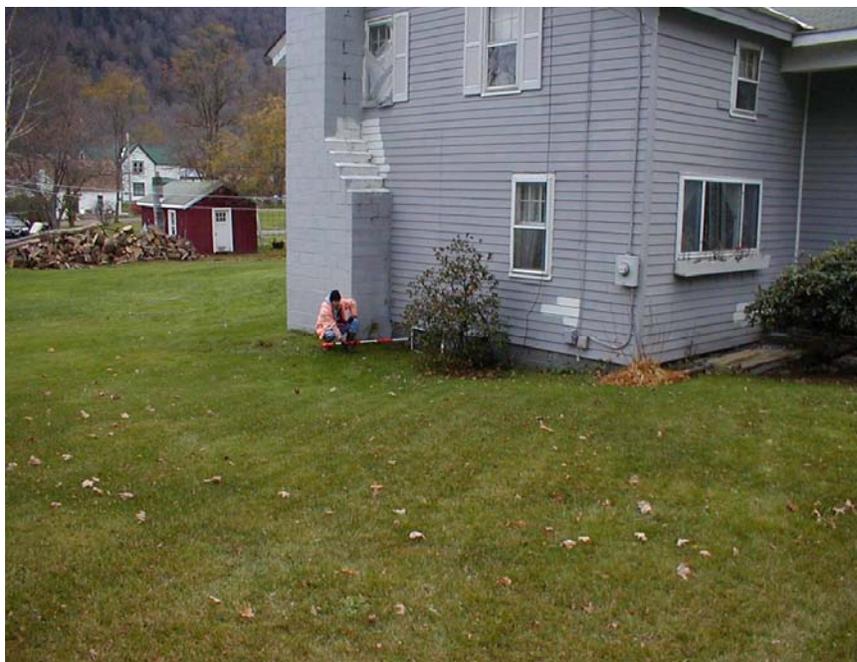
High-water mark 3.1 is an excellent mud line 0.7 feet above the ground, on the foundation of house 6512 on River Road, on the left bank, at elevation 1,100.53 feet above sea level (Lat 42° 04' 24.2", long 74° 59' 24.1").

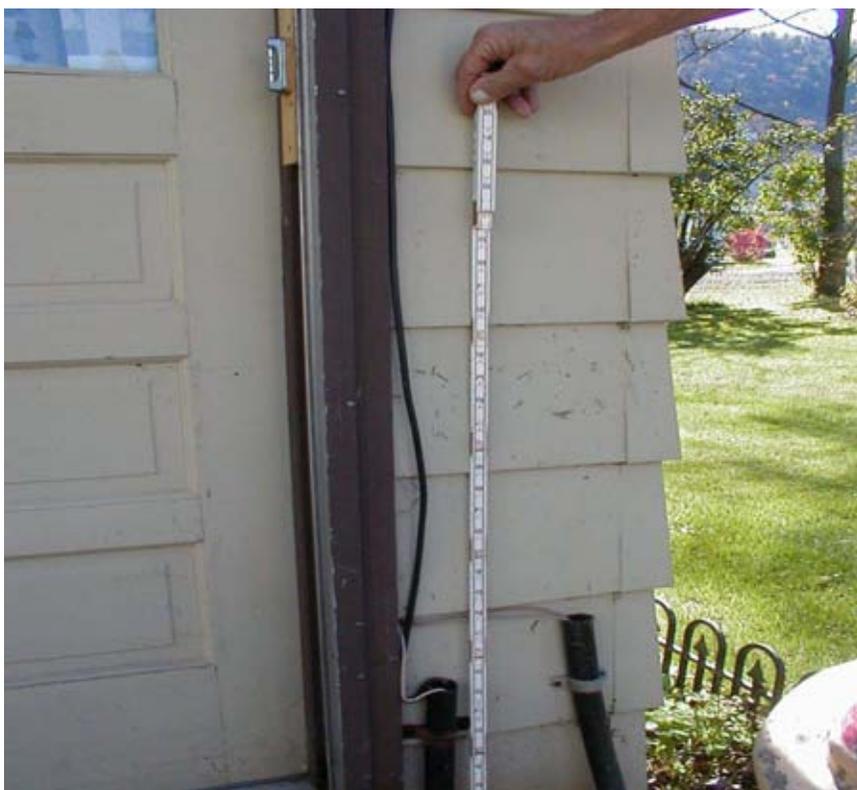
High-water mark 3.2 is an excellent seed line 2.4 feet above the ground, on the side of the guest house in the back yard of house 45 on Depot Street, on the left bank, at elevation 1,100.54 feet above sea level (Lat 42° 04' 22.8", long 74° 59' 23.6").

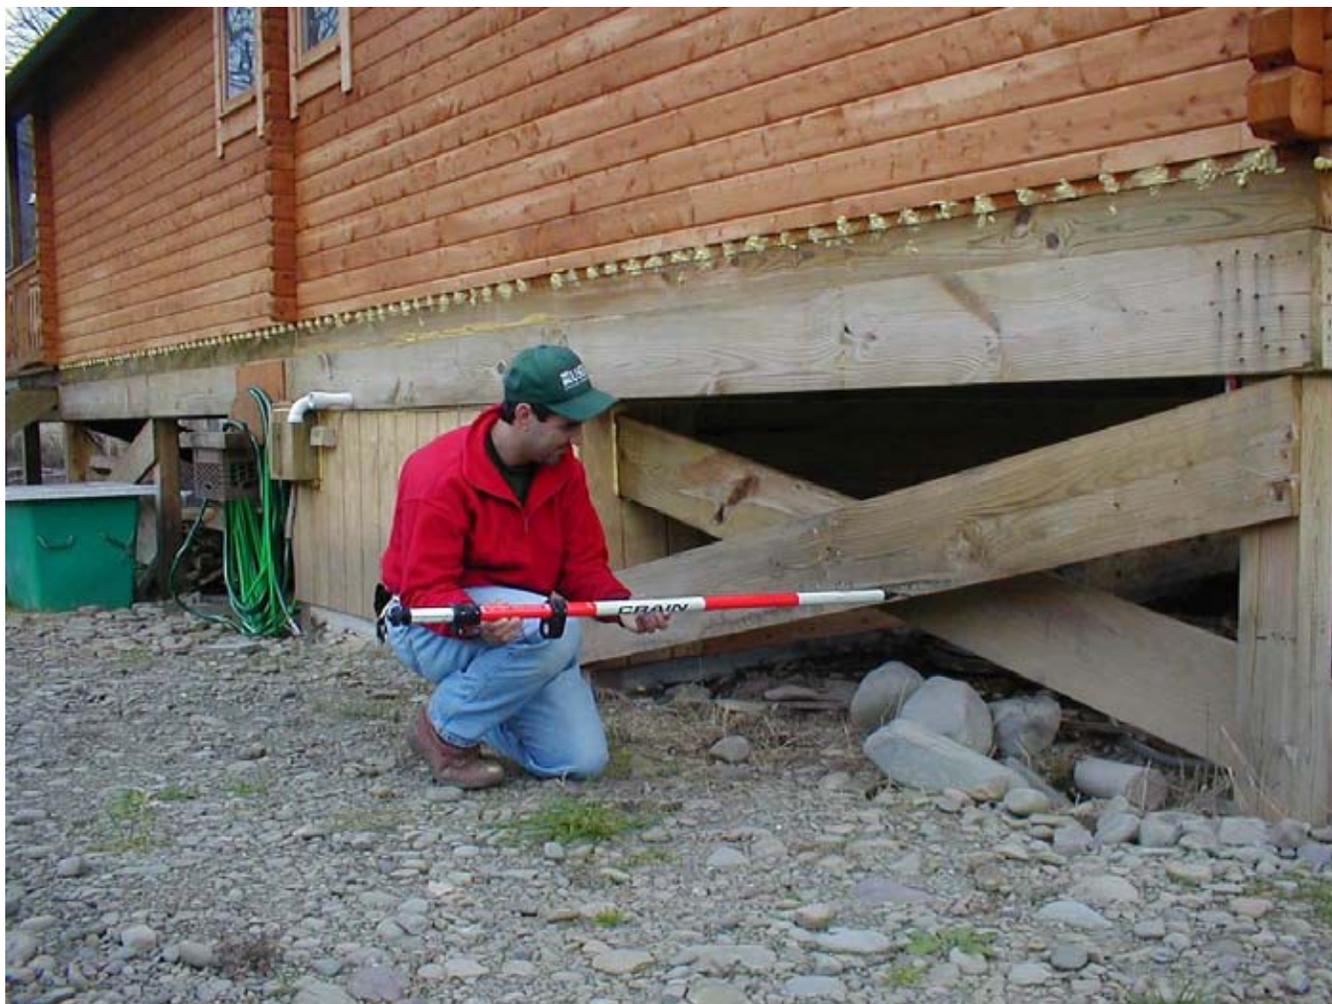
High-water mark 4.1 is a fair debris line on the piling foundation of a log house on State Route 30, about 350 feet north of Airport Road, on the right bank, at elevation 1,088.12 feet above sea level (Lat 42° 03' 29.5", long 75° 00' 37.7").

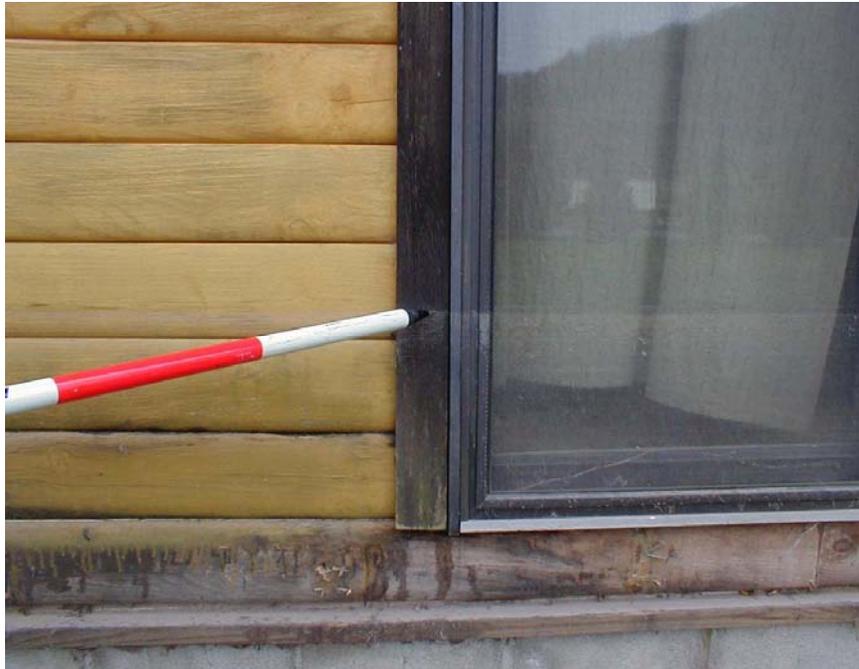
High-water mark 5.1 is an excellent mud line about 3.2 feet above the ground, on the front of the yellow house near the end of Airport Road, on the right bank, at elevation 1,088.10 feet above sea level (Lat 42° 03' 07.8", long 75° 00' 47.2").

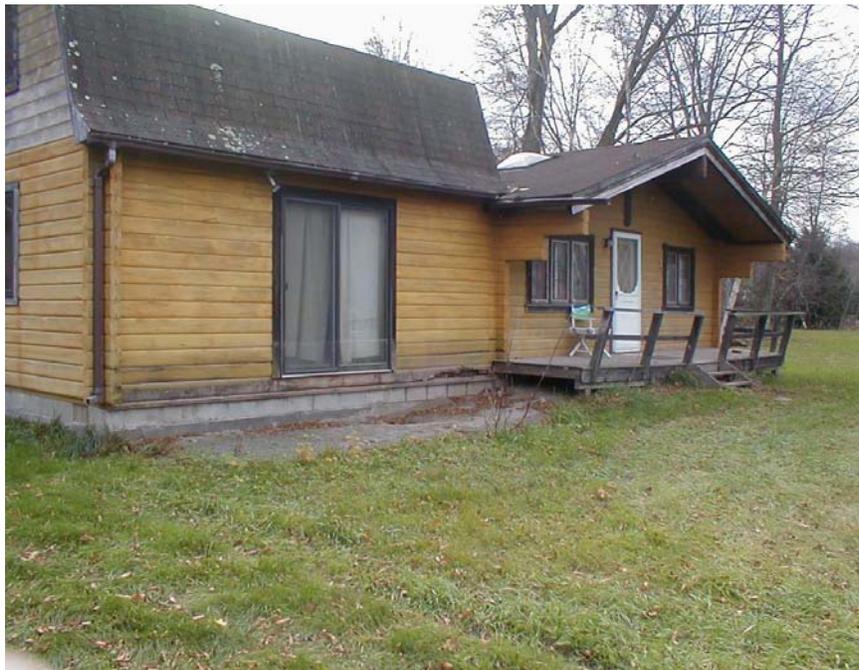
Yellow house near the end of Airport Road (Lat 42° 03' 07.8", long 75° 00' 47.2").

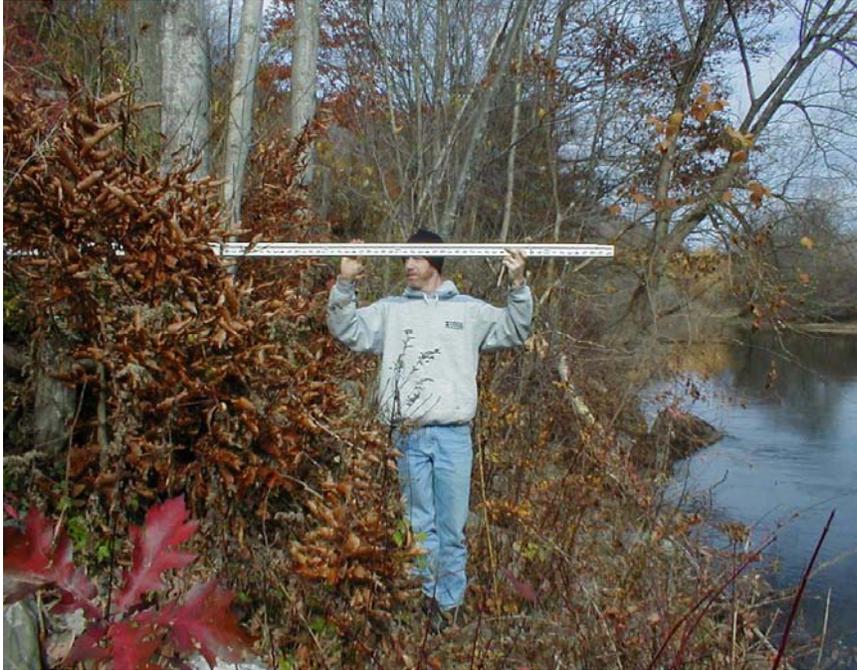
High-water mark 6.2 is a poor debris line on the ground, on the right bank, 110 feet upstream from the Corbett Road bridge, at elevation 1,083.13 feet above sea level (Lat 42° 02' 48.1", long 75° 01' 38.8").

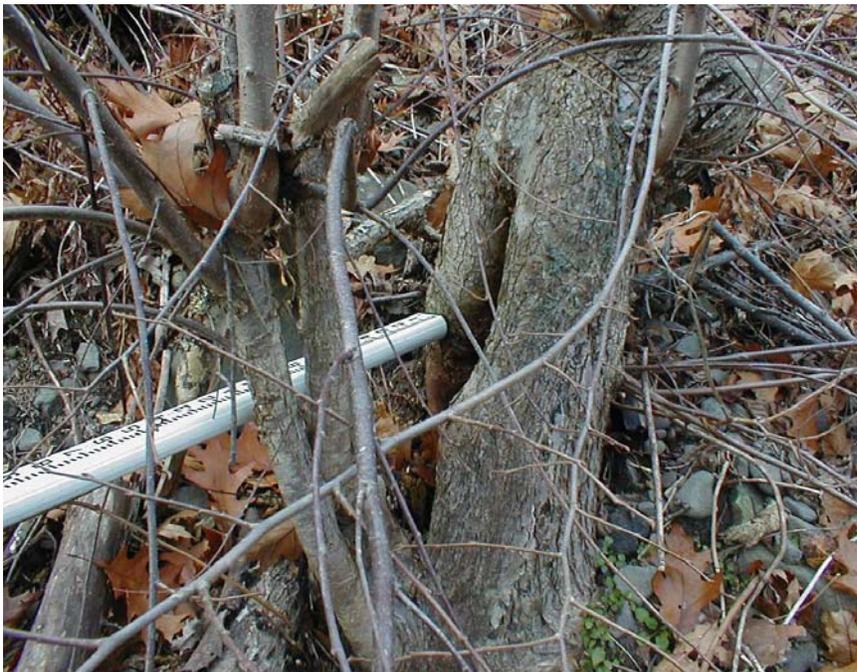
High-water mark 6.3 is a good seed line about 1 foot above the ground, on a tree on the right bank, 65 feet downstream from the Corbett Road bridge, at elevation 1,082.33 feet above sea level (Lat 42° 02' 47.1", long 75° 01' 39.8").

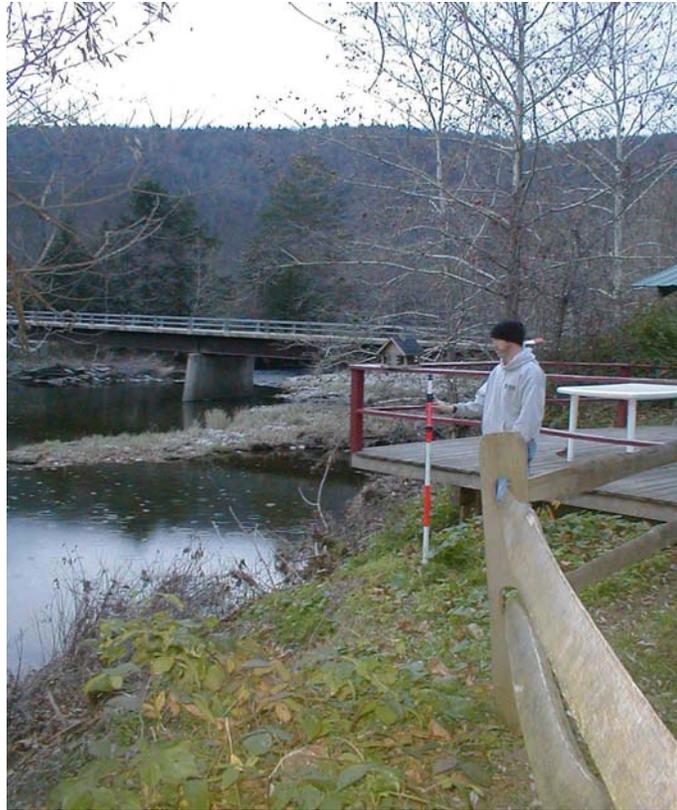
High-water mark 7.1 is a poor debris line on the ground, on the right bank, 132 feet upstream from the River Road bridge, at elevation 1,059.11 feet above sea level (Lat 42° 02' 21.8", long 75° 04' 00.5").

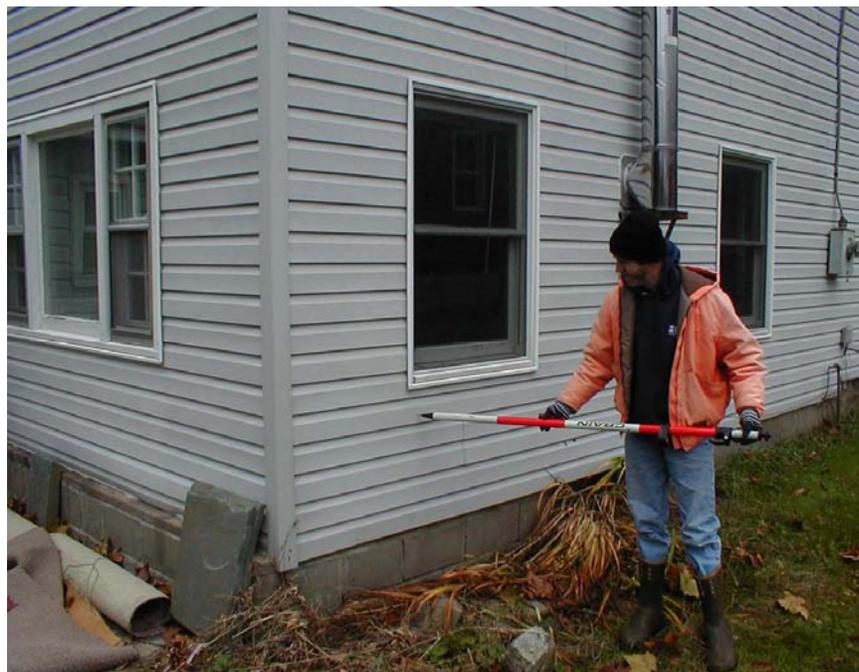
High-water mark 7.3 is an excellent seed line 2.2 feet above the floor, inside of the gray house, on the right bank, 300 feet downstream from the River Road bridge, at elevation 1,057.36 feet above sea level (Lat 42° 02' 24.5", long 75° 04' 05.4").

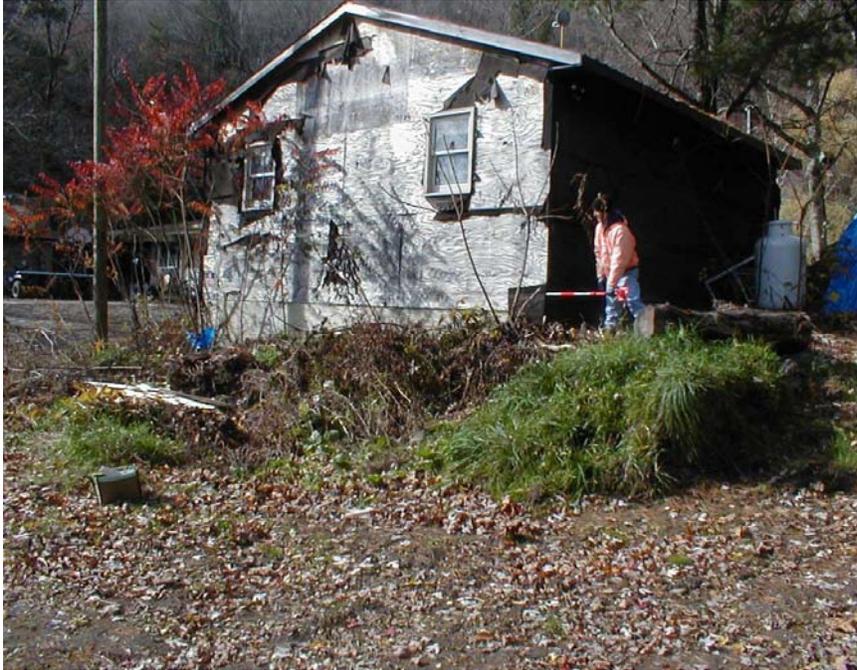
High-water mark 8.1 is a good mud line 2.7 feet above the ground, on the side of the garage next to the house at the end of Island Road, on the left bank, at elevation 1,048.00 feet above sea level (Lat 42° 02' 18.5", long 75° 04' 22.2").

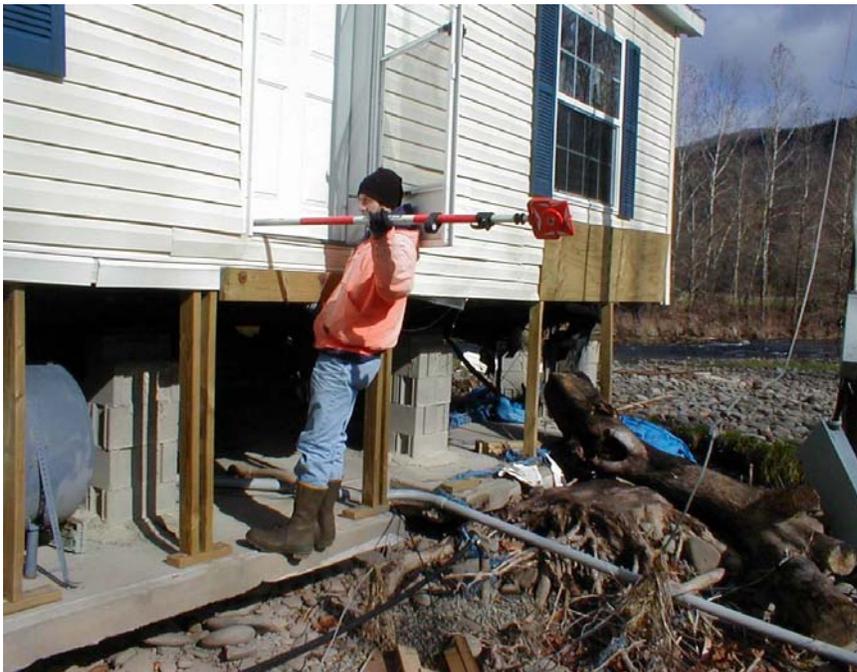
High-water mark 8.2 is a fair seed line about 6 feet above the ground, inside of the front door of house 188 on Island Road, on the left bank, at elevation 1,048.72 feet above sea level (Lat 42° 02' 20.3", long 75° 04' 18.5").

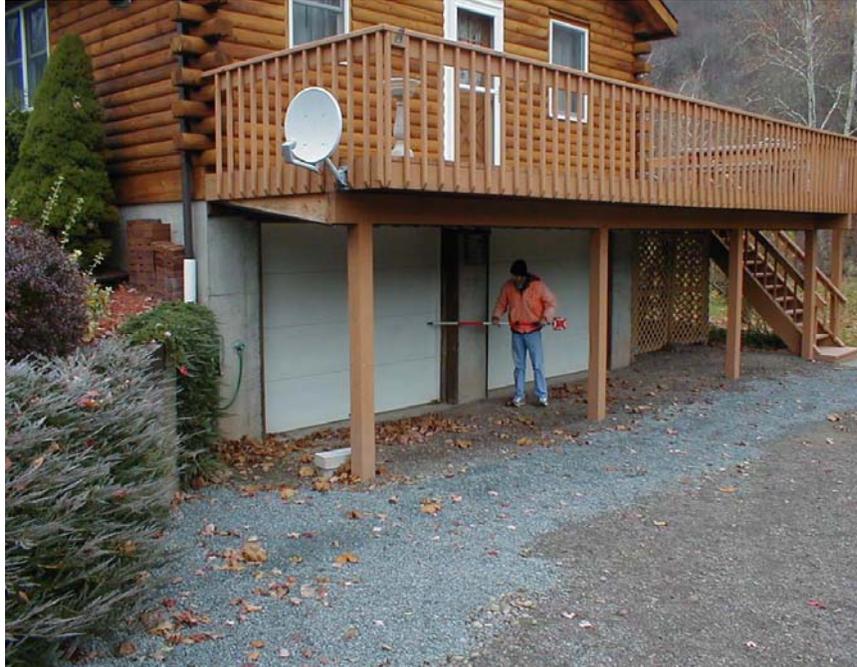
High-water mark 9.1 is a good mud line 3.2 feet above the ground, on the side of the second log house along Bronxville Road from the intersection with State Route 30, on the right bank, at elevation 1,045.06 feet above sea level (Lat 42° 01' 10.8", long 75° 03' 43.1").

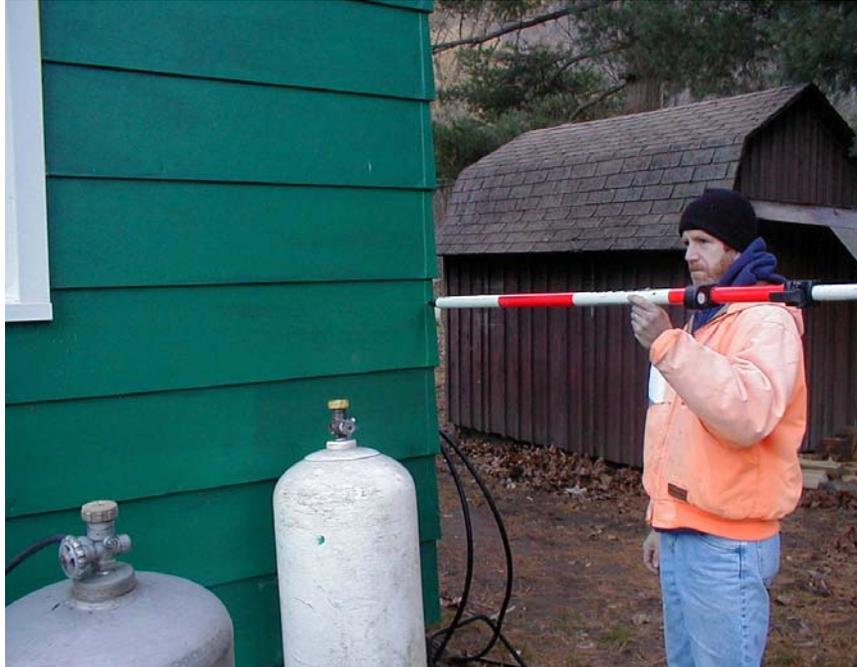
High-water mark 10.1 is an excellent seed line 5.0 feet above the ground, on the front of house 285 on Long Flats Road, on the right bank, at elevation 1,037.97 feet above sea level (Lat 42° 00' 40.4", long 75° 04' 46.9").

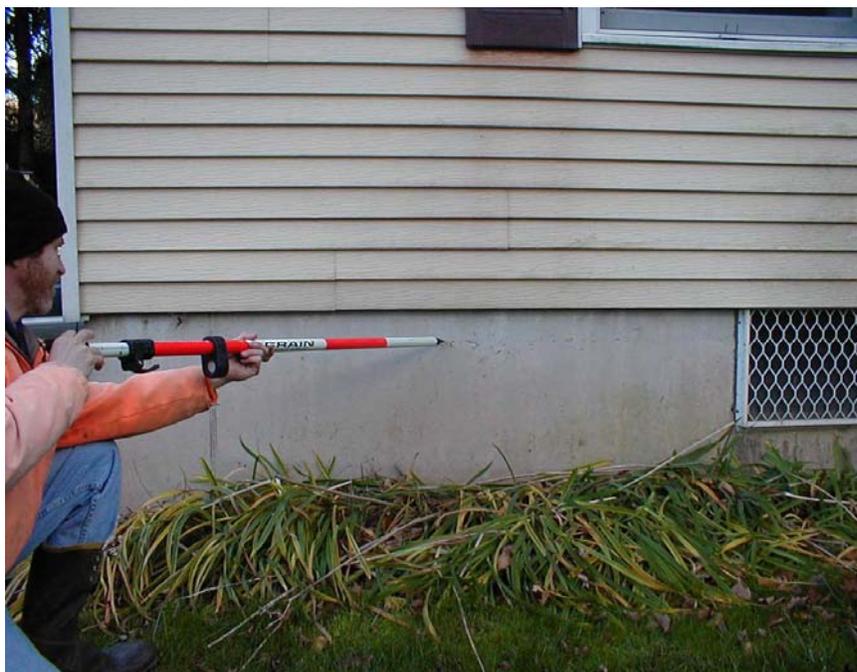
High-water mark 10.3 is an excellent seed line 2.0 feet above the ground, on the foundation of house 155 on Long Flats Road, on the right bank, at elevation 1,038.44 feet above sea level (Lat 42° 00' 37.7", long 75° 04' 37.8").
