FLOOD OF SEPTEMBER 18-19, 2004 IN THE UPPER DELAWARE RIVER BASIN, NEW YORK

Open-File Report 2005-1166

By Lloyd T. Brooks

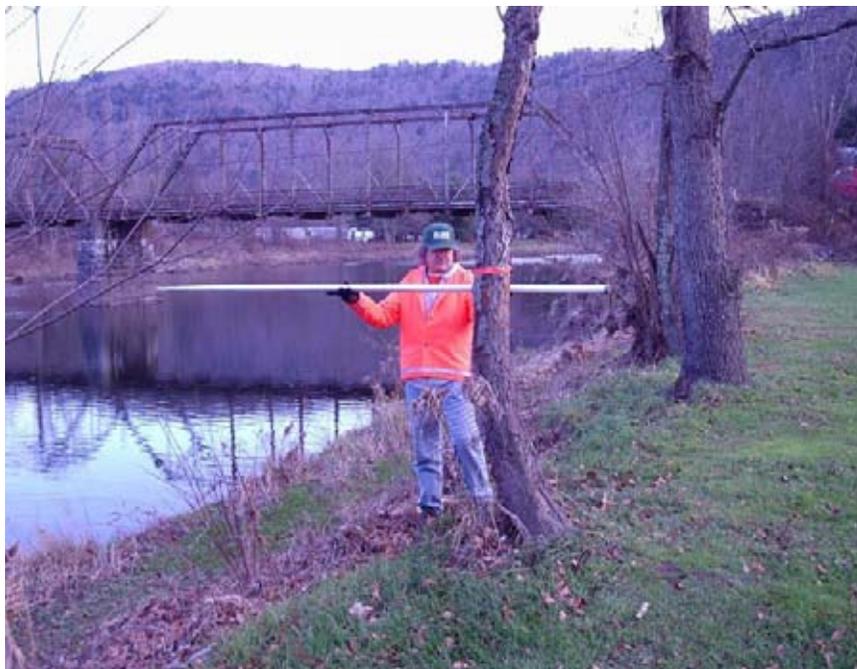
High-water mark 11.4 is a fair debris line about 5 feet above the ground, on a tree on the left bank, 170 feet downstream from the Harvard Road bridge, at elevation 1,025.68 feet above sea level (Lat 42° 01' 21.0", long 75° 07' 03.3").

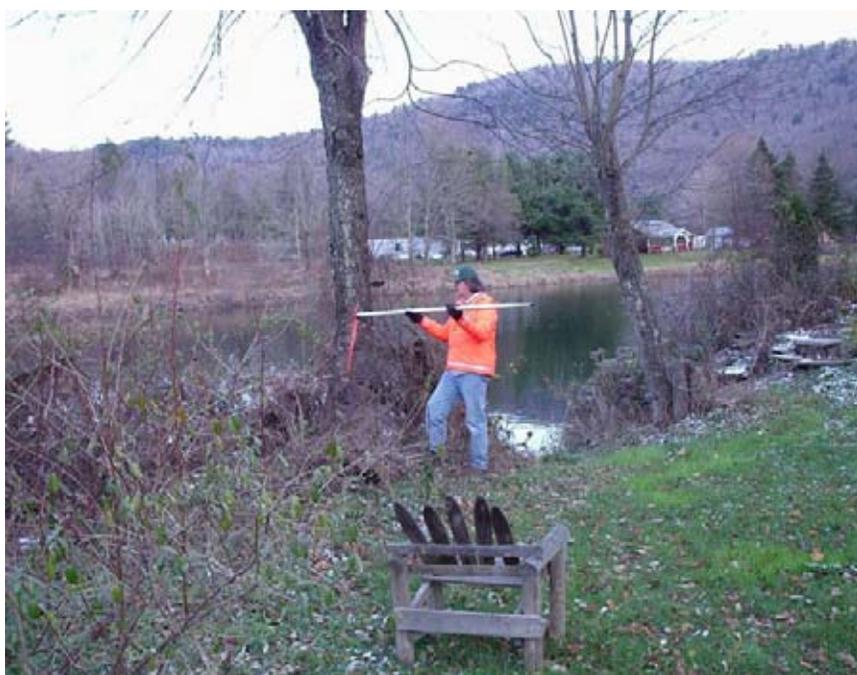
High-water mark 11.5 is a fair debris line about 4 feet above the ground, on a tree on the left bank, 100 feet upstream from the Harvard Road bridge, at elevation 1,025.88 feet above sea level (Lat 42° 01' 15.2", long 75° 07' 02.8").

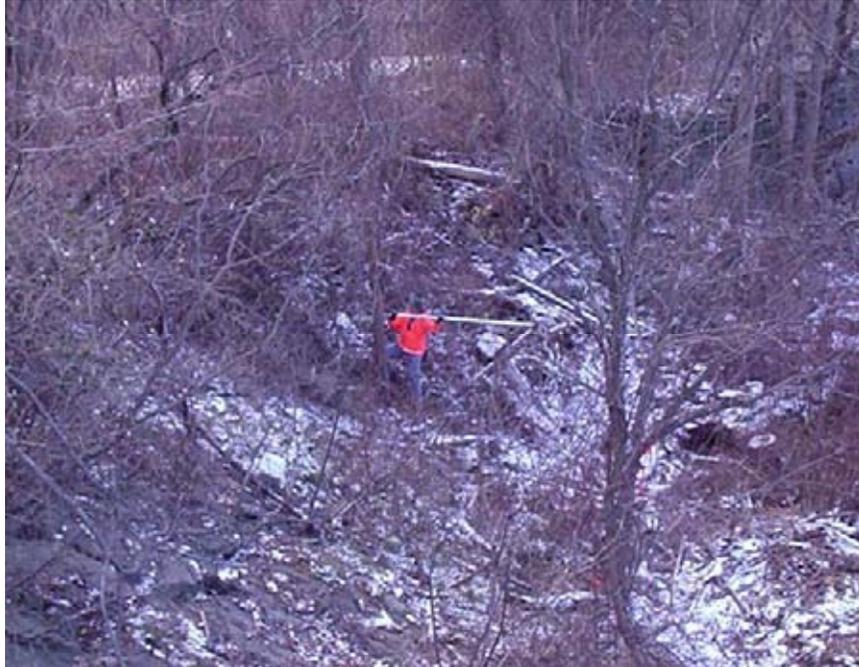
High-water mark 12.1 is a poor seed line about 5 feet above the ground, on a tree on the left bank, 121 feet downstream from the Old State Route 17 bridge, at elevation 1,005.59 feet above sea level (Lat 41° 59' 26.5", long 75° 07' 49.9").

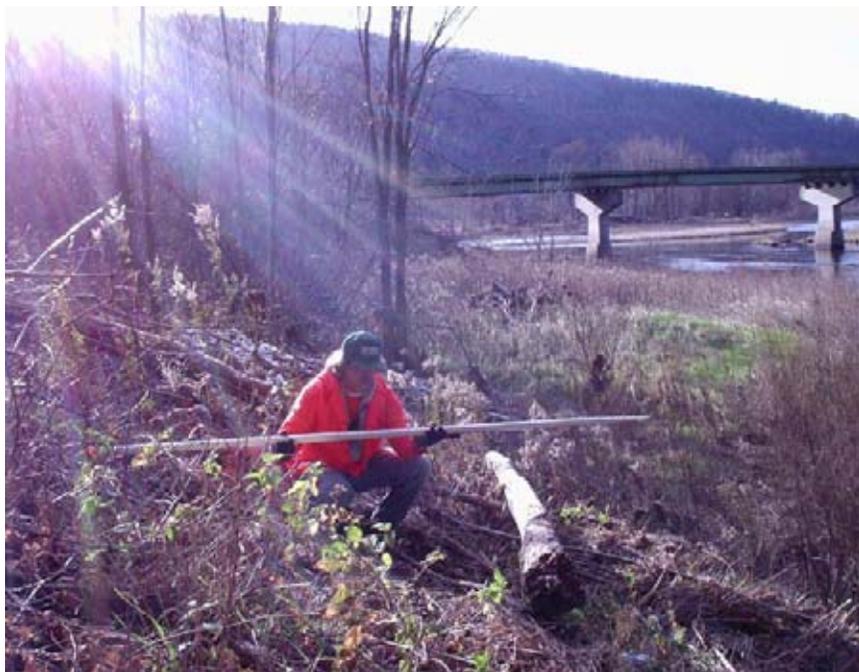
High-water mark 12.3 is a fair debris line on the ground, on the left bank, 249 feet upstream from the Old State Route 17 bridge, at the downstream side of the "new" State Route 17 bridge, at elevation 1,008.40 feet above sea level (Lat 41° 59' 29.2", long 75° 07' 43.2").

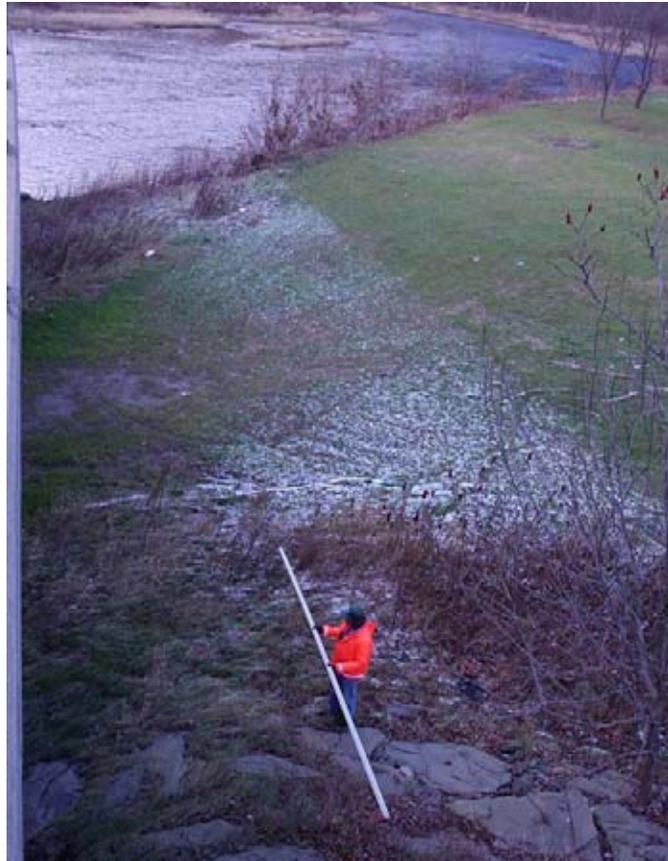
High-water mark 13.1 is a poor debris line on the ground, on the right bank, 10 feet downstream from the State Route 17 bridge, at elevation 995.01 feet above sea level (Lat 41° 59' 57.8", long 75° 09' 05.3").

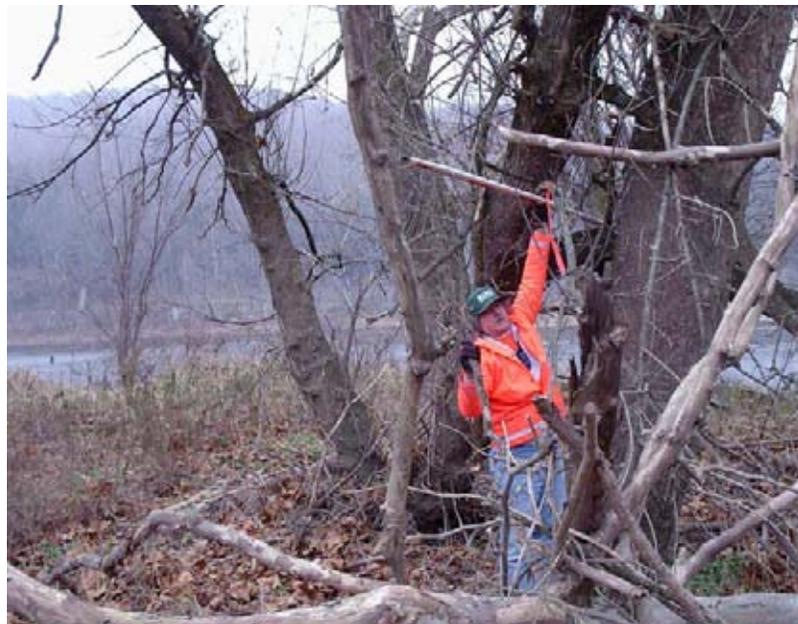
High-water mark 13.5 is a fair seed line about 7 feet above the ground, on a tree on the right bank, 248 feet upstream from the State Route 17 bridge, at elevation 997.00 feet above sea level (Lat 41° 59' 54.0", long 75° 09' 01.0").

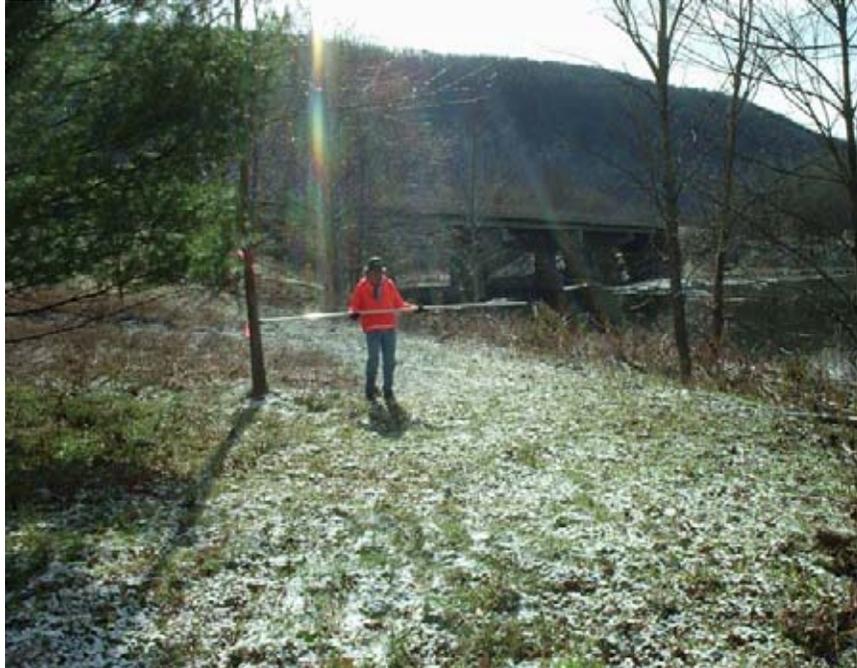
High-water mark 14.1 is a fair seed line about 4 feet above the ground, on a tree on the left bank, 195 feet upstream from the State Route 17 bridge, at elevation 989.45 feet above sea level (Lat 41° 59' 17.8", long 75° 09' 46.0").

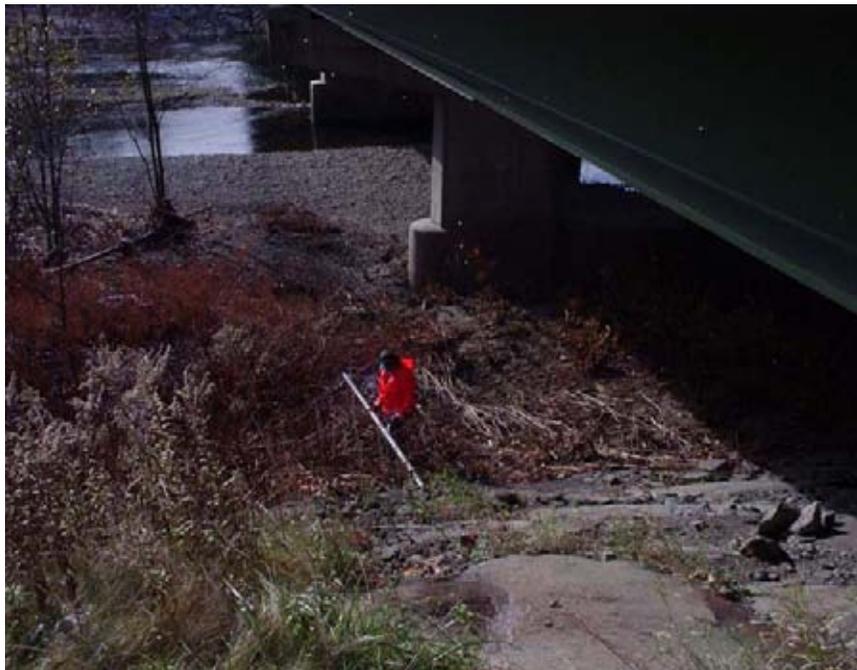
High-water mark 14.3 is a fair debris line on the ground, on the left bank, at the downstream side of the State Route 17 bridge, at elevation 988.50 feet above sea level (Lat 41° 59' 16.0", long 75° 09' 44.3").

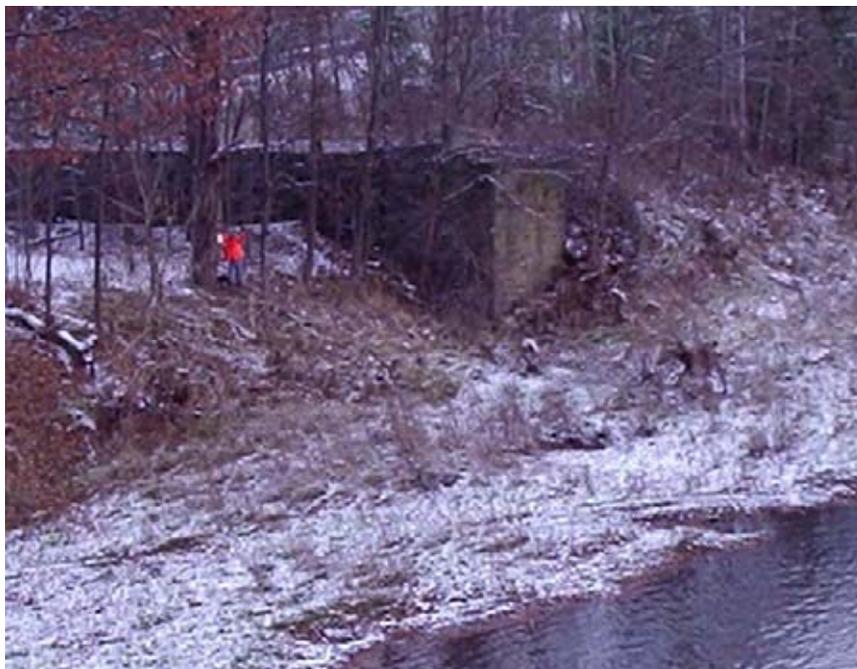
High-water mark 15.1 is a fair seed line about 6 feet above the ground, on a tree on the right bank, 325 feet upstream from the County Route 28 bridge, at elevation 971.82 feet above sea level (Lat 41° 58' 01.0", long 75° 10' 47.3").

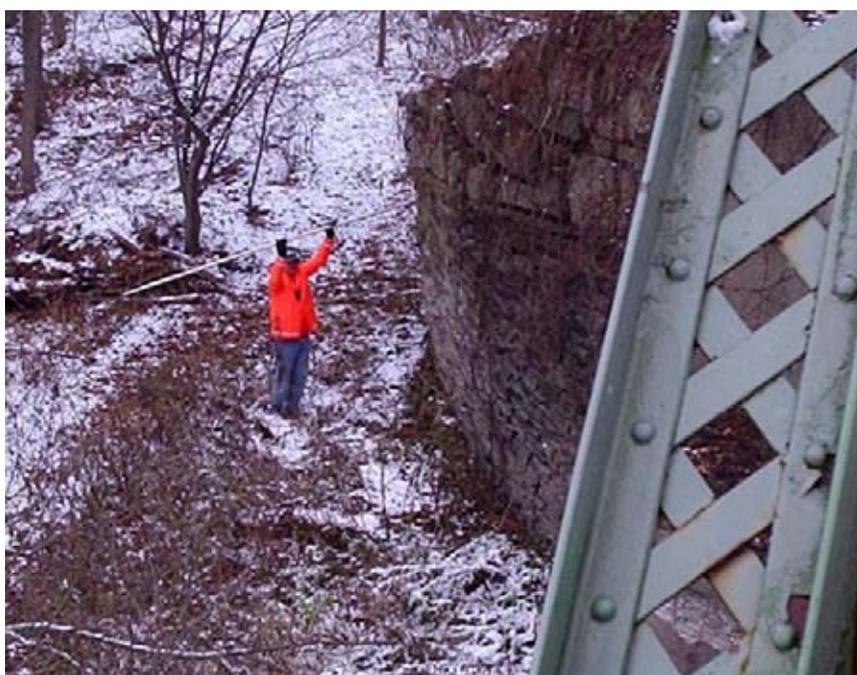
High-water mark 15.3 is a fair debris line about 7 feet above the ground, on the bridge wingwall on the right bank, at the downstream side of the County Route 28 bridge, at elevation 971.11 feet above sea level (Lat 41° 57' 57.8", long 75° 10' 52.1").

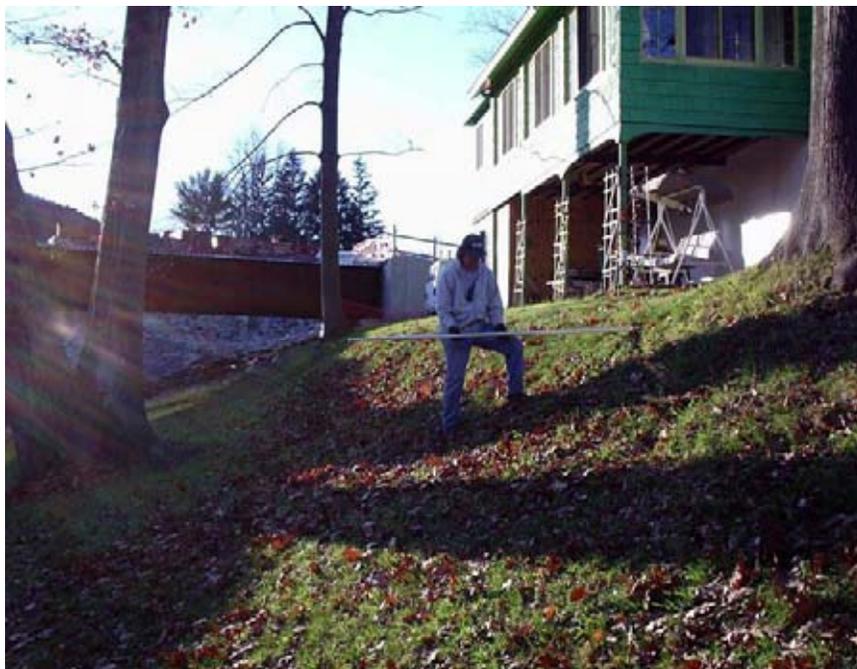
High-water mark 16.4 is a fair debris line on the ground, on the right bank, 40 feet downstream from the State Route 97 bridge, at elevation 905.88 feet above sea level (Lat 41° 57' 12.7", long 75° 16' 37.4").

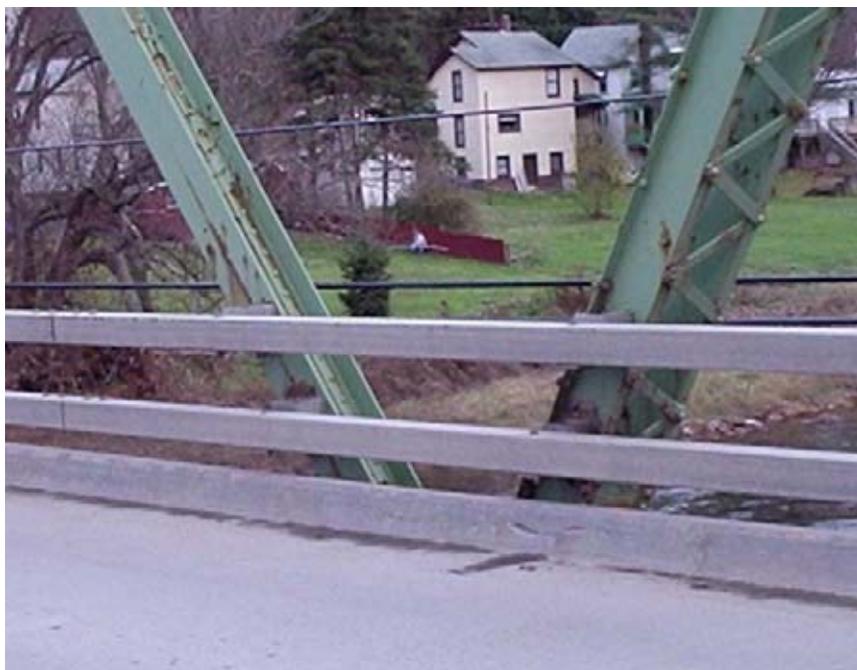
High-water mark 16.6 is a fair debris line about one foot above the ground, on a fence on the right bank, 200 feet upstream from the State Route 97 bridge, at elevation 906.08 feet above sea level (Lat 41° 57' 13.1", long 75° 16' 33.8").

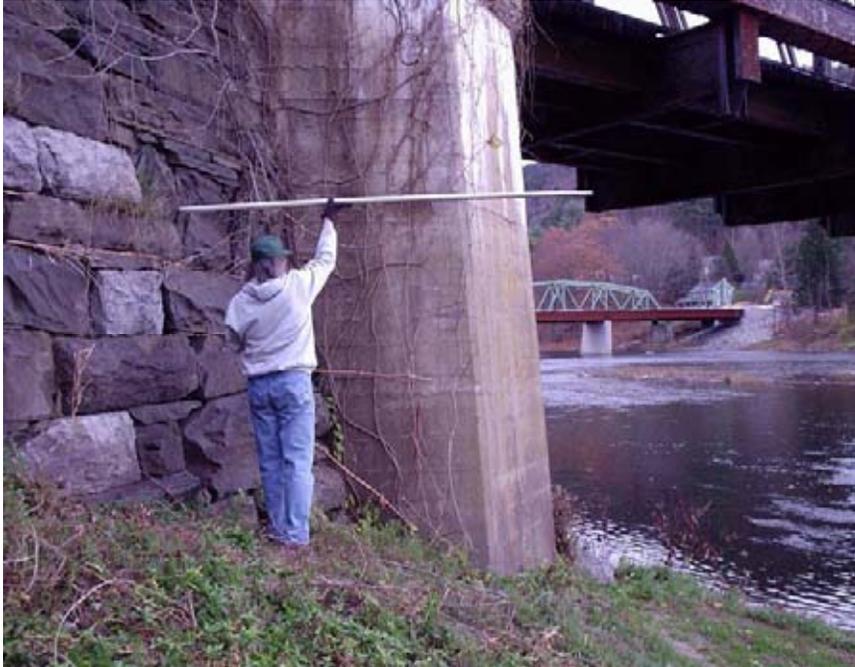
High-water mark 17.1 is a fair debris line about 7 feet above the ground, on a stone wall on the right bank, 10 feet downstream from the Conrail Railroad bridge, at elevation 904.93 feet above sea level (Lat 41° 57' 10.9", long 75° 16' 45.0").

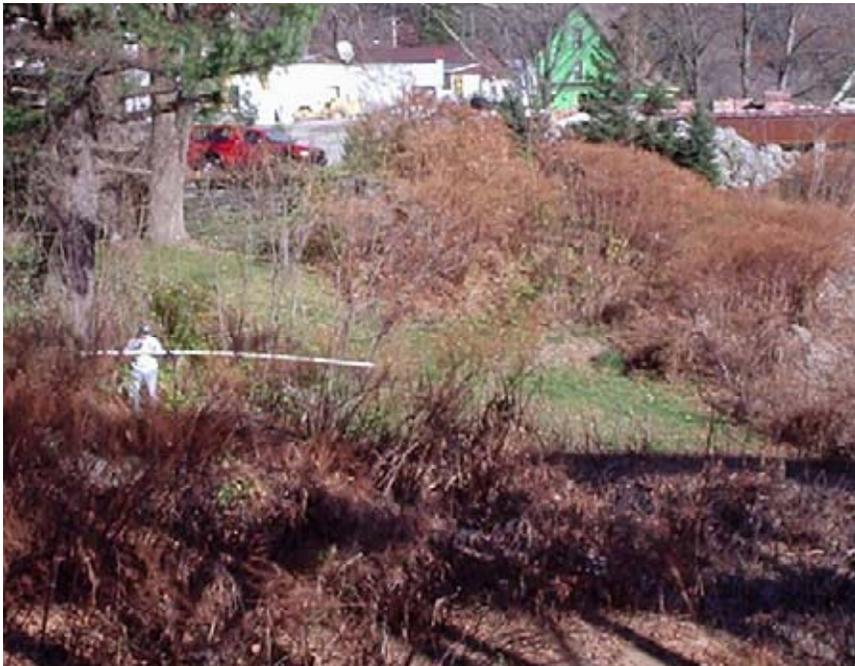
High-water mark 17.5 is a fair seed line about 3 feet above the ground, on a tree on the right bank, 123 feet upstream from the Conrail Railroad bridge, at elevation 905.35 feet above sea level (Lat 41° 57' 10.5", long 75° 16' 43.1").

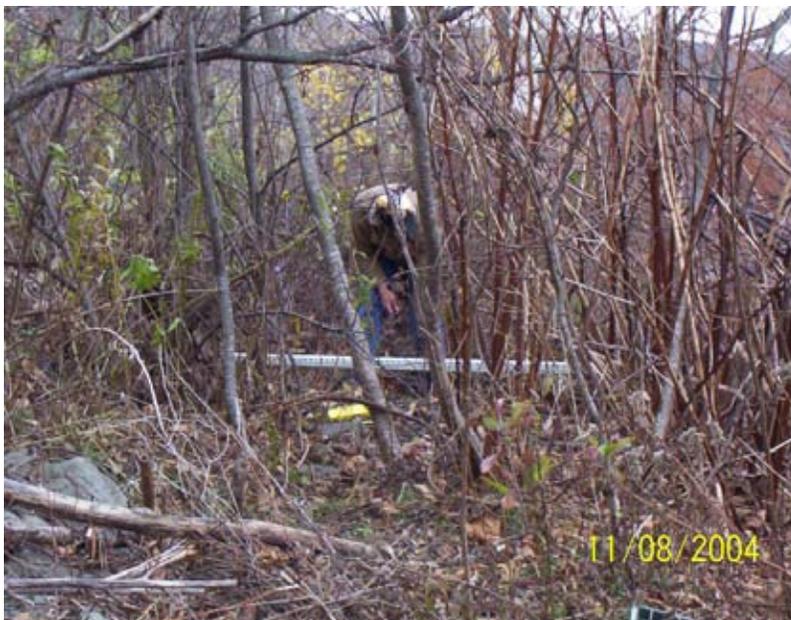
High-water mark 18.1 is a fair seed line on the ground, on the left bank, 29 feet downstream from the Lordville Road bridge, at elevation 858.48 feet above sea level (Lat 41° 52' 06.5", long 75° 12' 49.1").

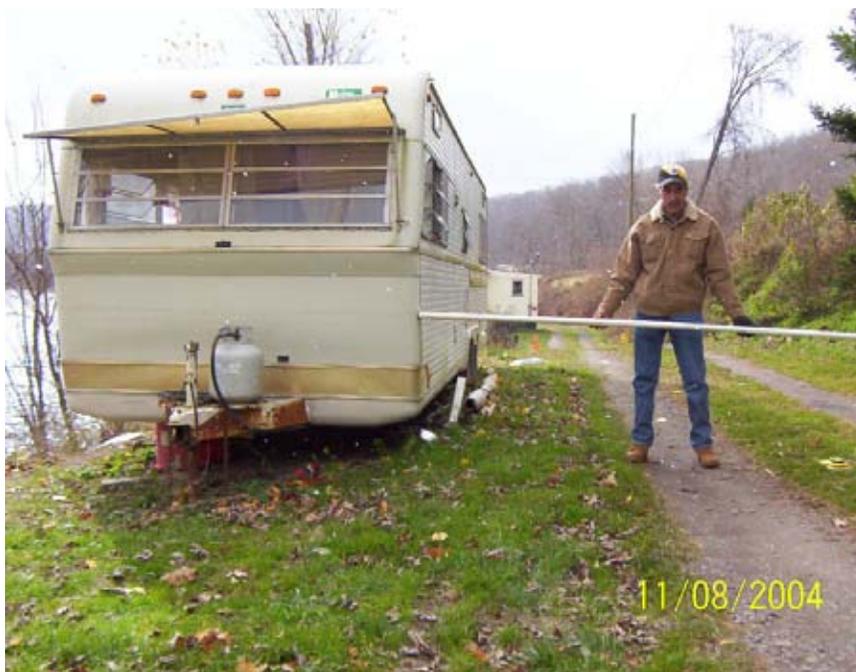
High-water mark 18.5 is a good mud line about three feet above the ground, on a trailer on the left bank, 290 feet upstream from the Lordville Road bridge, at elevation 860.77 feet above sea level (Lat 41° 52' 05.5", long 75° 12' 53.3").

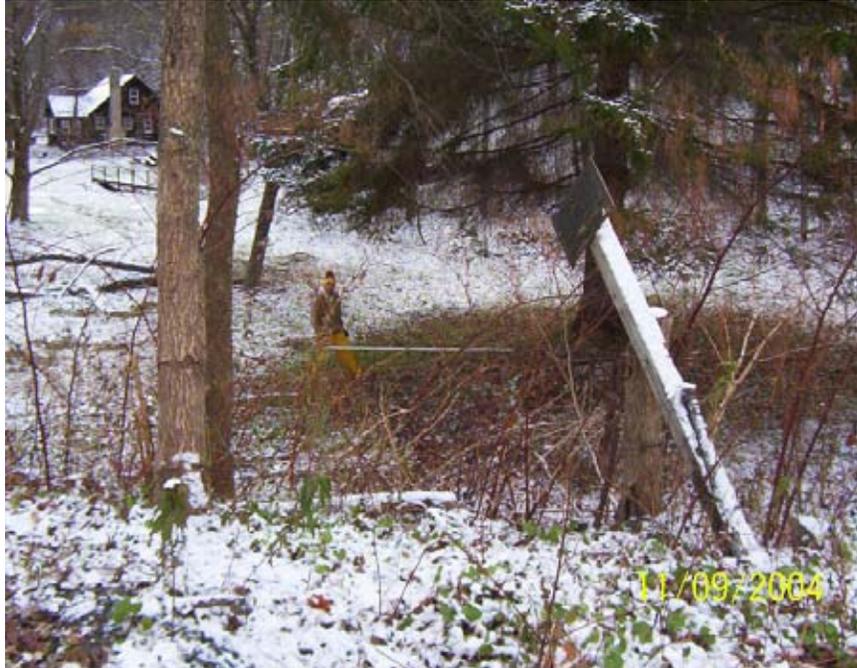
High-water mark 19.1 is a fair debris line on the ground, on the right bank, 51 feet downstream from the Kellams Bridge Road bridge, at elevation 811.43 feet above sea level (Lat 41° 49' 22.4", long 75° 06' 52.6").

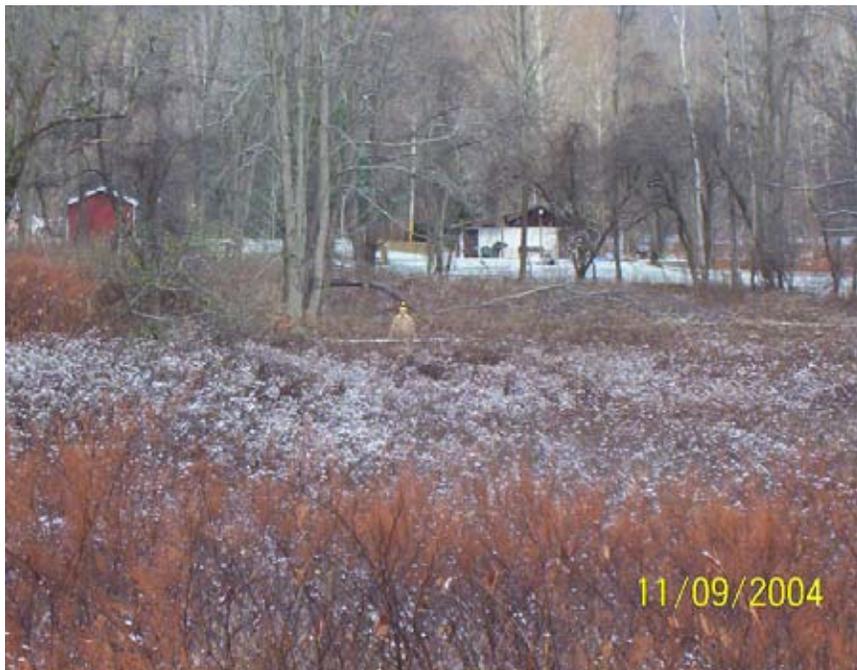
High-water mark 19.5 is a good seed line about two feet above the ground, on a tree on the right bank, 240 feet upstream from the Kellams Bridge Road bridge, at elevation 811.57 feet above sea level (Lat 41° 49' 25.0", long 75° 06' 54.5").

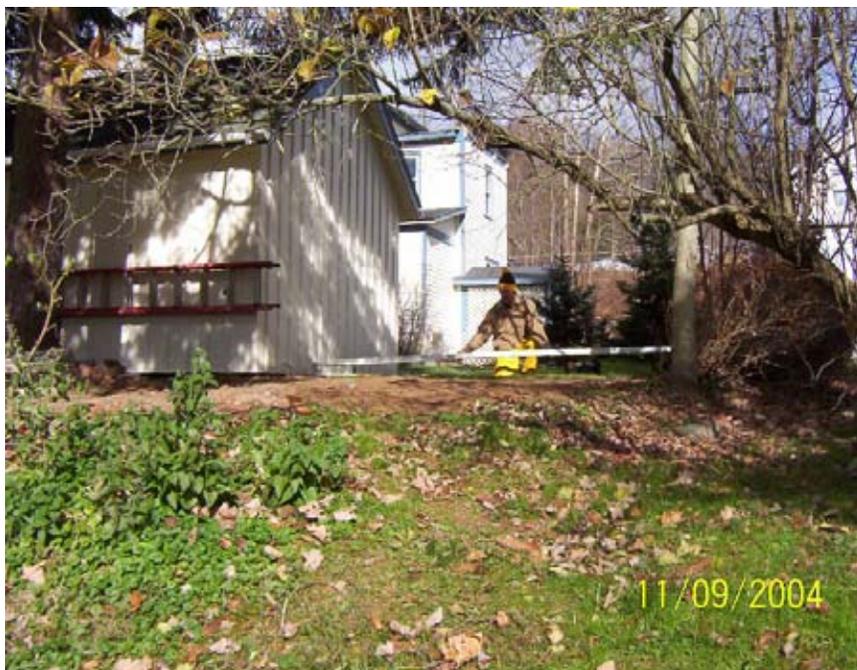
High-water mark 20.1 is a good seed/mud line 0.5 feet above the ground, on a storage shed on the left bank, 215 feet upstream from the Bridge Street bridge, at elevation 755.98 feet above sea level (Lat 41° 46' 00.2", long 75° 03' 35.0").

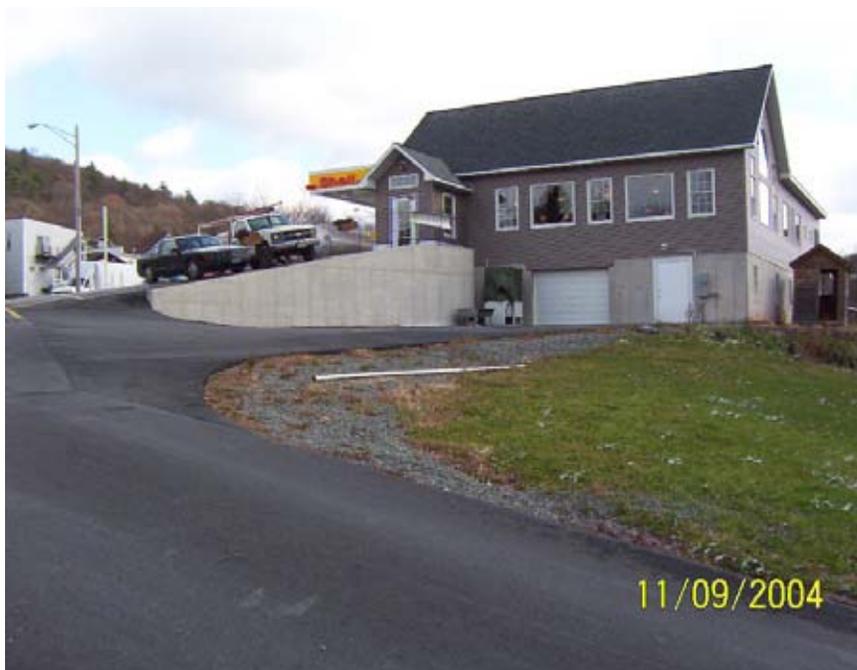
High-water mark 20.3 is a good debris line on the ground, on the left bank, 140 feet downstream from the Bridge Street bridge, at elevation 755.61 feet above sea level (Lat 41° 45' 56.5", long 75° 03' 33.4").

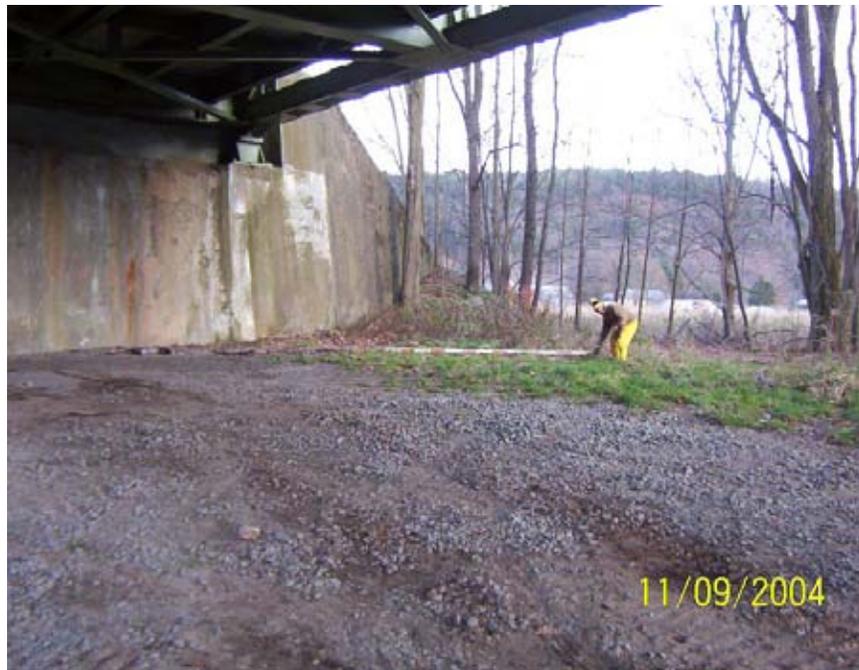
High-water mark 21.1 is a good debris line on the ground, on the left bank, at the downstream side of the State Route 371 bridge, at elevation 735.92 feet above sea level (Lat 41° 42' 21.1", long 75° 03' 56.3").

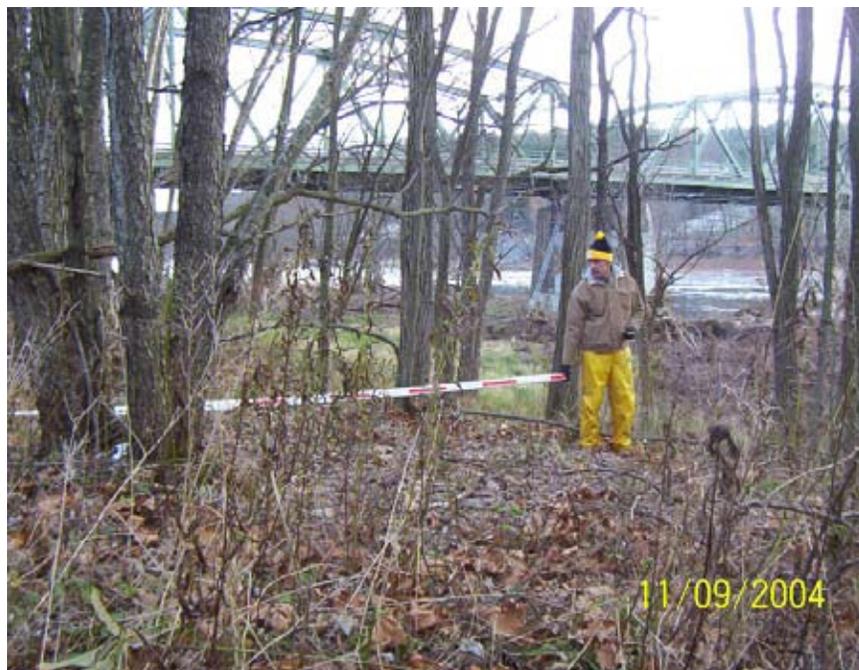
High-water mark 21.6 is a good debris line on the ground, on the left bank, 84 feet upstream from the State Route 371 bridge, at elevation 736.10 feet above sea level (Lat 41° 42' 21.7", long 75° 03' 59.0").

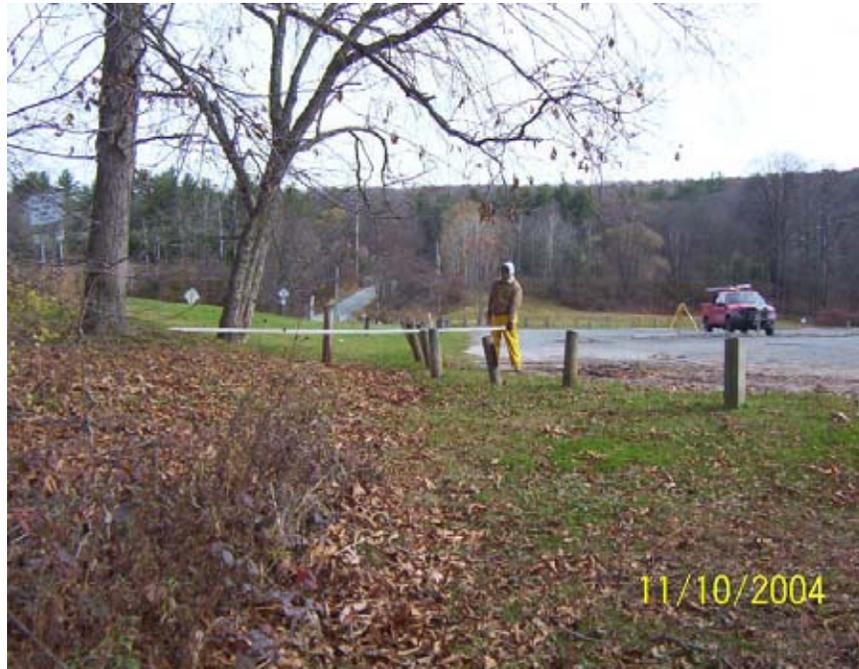
High-water mark 22.1 is a fair debris line on the ground, on the left bank, 25 feet downstream from the Skinners Falls Road bridge, at elevation 720.25 feet above sea level (Lat 41° 40' 12.5", long 75° 03' 26.0").

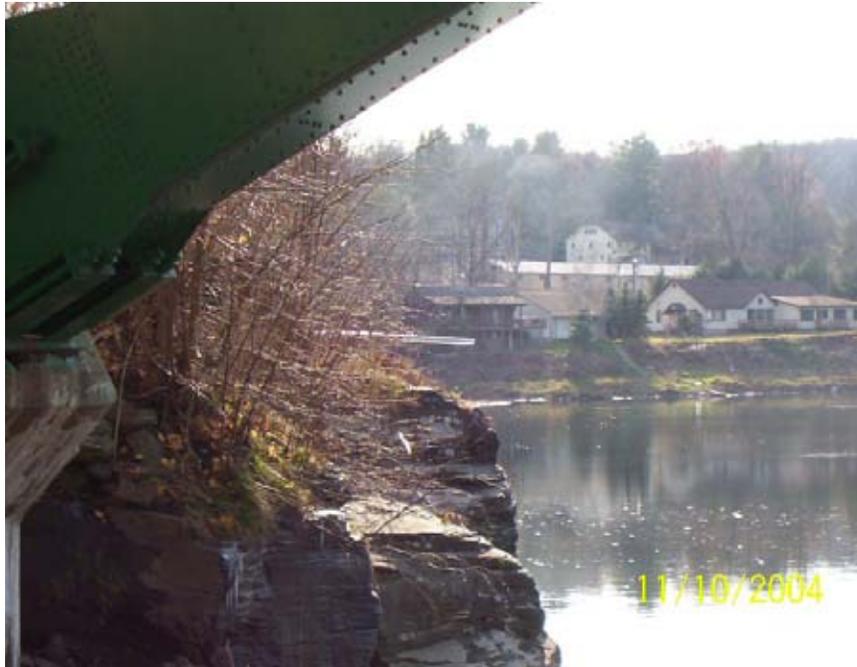
High-water mark 23.1 is a poor debris line on the ground, on the left bank, 40 feet downstream from the U.S. Route 652 bridge, at elevation 693.54 feet above sea level (Lat 41° 36' 33.4", long 75° 03' 41.6").

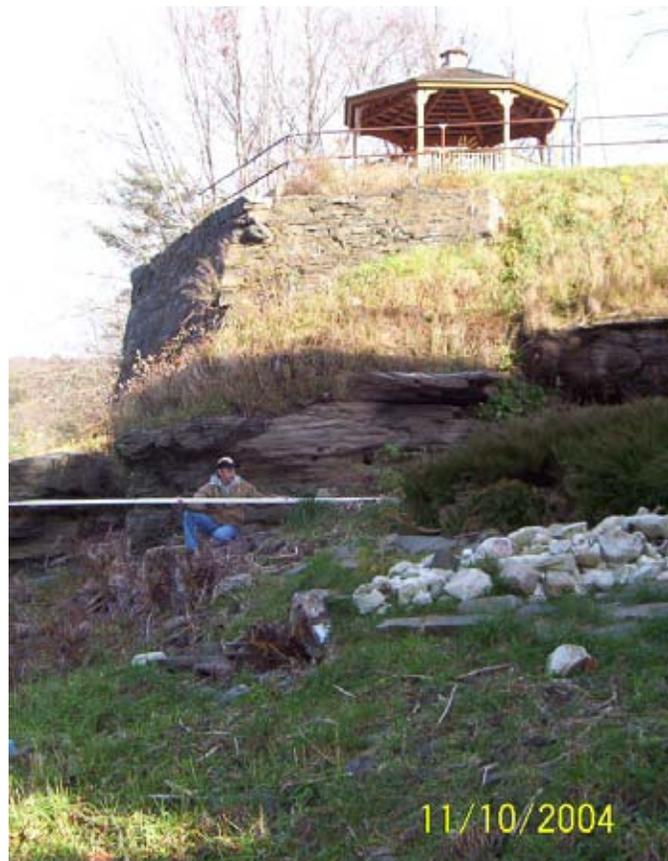
High-water mark 23.3 is a poor debris line on the ground, on the left bank, 75 feet upstream from the U.S. Route 652 bridge, at elevation 695.91 feet above sea level (Lat 41° 36' 34.1", long 75° 03' 40.4").

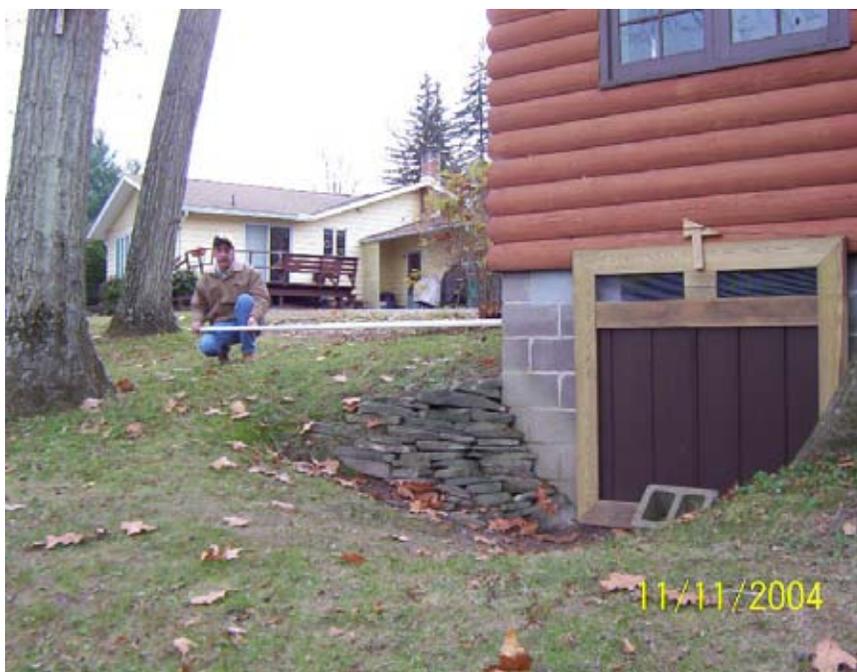
High-water mark 24.1 is a fair mud line about 2 feet above the ground, on a storage shed between house 72 and house 80 on 2nd Avenue, on the left bank, at elevation 694.57 feet above sea level (Lat 41° 36' 31.1", long 75° 03' 03.1").

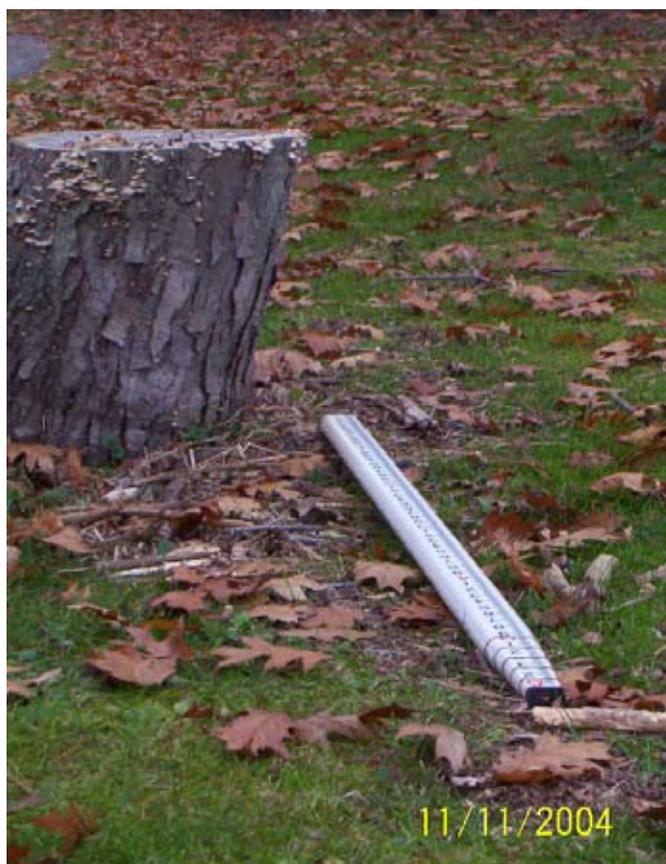
High-water mark 24.3 is a good debris line on the ground, at park on 2nd Avenue, on the left bank, at elevation 693.44 feet above sea level (Lat 41° 36' 32.6", long 75° 04' 08.6").

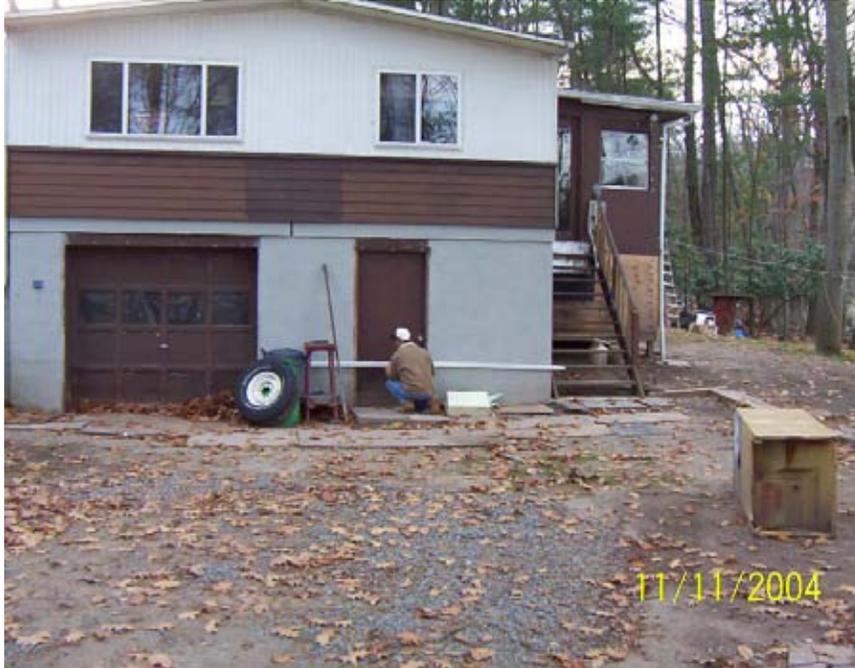
High-water mark 24.4 is an excellent mud line about 2 feet above the ground, on the upstream side of house 122 on 2nd Avenue, on the left bank, at elevation 693.52 feet above sea level (Lat 41° 36' 33.1", long 75° 04' 10.8").

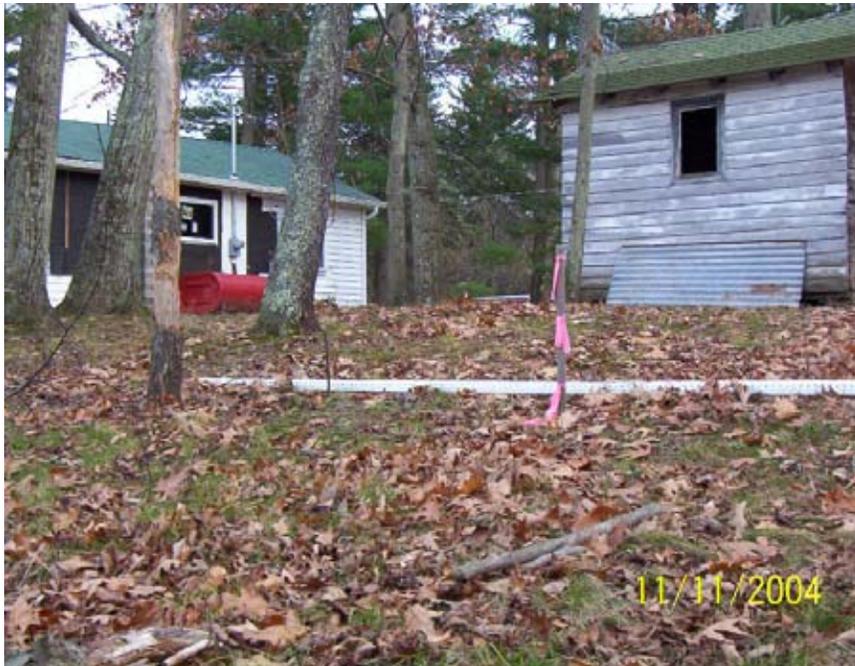
High-water mark 24.5 is a fair debris line on the ground, behind house 140 on Delaware Drive, on the left bank, at elevation 692.26 feet above sea level (Lat 41° 36' 31.7", long 75° 04' 17.1").

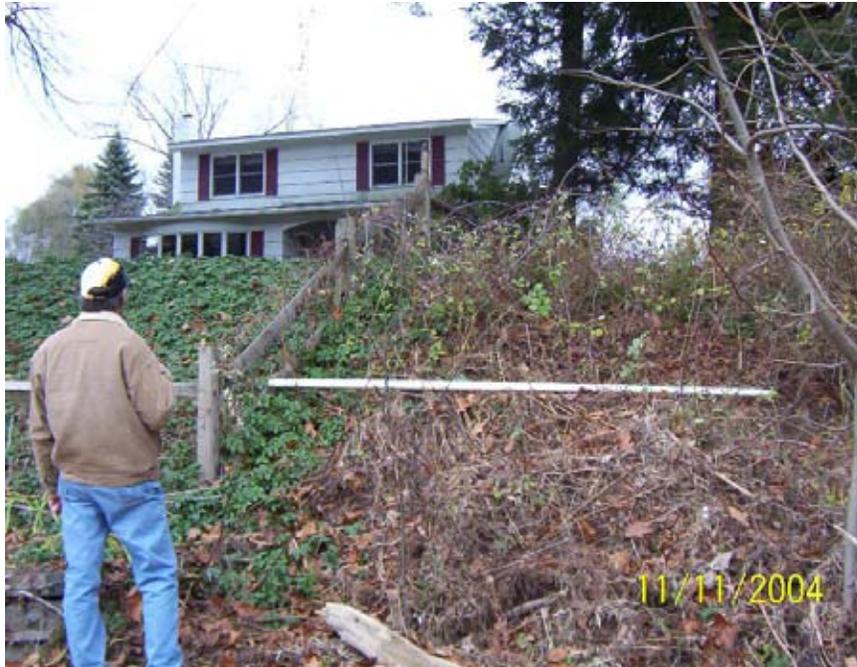
High-water mark 24.7 is a poor debris line on the ground, between house 204 and house 210 on Delaware Drive, on the left bank, at elevation 689.53 feet above sea level (Lat 41° 36' 25.7", long 75° 04' 25.7").

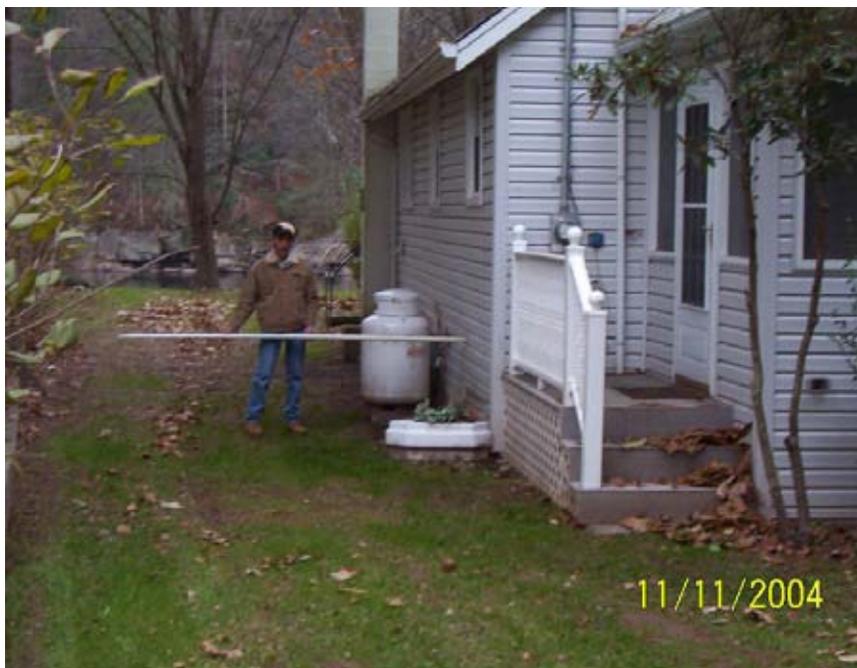
High-water mark 24.8 is a fair mud line about 3 feet above the ground, on the downstream side of house 242 on Delaware Drive, on the left bank, at elevation 688.27 feet above sea level (Lat 41° 36' 21.0", long 75° 04' 21.2").

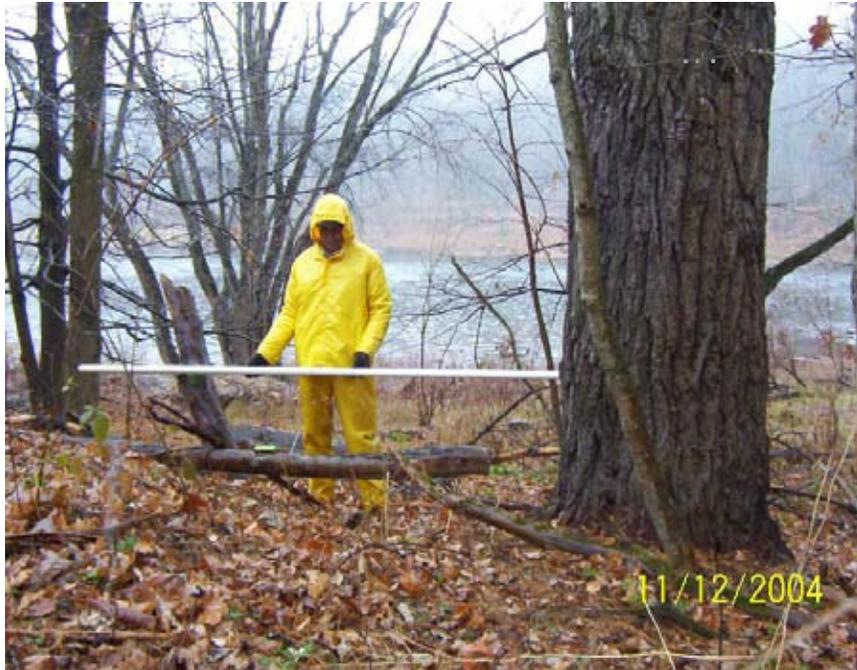
High-water mark 25.3 is a good seed line about 3 feet above the ground, on a tree on the left bank, 25 feet downstream from the Tusten Trail sign, at elevation 665.40 feet above sea level (Lat 41° 33' 15.5", long 75° 01' 08.6").

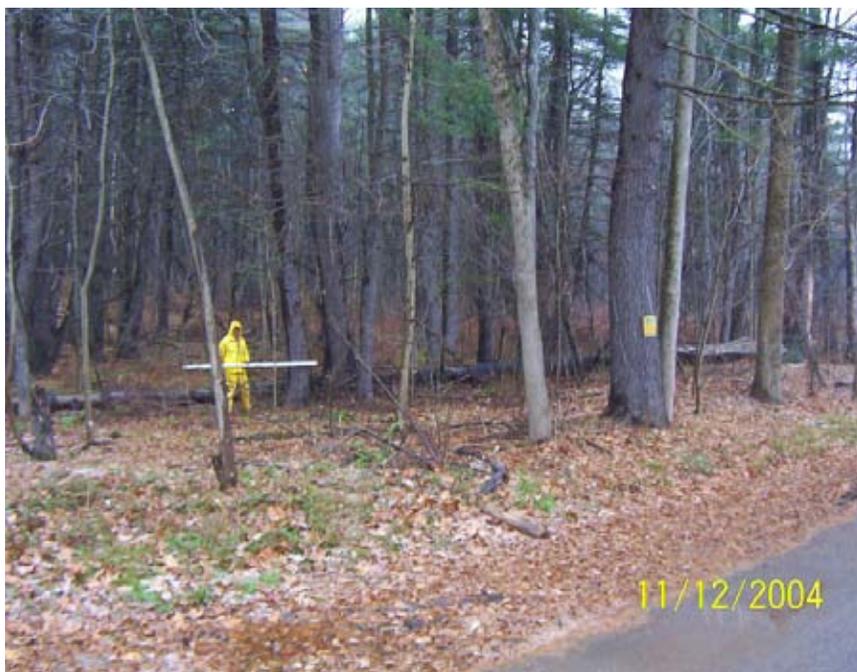
High-water mark 25.7 is a fair seed line about 3 feet above the ground, on a tree on the left bank, 280 feet downstream from the Tusten Trail sign, at elevation 665.31 feet above sea level (Lat 41° 33' 13.6", long 75° 01' 06.2").

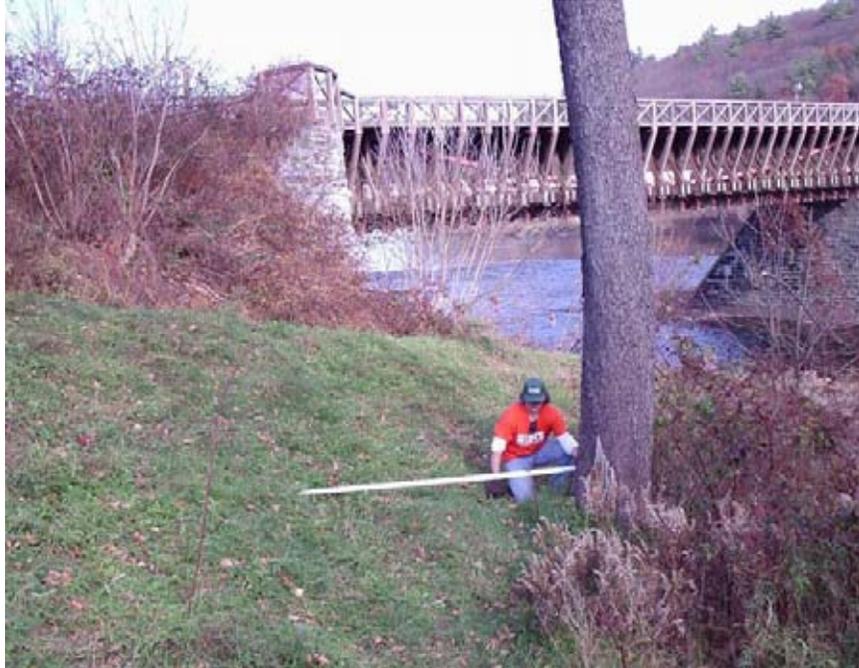
High-water mark 26.2 is a fair seed line about one foot above the ground, on a tree on the right bank, 72 feet downstream from the Roebling Bridge, at elevation 617.09 feet above sea level (Lat 41° 28' 55.2", long 74° 59' 07.0").

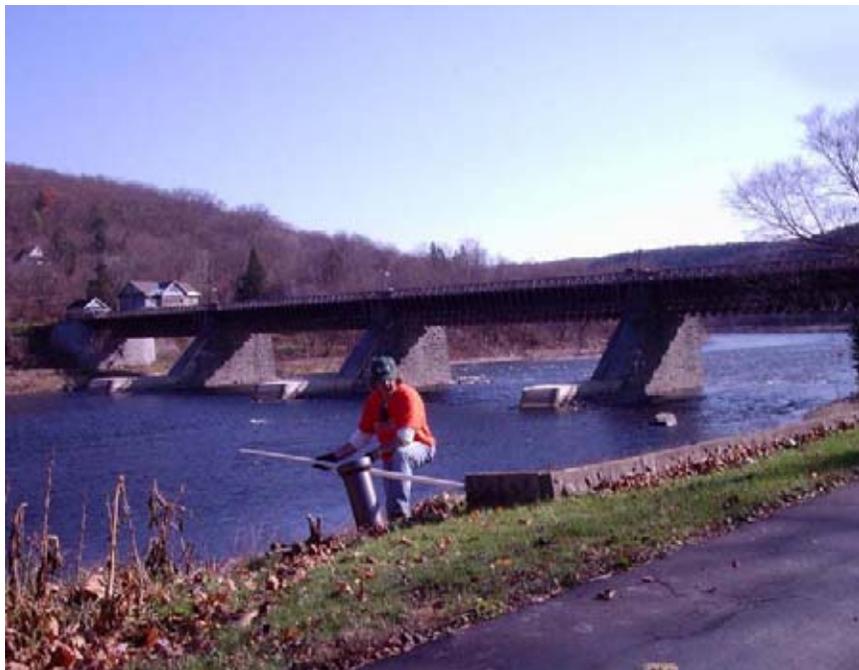
High-water mark 26.3 is a good seed line about one foot above the ground, on a concrete wall on the right bank, 275 feet upstream from the Roebling Bridge, at elevation 617.35 feet above sea level (Lat 41° 28' 58.9", long 74° 59' 09.5").

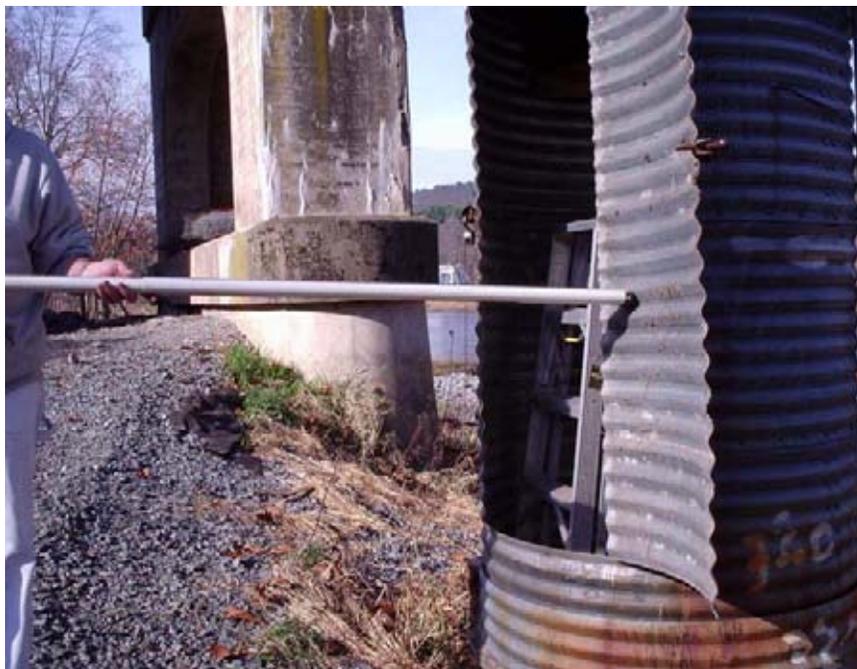
High-water mark 27.1 is an excellent seed line about 4 feet above the ground, inside of the USGS gage house, on the right bank, 15 feet downstream from the State Route 55 bridge, at elevation 585.14 feet above sea level (Lat 41° 28' 30.7", long 74° 54' 47.0").
