FLOOD OF SEPTEMBER 18-19, 2004 IN THE UPPER DELAWARE RIVER BASIN, NEW YORK

Open-File Report 2005-1166

By Lloyd T. Brooks

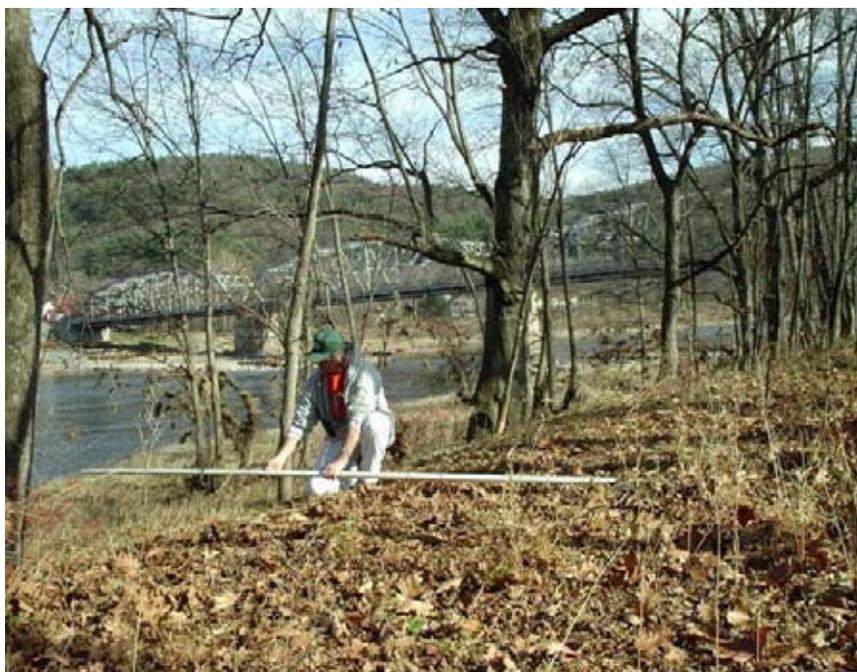
High-water mark 27.5 is a fair debris line on the ground, on the right bank, 315 feet upstream from the State Route 55 bridge, at elevation 586.24 feet above sea level (Lat 41° 28' 33.4", long 74° 54' 52.4").

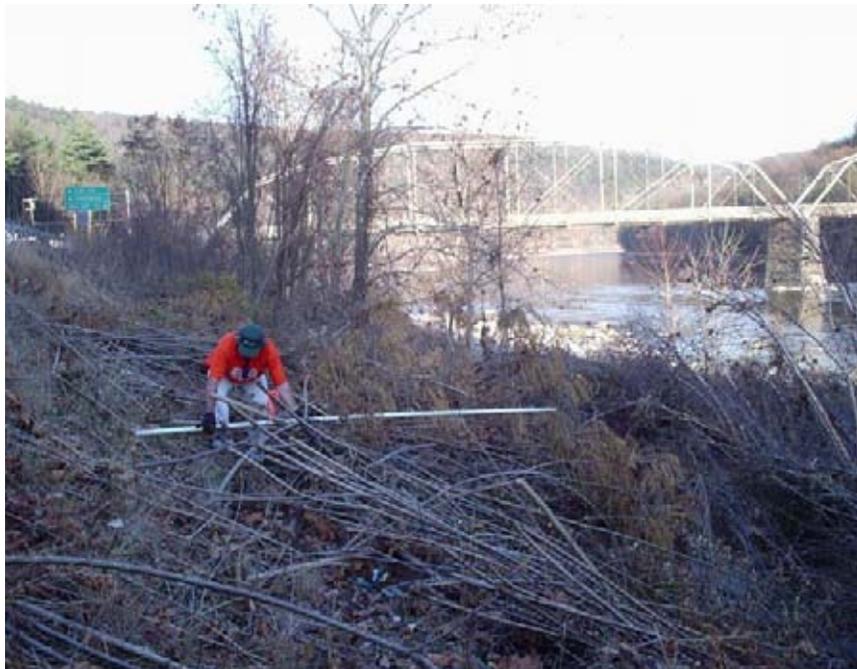
High-water mark 28.3 is a fair debris line on the ground, on the left bank, 300 feet upstream from the County Route 41 bridge, at elevation 525.42 feet above sea level (Lat 41° 26' 20.8", long 74° 49' 16.6").

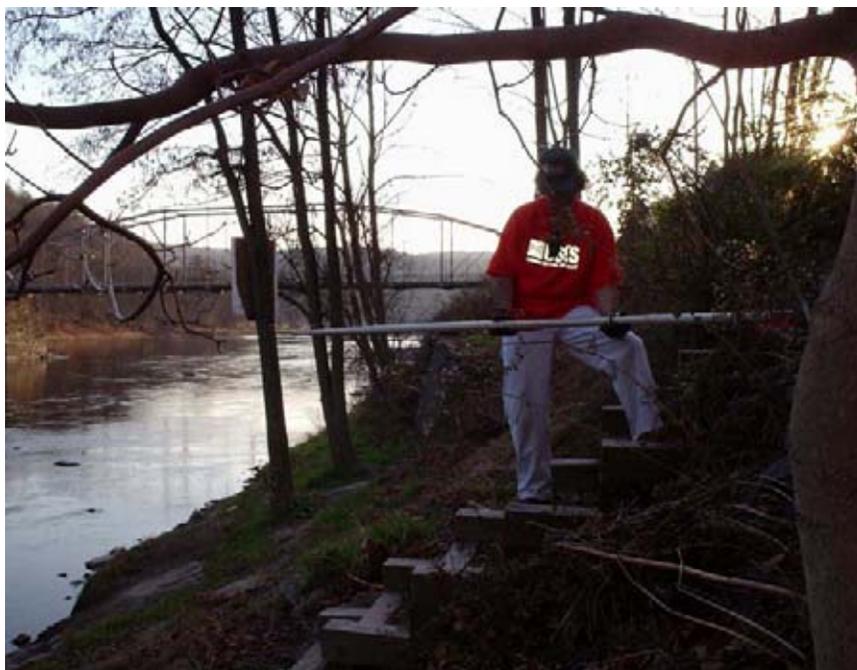
High-water mark 28.4 is a fair debris line on the ground, under the wooden steps on the left bank, 273 feet downstream from the County Route 41 bridge, at elevation 523.69 feet above sea level (Lat 41° 26' 26.3", long 74° 49' 10.1").

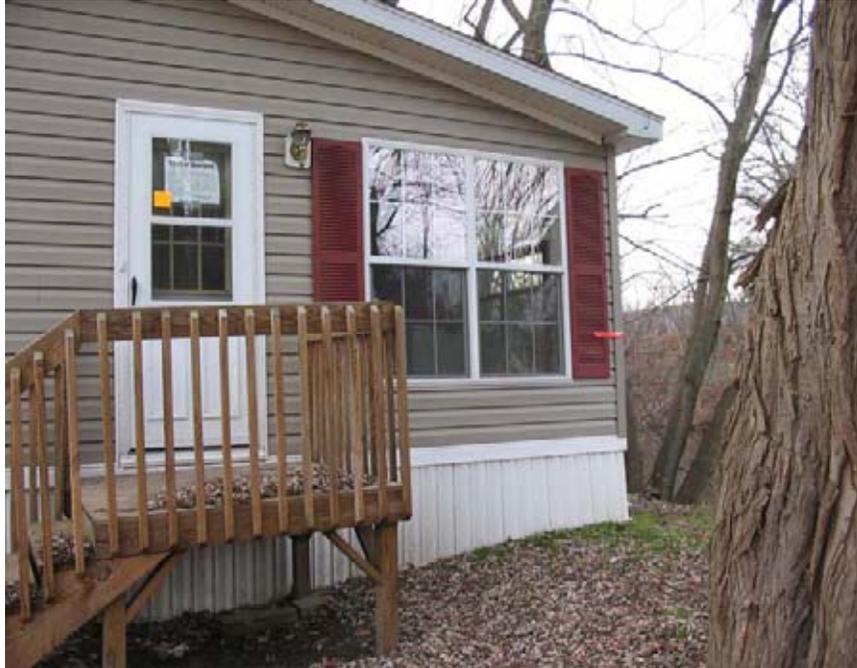
High-water mark 29.1 (bottom of orange flagging) is an excellent seed line about 5 feet above the ground, on house 25 on Butler Road, on the left bank, 430 feet upstream from the westbound (upstream) Interstate Route 84 bridge, at elevation 428.30 feet above sea level (Lat 41° 21' 28.0", long 74° 41' 33.1").

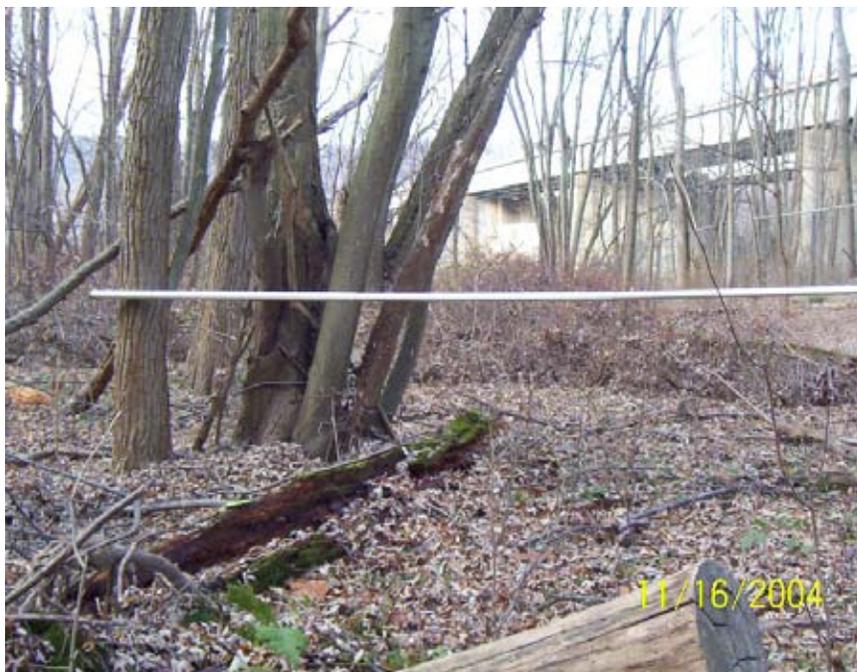
High-water mark 29.4 is a fair seed line about 4 feet above the ground, on a tree on the left bank, 100 feet downstream from the eastbound (downstream) Interstate Route 84 bridge, at elevation 428.18 feet above sea level (Lat 41° 21' 23.3", long 74° 41' 35.7").

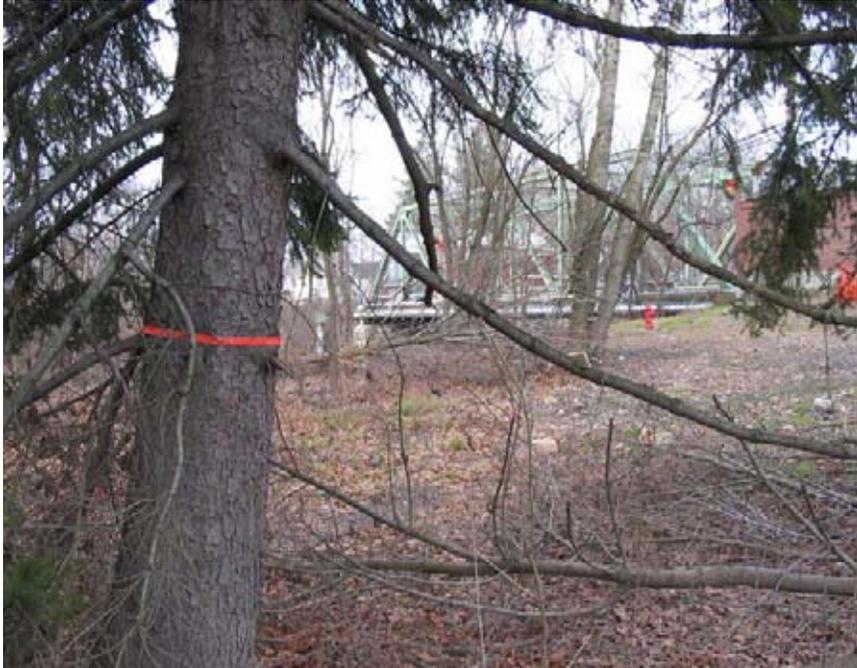
High-water mark 30.1 (bottom of orange flagging) is a fair seed line about 6 feet above the ground, on a tree on the left bank, 95 feet downstream from the State Route 6 bridge, at elevation 428.37 feet above sea level (Lat 41° 21' 38.5", long 74° 41' 07.4").

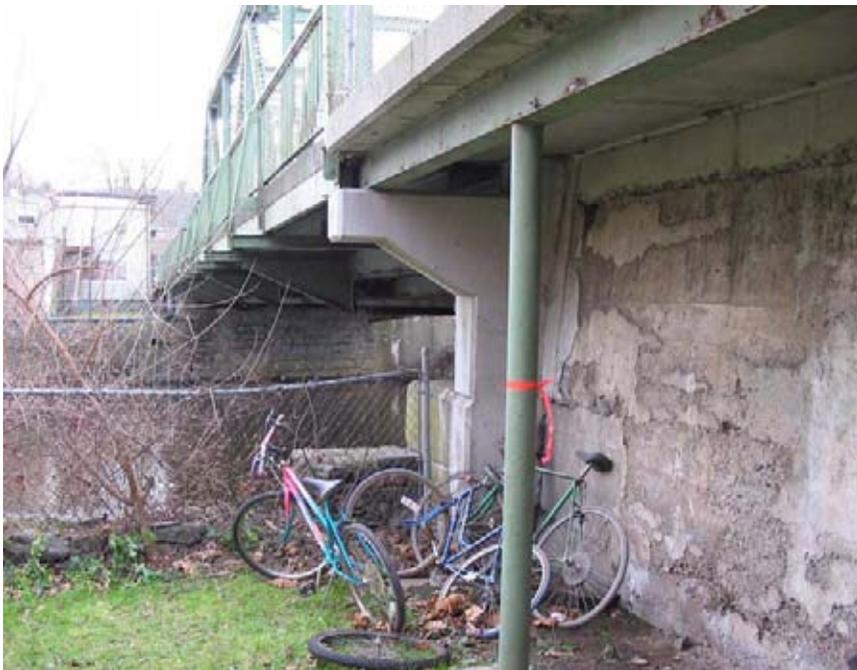
High-water mark 30.7 (bottom of orange flagging) is an excellent seed line about 4 feet above the ground, on a support post on the right bank, at the upstream side of the State Route 6 bridge, at elevation 428.57 feet above sea level (Lat 41° 21' 40.6", long 74° 41' 07.3").

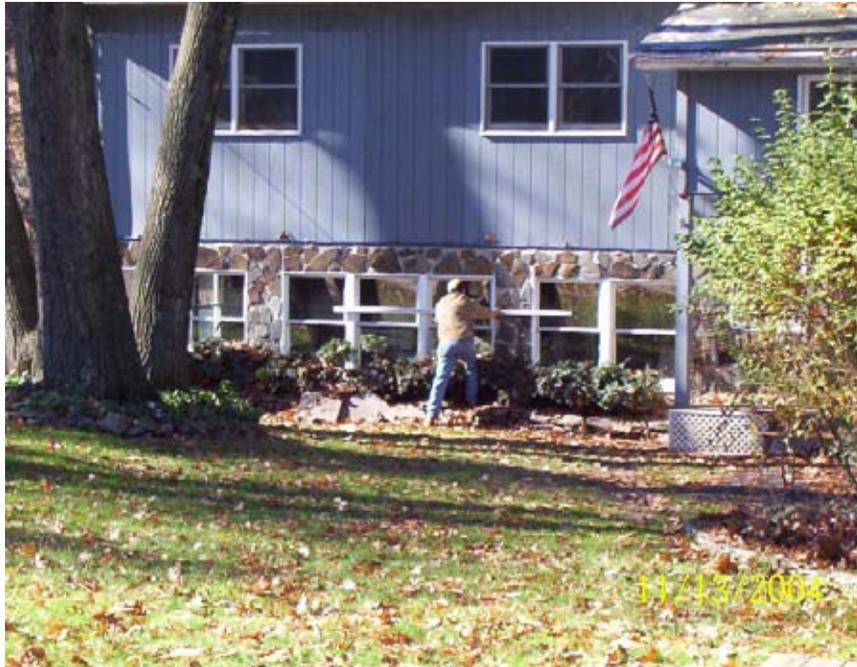
High-water mark 31.1 is an excellent mud line about 4 feet above the ground, on the landward side of house 23 on Rivers Edge Road, on the left bank, at elevation 429.01 feet above sea level (Lat 41° 22' 17.4", long 74° 40' 45.3").

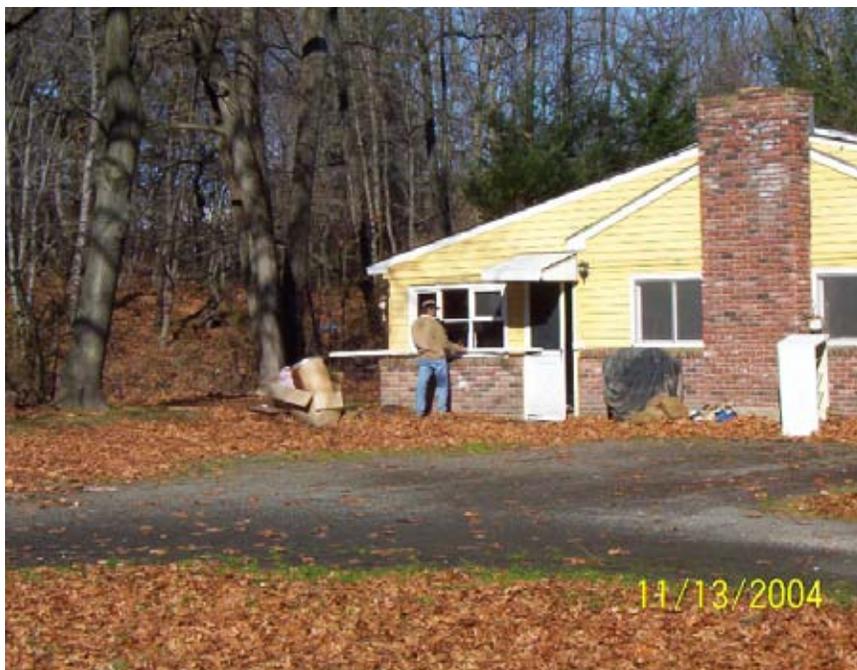
High-water mark 31.4 is an excellent mud line about 3 feet above the ground, on the downstream side of house 33 on Rivers Edge Road, on the left bank, at elevation 429.08 feet above sea level (Lat 41° 22' 24.5", long 74° 40' 42.4").

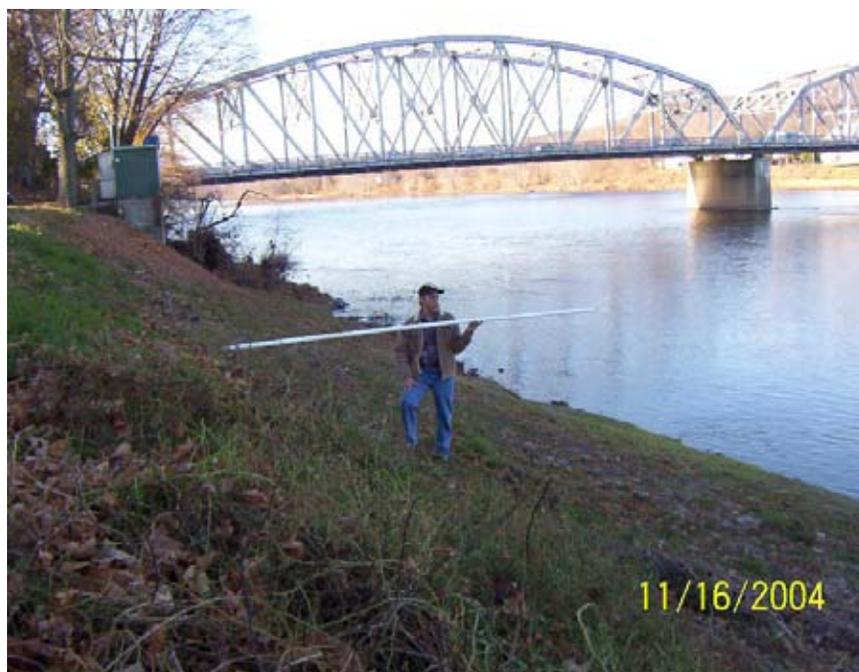
High-water mark 32.2 is a fair debris line on the ground, on the right bank, 110 feet downstream from the USGS gaging station 01434000, 360 feet downstream from U.S. Routes 6 and 209 bridge, at elevation 435.51 feet above sea level (Lat $41^{\circ} 22' 13.3''$, long $74^{\circ} 41' 48.5''$).

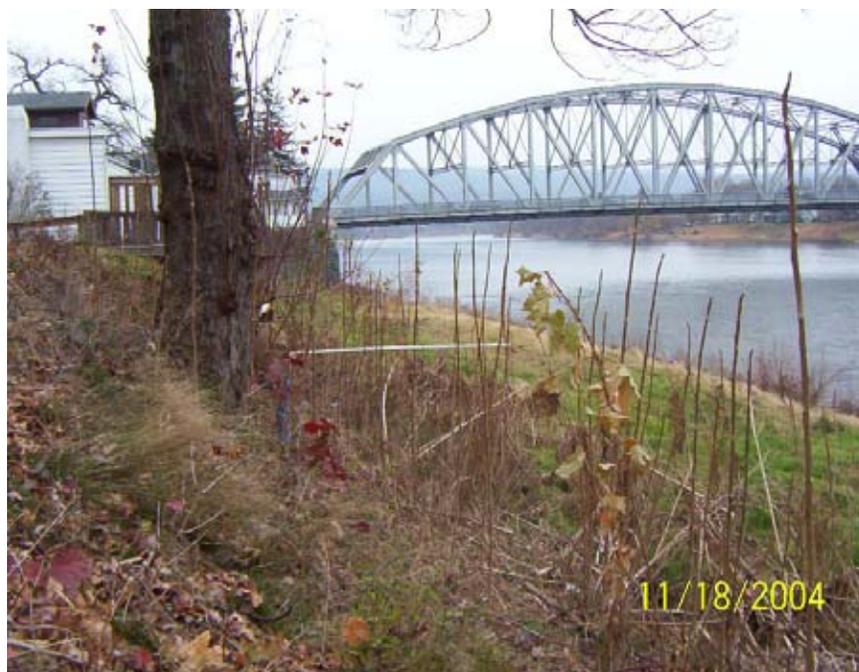
High-water mark 32.5 is a fair debris line on the ground, on the left bank, 344 feet upstream from the U.S. Routes 6 and 209 bridge, at elevation 436.46 feet above sea level (Lat $41^{\circ} 22' 23.6''$, long $74^{\circ} 41' 50.3''$).

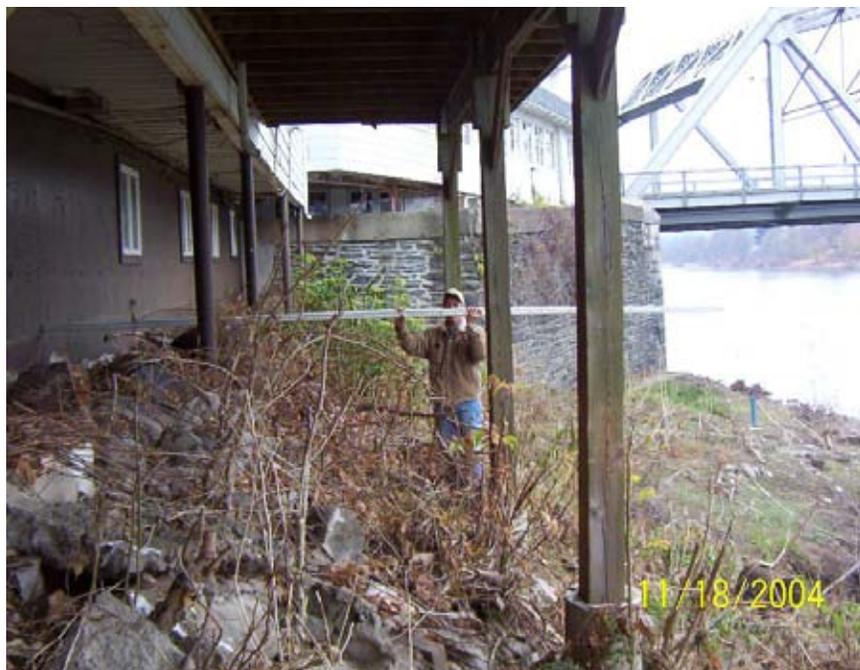
High-water mark 32.8 is a good mud line about 2 feet above the ground, on the streamward side of a restaurant on the left bank, 130 feet upstream from the U.S. Routes 6 and 209 bridge, at elevation 436.51 feet above sea level (Lat 41° 22' 22.0", long 74° 41' 48.3").

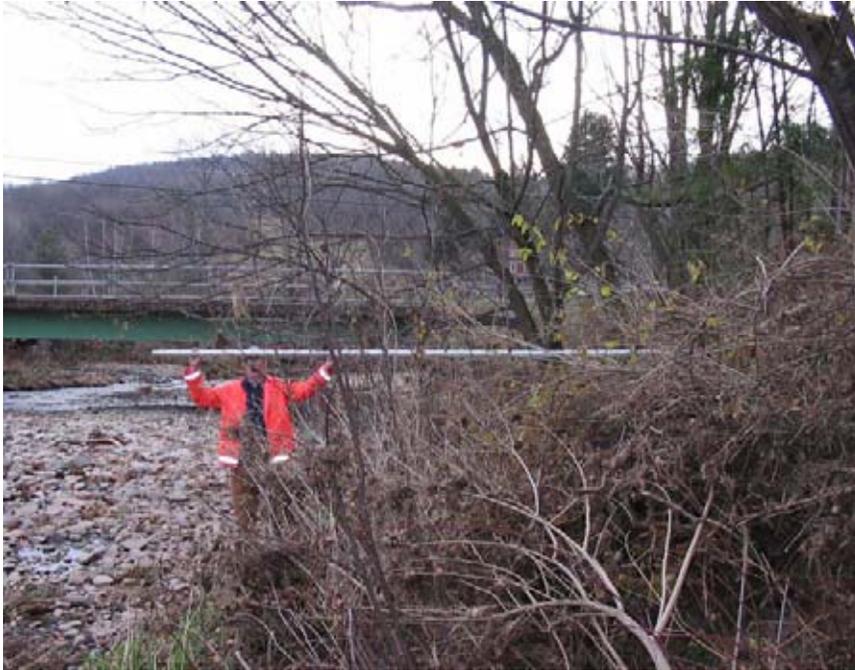
High-water mark 33.1 is a poor debris line on the ground, on the right bank, 75 feet upstream from the County Route 146 bridge, at elevation 1,465.23 feet above sea level (Lat 41° 52' 50.3", long 74° 48' 31.0").

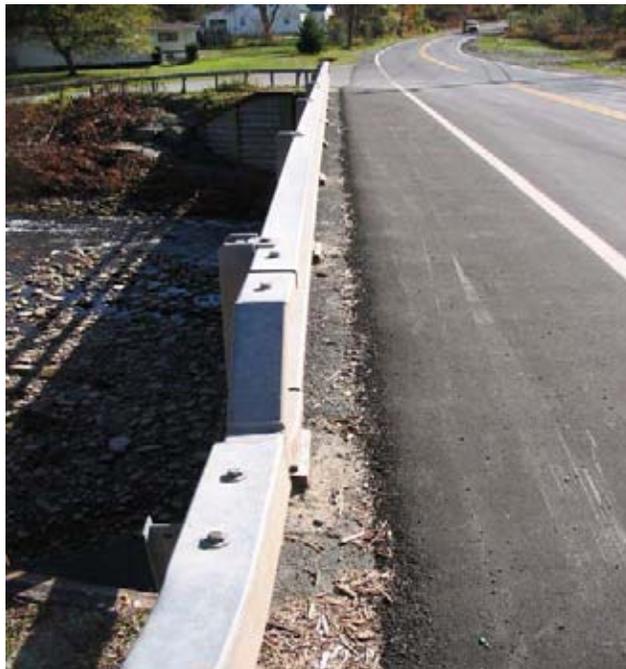
High-water mark 33.6 from communication with homeowner, is at the base of a tree, on the left bank, 57 feet upstream from the County Route 146 bridge, at elevation 1,466.22 feet above sea level (Lat 41° 52' 48.9", long 74° 48' 30.3"). Tree is visible in upper left corner of above photo. Note debris on upstream side of bridge.

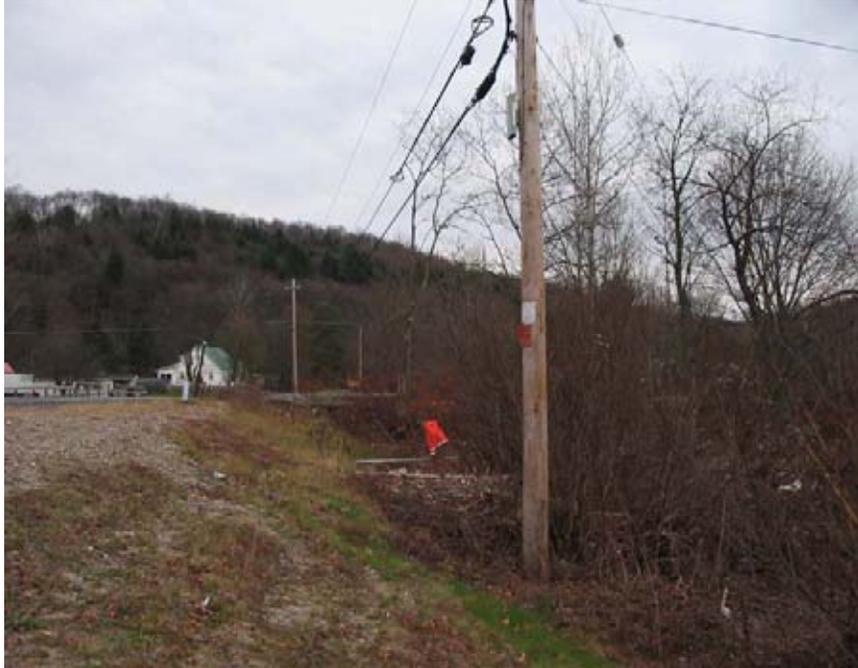
High-water mark 33.10 is a poor debris line on the ground, on the right bank, 107 feet downstream from the County Route 146 bridge, at elevation 1,462.70 feet above sea level (Lat 41° 52' 50.4", long 74° 48' 33.9").

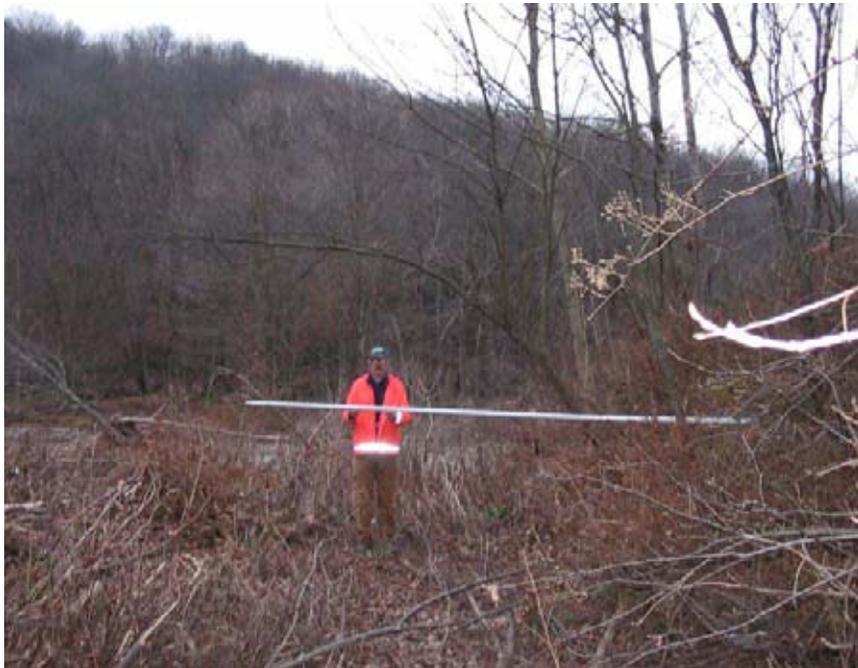
High-water mark 33.8 is a poor debris line on the ground, on the right bank, 340 feet downstream from the County Route 146 bridge, at elevation 1,459.66 feet above sea level (Lat 41° 52' 52.9", long 74° 48' 35.7").

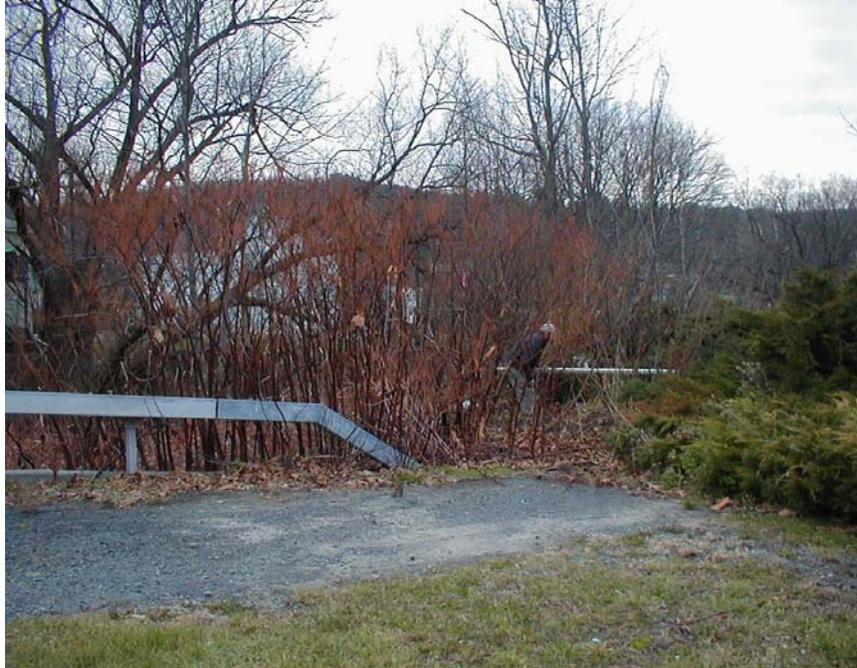
High-water mark 34.1 is a poor debris line on the ground, on the right bank of Little Beaver Kill, 251 feet downstream from the Main Street bridge, at elevation 1,420.45 feet above sea level (Lat 41° 54' 4.1", long 74° 49' 44.7").

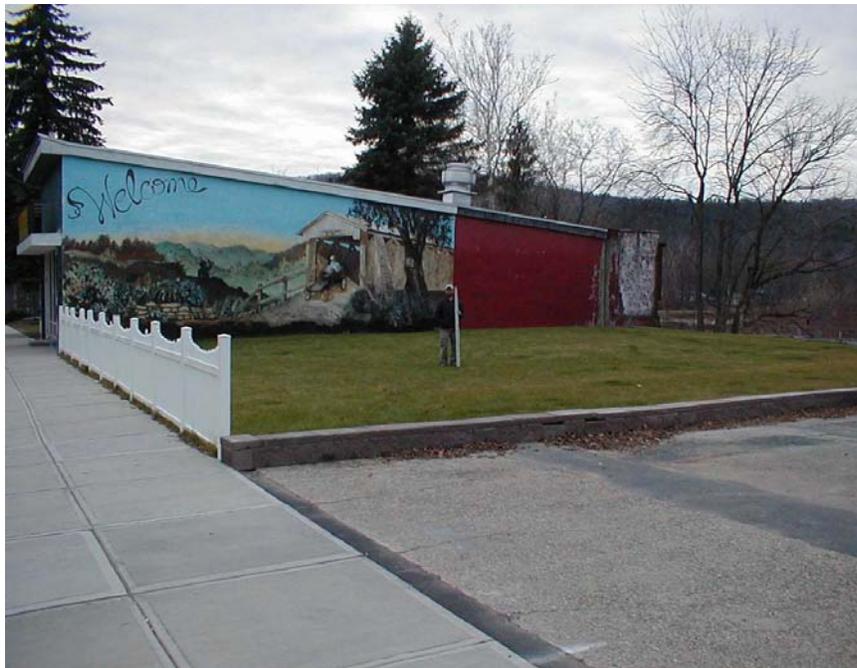
High-water mark 34.2 from communications with business owners and photos taken during the flood, is on the ground, on the left bank of Willowemoc Creek, 436 feet northeast from the northeast end of the Main Street bridge, at elevation 1,423.53 feet above sea level (Lat 41° 54' 04.9", long 74° 49' 37.9").

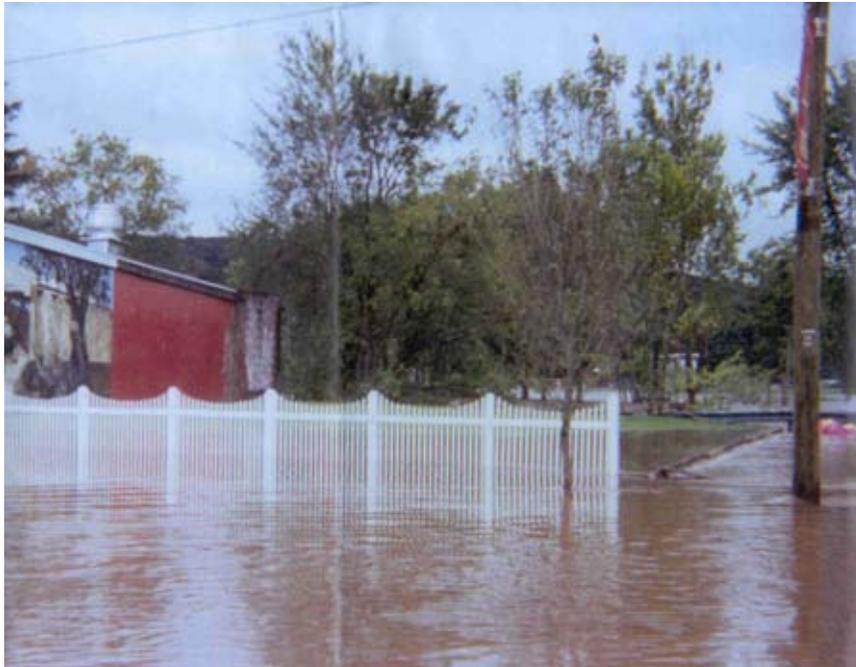
High-water mark 34.2 photo provided by George Fulton, Surveyor, Livingston Manor. Note water surface on grass.

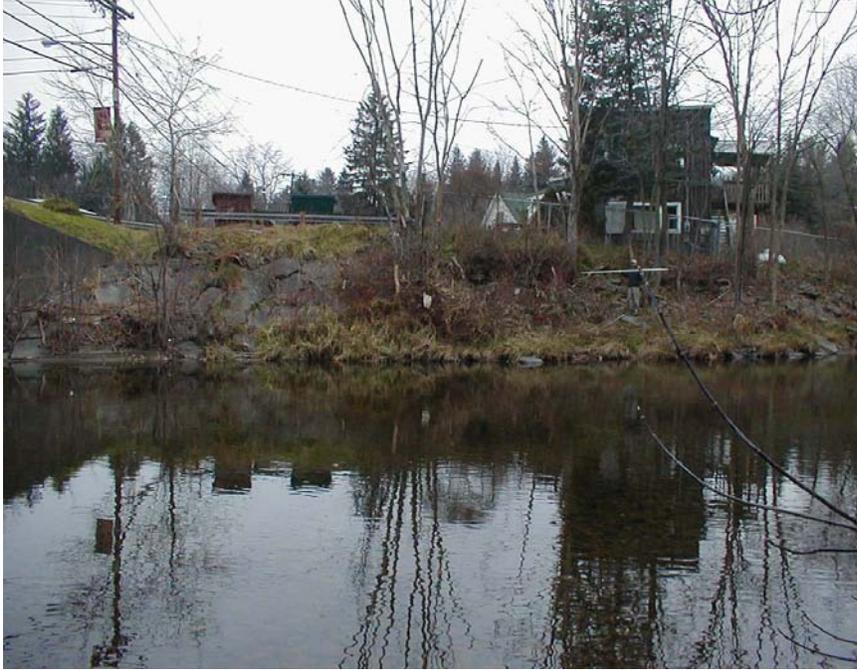
High-water mark 35.1 is a poor debris line on the ground, on the right bank, 90 feet upstream from the County Route 178 bridge, at elevation 1,426.34 feet above sea level (Lat 41° 54' 13.2", long 74° 49' 26.0").

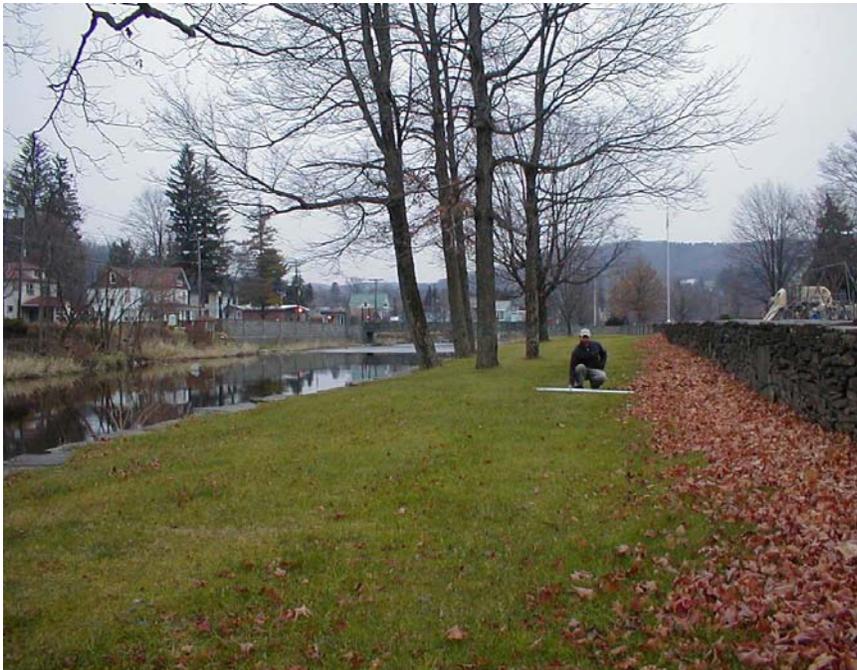
High-water mark 35.3 from communications with business owners and photos taken during the flood, is on the ground, on the right bank, 162 feet downstream from the County Route 178 bridge, at elevation 1,423.20 feet above sea level (Lat 41° 54' 11.6", long 74° 49' 30.1").

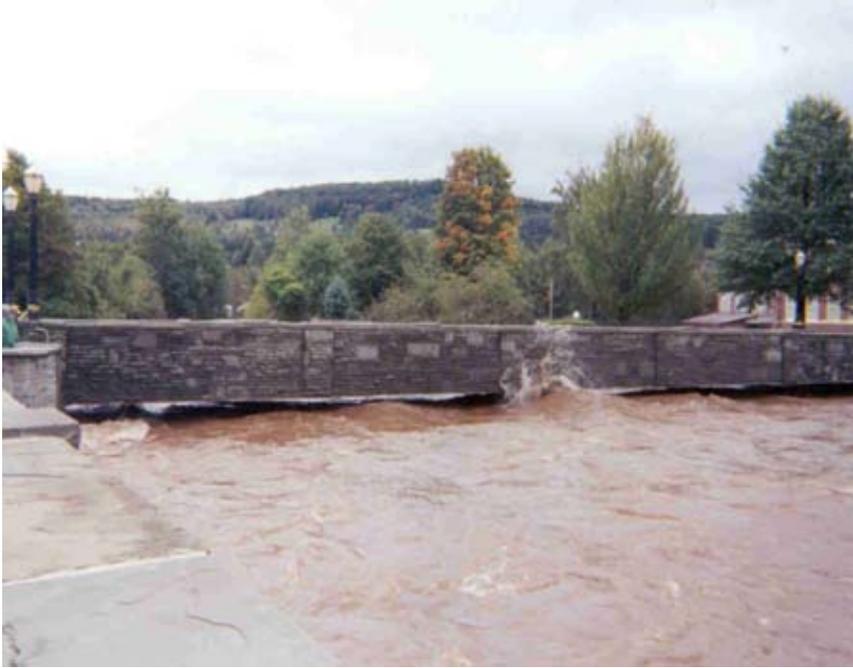
High-water photo provided by George Fulton, Surveyor, Livingston Manor. Walkway is located about 550 feet downstream from the County Route 178 bridge, low chord of walkway near left bank at elevation 1,424.6 feet above sea level (Lat 41° 54' 07.8", long 74° 49' 34.2").

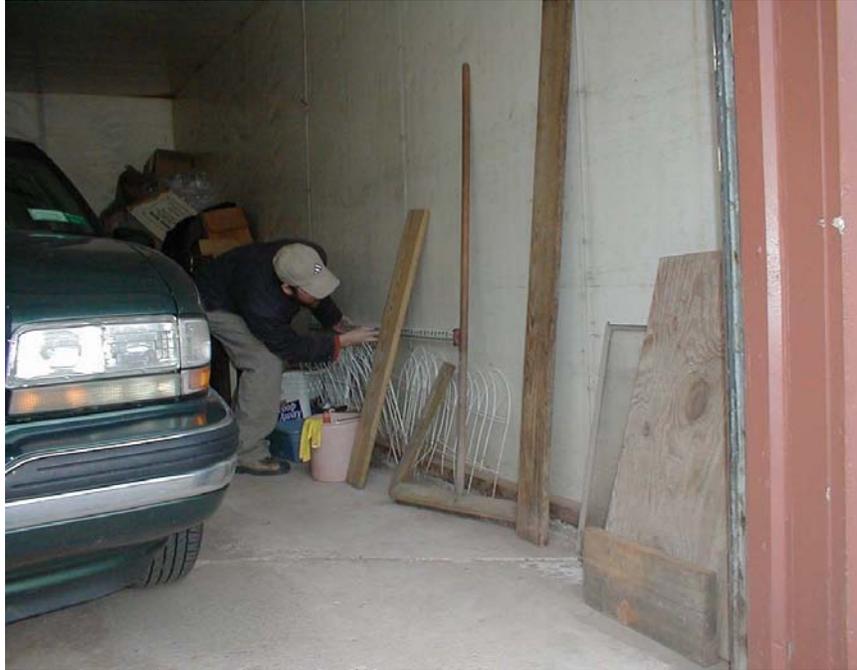
High-water mark 36.1 is a good mud line about 2 feet above the floor, on garage wall of house 32 on Pearl Street, on the right bank, 719 feet upstream from the Main Street bridge, at elevation 1,424.60 feet above sea level (Lat 41° 53' 58.4", long 74° 49' 33.2").

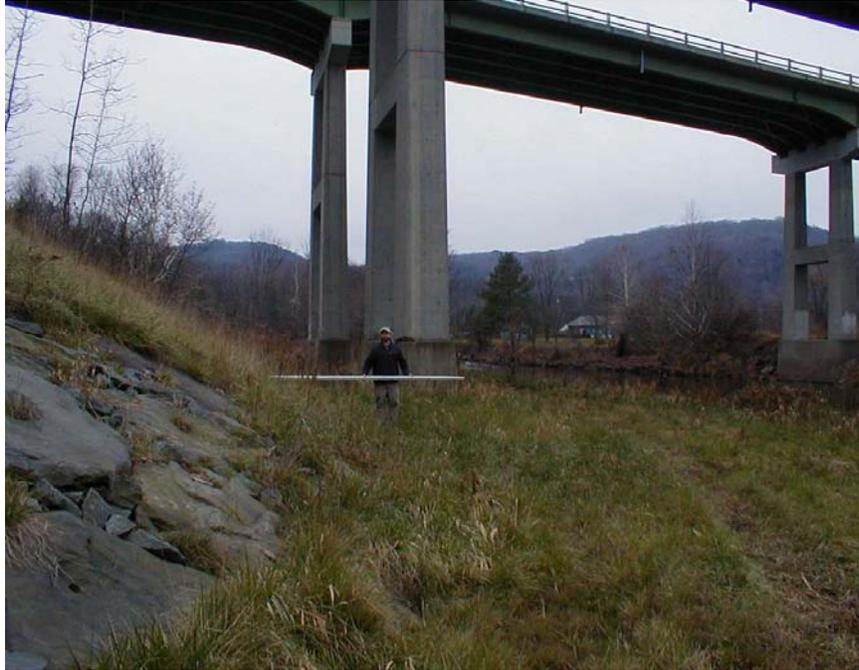
High-water mark 37.1 is a poor debris line on the ground, on the right bank, 51 feet downstream from the westbound (downstream) State Route 17 bridge, at elevation 1,402.42 feet above sea level (Lat 41° 54' 40.9", long 74° 49' 45.5").

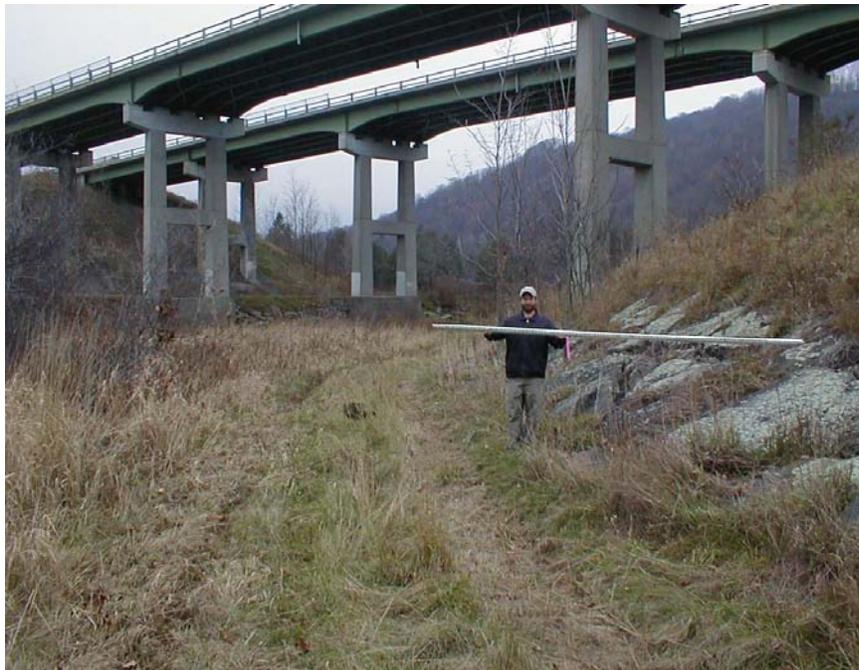
High-water mark 37.4 is a poor debris line on the ground, on the right bank, 102 feet upstream from the eastbound (upstream) State Route 17 bridge, at elevation 1,404.14 feet above sea level (Lat 41° 54' 38.4", long 74° 49' 46.8").

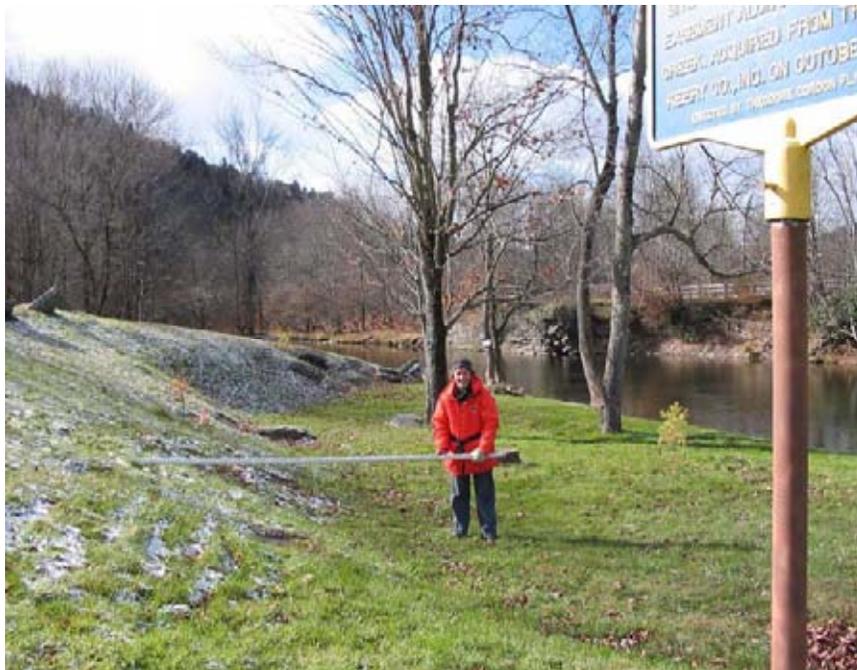
High-water mark 38.1 is a poor debris line on the ground, on the left bank, 56 feet downstream from the Hazel Road bridge, at elevation 1,337.43 feet above sea level (Lat 41° 55' 33.7", long 74° 52' 30.6").

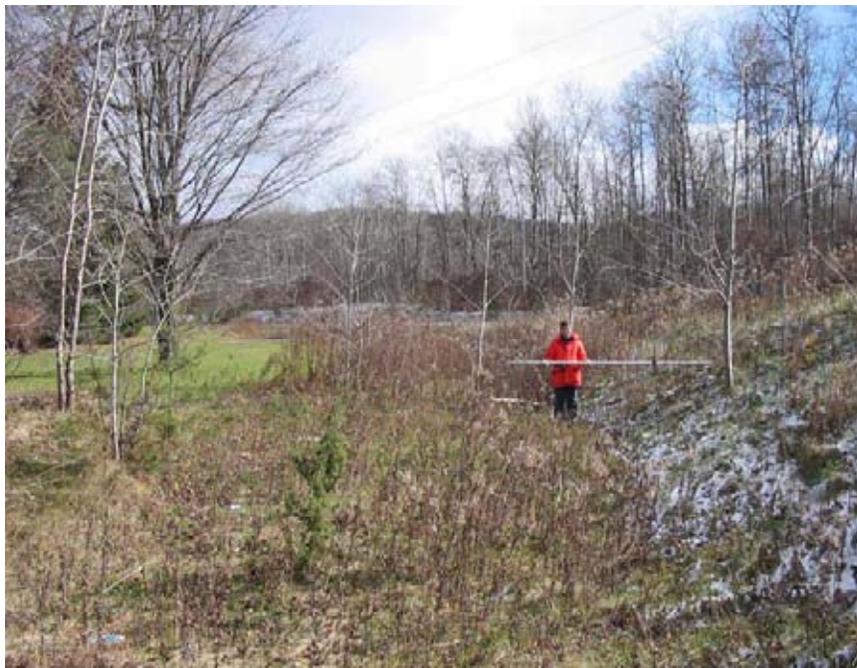
High-water mark 38.5 is a poor debris line on the ground, on the left bank, 116 feet upstream from the Hazel Road bridge, at elevation 1,338.06 feet above sea level (Lat 41° 55' 33.6", long 74° 52' 28.3").

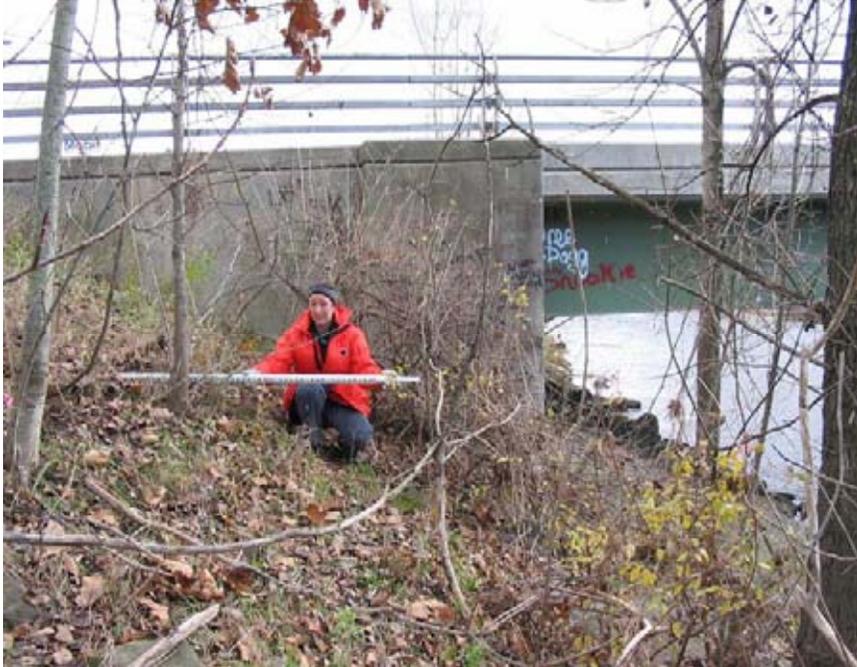
High-water mark 39.1 is a poor debris line on the ground, on the right bank, 12 feet downstream from the Stewart Avenue bridge, at elevation 1,282.24 feet above sea level (Lat 41° 55' 50.5", long 74° 54' 53.2").

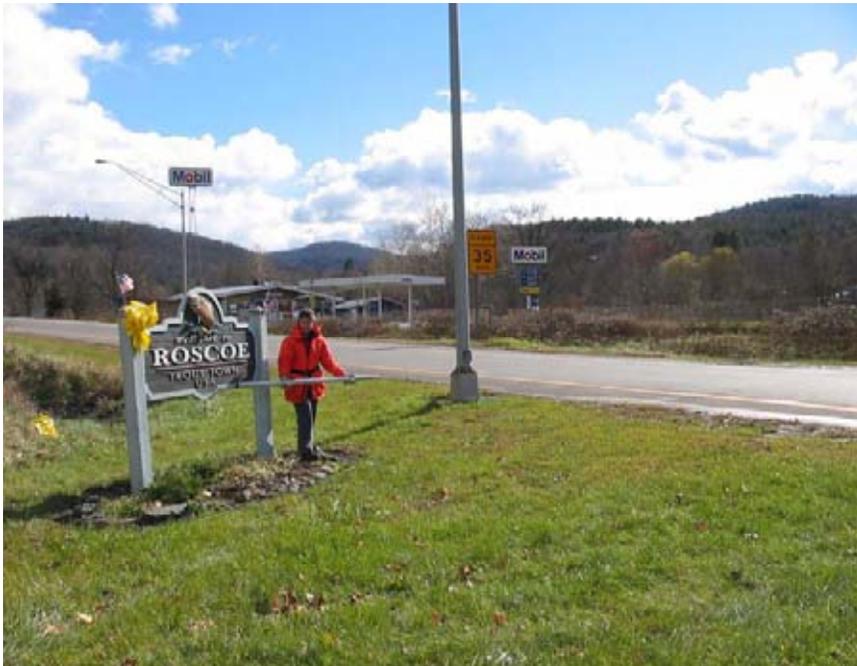
High-water mark 39.4 from communication with business owner, is 2 inches above the bottom of the Roscoe sign, on the right bank, 230 feet landward and about 50 feet upstream from the Stewart Avenue bridge, at elevation 1,283.20 feet above sea level (Lat 41° 55' 51.9", long 74° 54' 50.6").

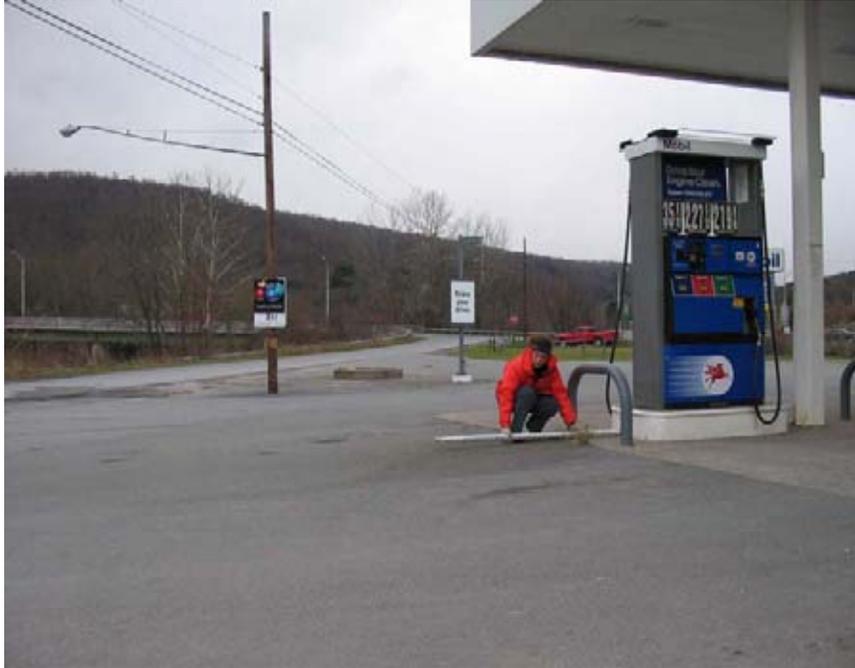
High-water mark 39.5 from communication with business owner, is at the bottom of the concrete base of pump number 6 at the Mobil station, on the right bank, 368 feet upstream from the Stewart Avenue bridge, at elevation 1,284.33 feet above sea level (Lat 41° 55' 48.7", long 74° 54' 48.5").

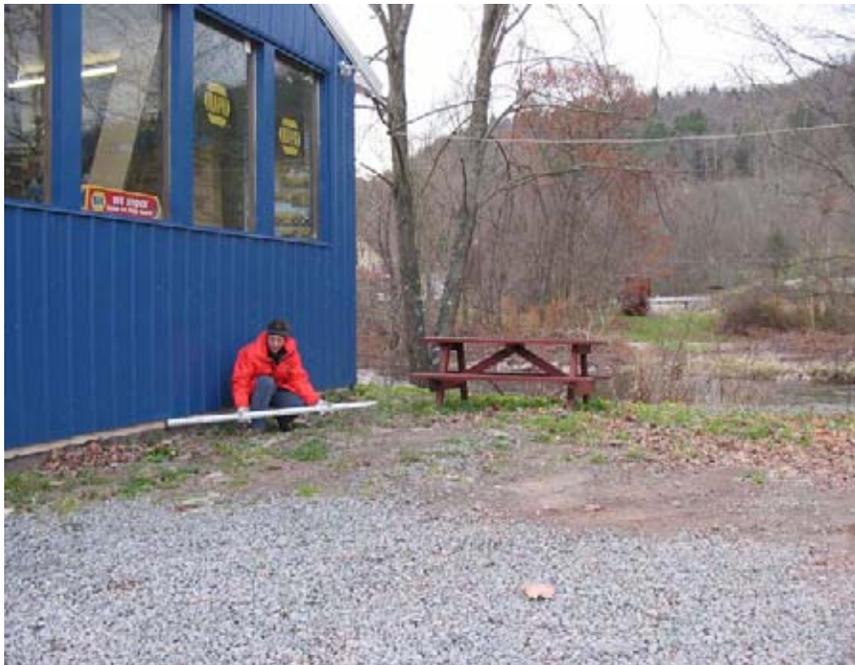
High-water mark 39.6 from communication with business owner, is at the bottom of the blue siding of the NAPA store, on the right bank, 665 feet upstream from the Stewart Avenue bridge, at elevation 1,284.35 feet above sea level (Lat 41° 55' 46.4", long 74° 54' 46.0").

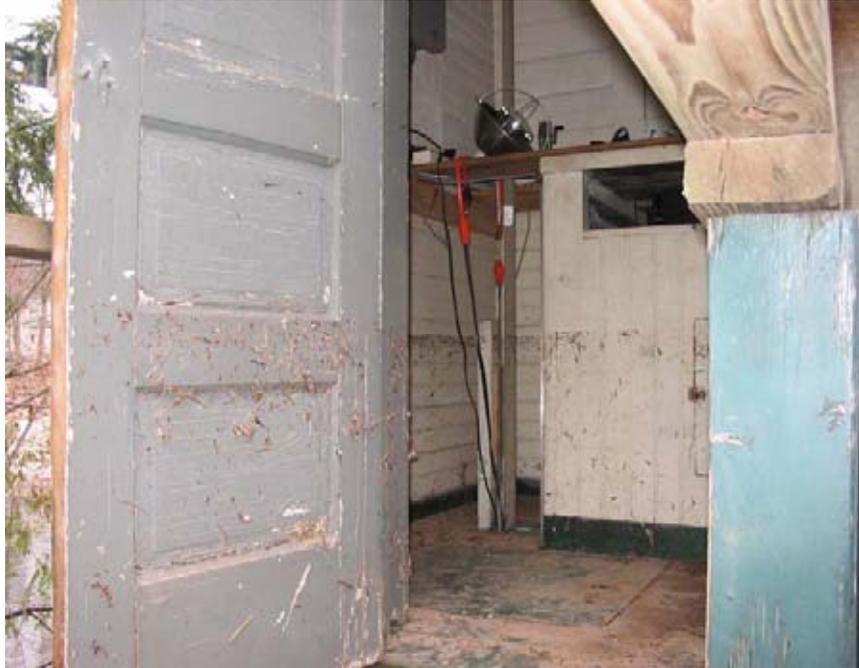
High-water mark 40-A.1 is a good seed line about 2 feet above the floor, inside of the USGS gage house, on the left bank, 125 feet downstream from the Cooks Brook Road bridge, at elevation 1,169.61 feet above sea level (Lat 41° 56' 46.8", long 74° 58' 47.4").

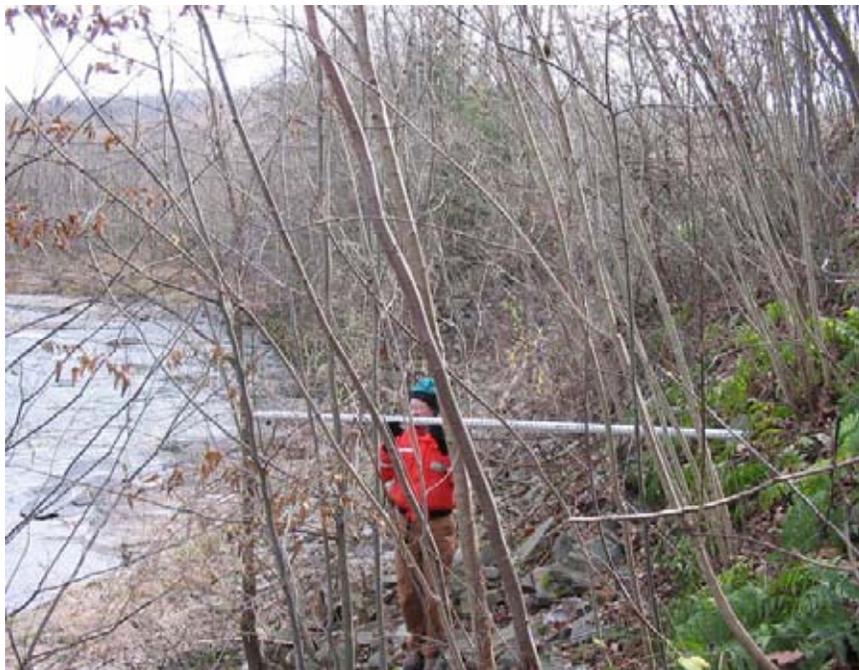
High-water mark 40-A.2 is a poor debris line on the ground, on the left bank, 51 feet upstream from the Cooks Brook Road bridge, at elevation 1,173.67 feet above sea level (Lat 41° 56' 46.7", long 74° 58' 45.1").

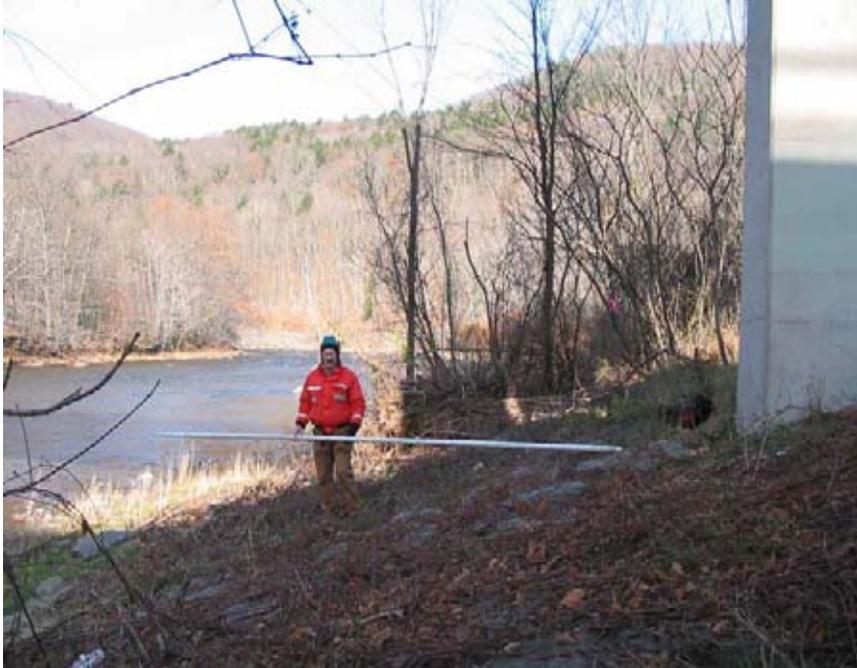
High-water mark 40-B.5 is a poor debris line on the ground, on the right bank, at the downstream side of the westbound (upstream) State Route 17 bridge, at elevation 1,194.89 feet above sea level (Lat 41° 57' 01.9", long 74° 57' 55.4").

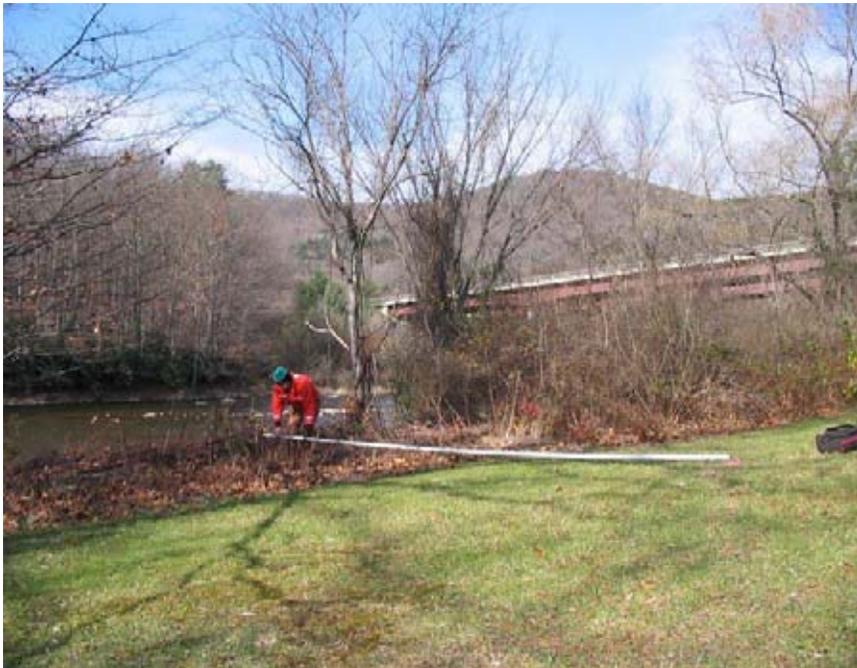
High-water mark 40-B.7 is a good debris line on the ground, on the right bank, 296 feet upstream from the eastbound (downstream) State Route 17 bridge, at elevation 1,196.04 feet above sea level (Lat 41° 56' 57.5", long 74° 57' 56.5").

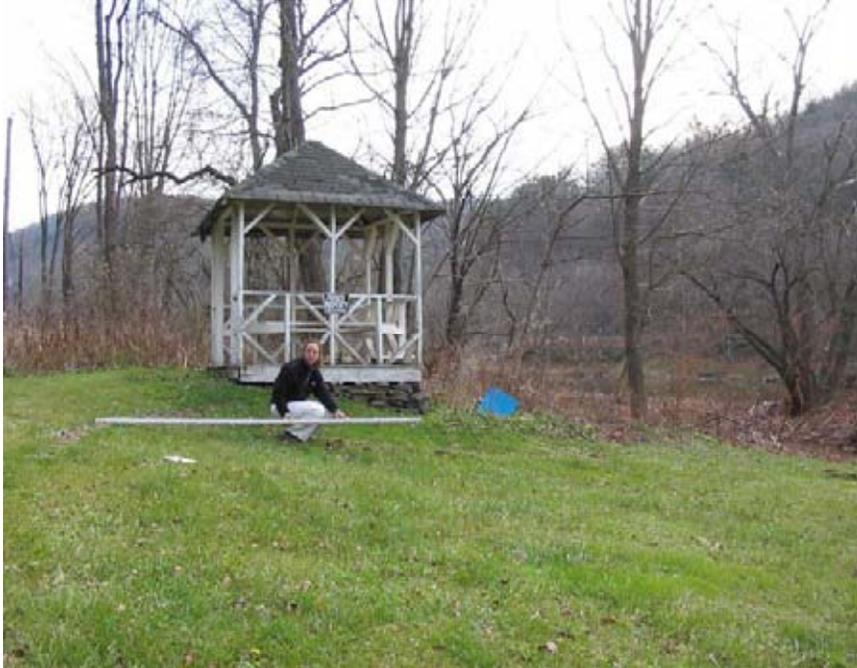
High-water mark 41.1 is a fair debris line on the ground, across the road from house 227 on Cooks Falls Road, on the right bank, at elevation 1,154.76 feet above sea level (Lat 41° 57' 19.1", long 74° 59' 23.9").
