FLOOD OF SEPTEMBER 18-19, 2004 IN THE UPPER DELAWARE RIVER BASIN, NEW YORK

Open-File Report 2005-1166

By Lloyd T. Brooks

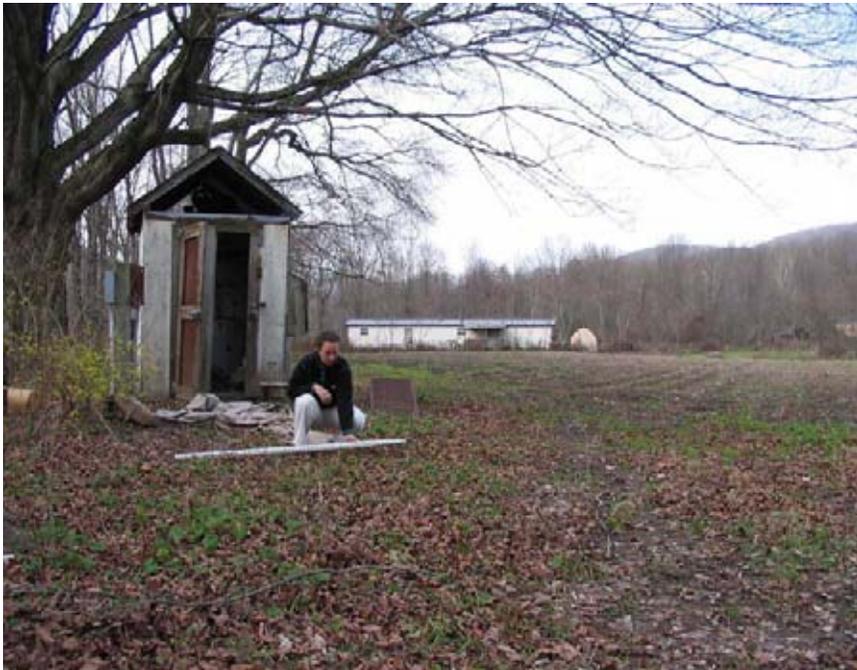
High-water mark 41.5 is a poor debris line on the ground, near a shed about 300 feet south from the firehouse on Cooks Falls Road, on the right bank, at elevation 1,153.12 feet above sea level (Lat 41° 57' 21.0", long 74° 59' 27.1").

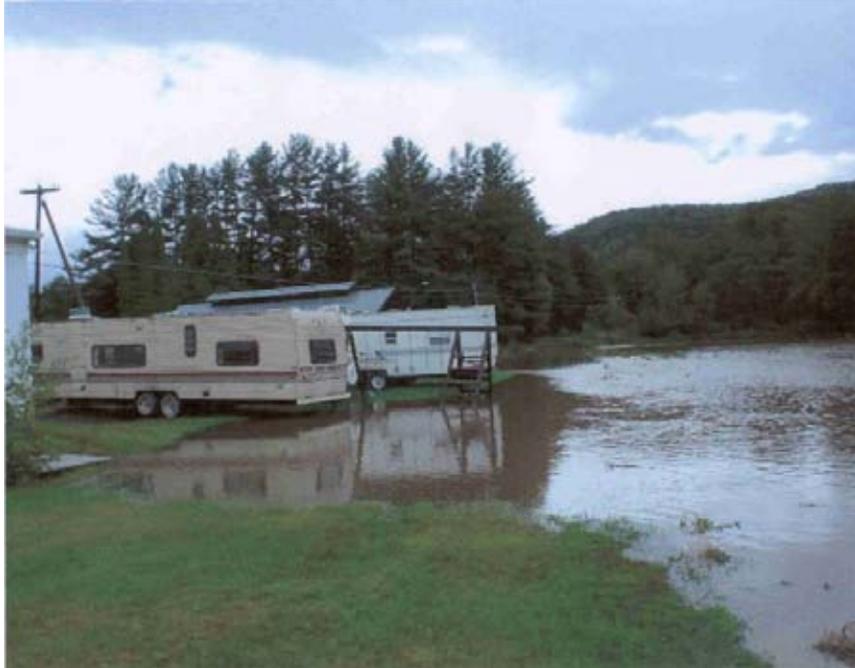
High-water mark 41.3 from communications with Town of Colchester personnel and photos taken during the flood, is at the corner of the concrete slab, of the firehouse on Cooks Falls Road, on the right bank, at elevation 1,152.87 feet above sea level (Lat 41° 57' 24.3", long 74° 59' 26.4"). Concrete slab is visible in extreme left of above photo.

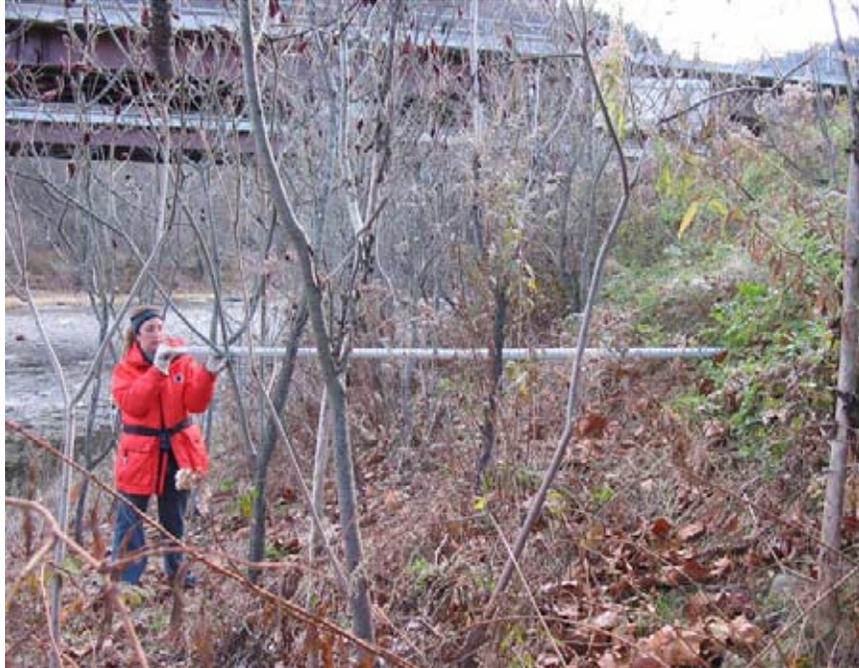
High-water mark 42.1 is a poor debris line on the ground, on the right bank, 110 feet upstream from the westbound (upstream) State Route 17 bridge, at elevation 1,120.49 feet above sea level (Lat 41° 58' 14.5", long 75° 01' 18.8").

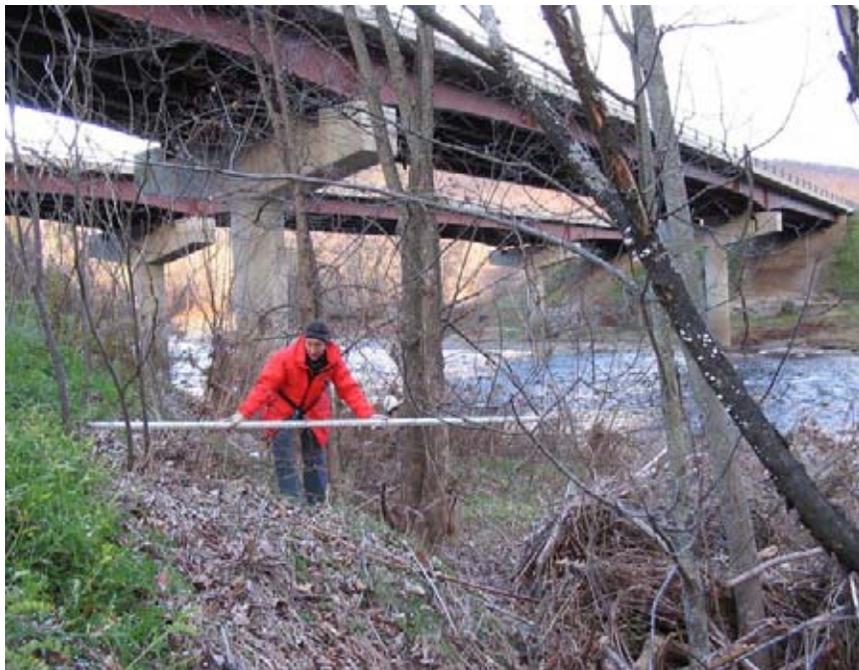
High-water mark 42.7 is a poor debris line on the ground, on the right bank, 35 feet downstream from the eastbound (downstream) State Route 17 bridge, at elevation 1,118.42 feet above sea level (Lat 41° 58' 12.3", long 75° 01' 20.2").
