New York Water Science Center News Volume 16, April 2013

U.S. Geological Survey, New York Water Science Center Newsletter

USGS Storm-Tide Gaging Network Measures Historic Storm-Tide Elevations

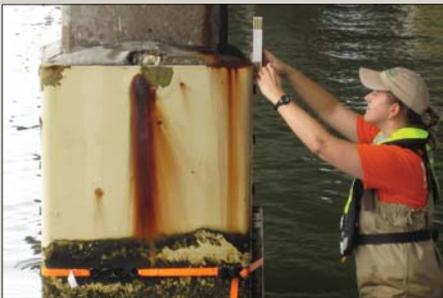
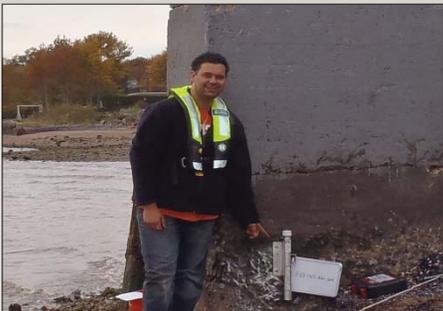
USGS Scientist deploying storm-surge sensors. Inside of these steel housings, a self-contained pressure transducer measures the height of water above it. These measurements are made every 6 minutes and stored internally. After the storm, the elevation of each transducer is measured—relative to some datum—and data are retrieved.

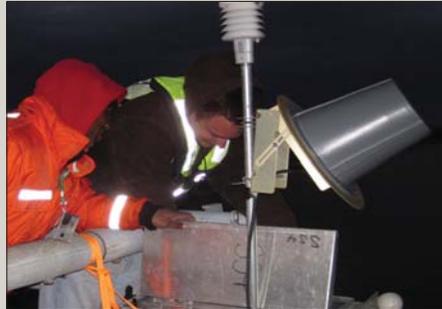
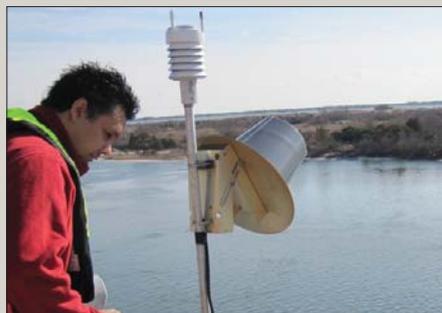
RDG installed on bridge over State Boat Channel, Captree Island, NY.

After the storm, USGS scientists and technicians retrieved the temporary storm-tide sensors and RDGs within 10 days after Hurricane Sandy's landfall. Two of the four RDGs were damaged during Hurricane Sandy and did not record the maximum storm tide, but the existing coastal gages generally fared better because they incorporate flood-resilient design features. The surviving RDGs—in Suffolk and Westchester Counties—recorded peak storm-tide elevations of 5.2 and 10.2 ft (feet) above mean sea level (NAVD 88 -- North American Vertical Datum of 1988), respectively.

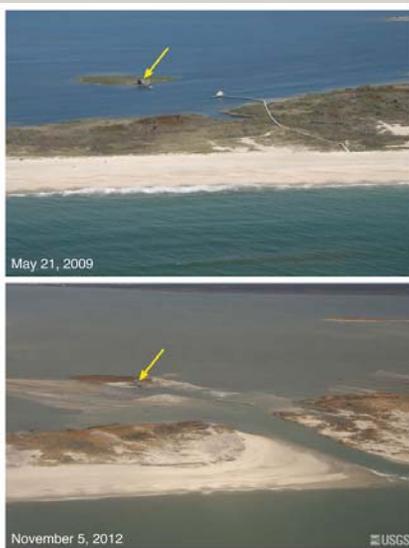
Oblique aerial photographs of Pelican Island and Fire Island, New York. The view is looking northwest across Fire Island towards Great South Bay. This location is within Fire Island National Seashore near Old Inlet—a very narrow portion of the island that has experienced breaching in previous large storms. The island breached during Hurricane Sandy, creating a new inlet. Despite the breach, the fishing shack (yellow arrow) remained standing.
